FLIGHT SAFETY

Crew Error Cited as Major Cause of U.S. Aerial Fire Fighting Accidents

Errors in judgment and deficiencies in crew resource management and compliance with standard operating procedures were common causes of U.S. aerial fire fighting accidents involving fixed-wing aircraft in 1976–1998.

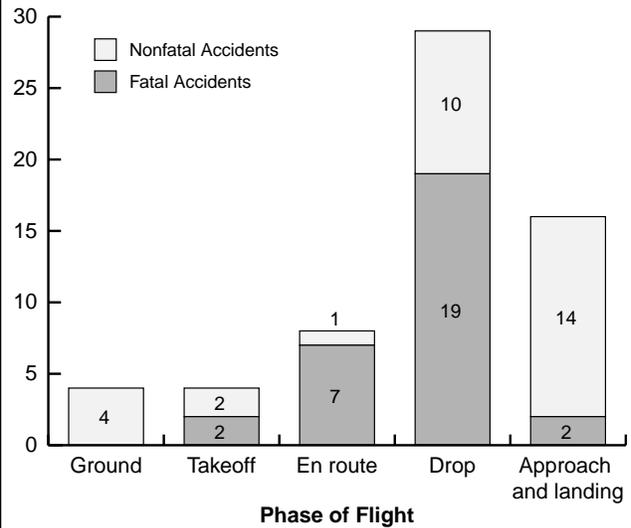
Figure 1

**Phase of Flight for 61 U.S. Aerial
Fire Fighting Airplane Accidents,
1976–1998**

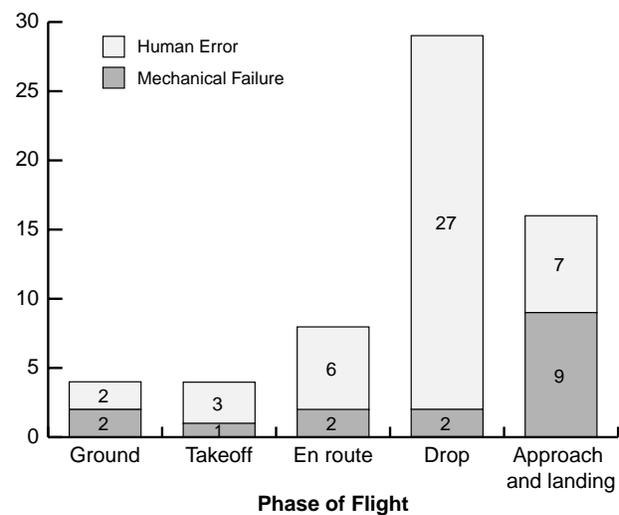
Figure 2 shows that human error was involved in 27 drop-phase accidents (93 percent) and that mechanical failure was involved in two drop-phase accidents (7 percent).

**Involvement of Human Error and
Mechanical Failure by Phase of Flight
In 61 U.S. Aerial Fire Fighting
Airplane Accidents, 1976–1998**

Figure 2 (page 2) shows that seven ALAs involved human error and nine ALAs involved mechanical failure.
