# FLIGHT SAFETY

## Safety Study

# Emergency Evacuation of Commercial Airplanes

NTSB Report

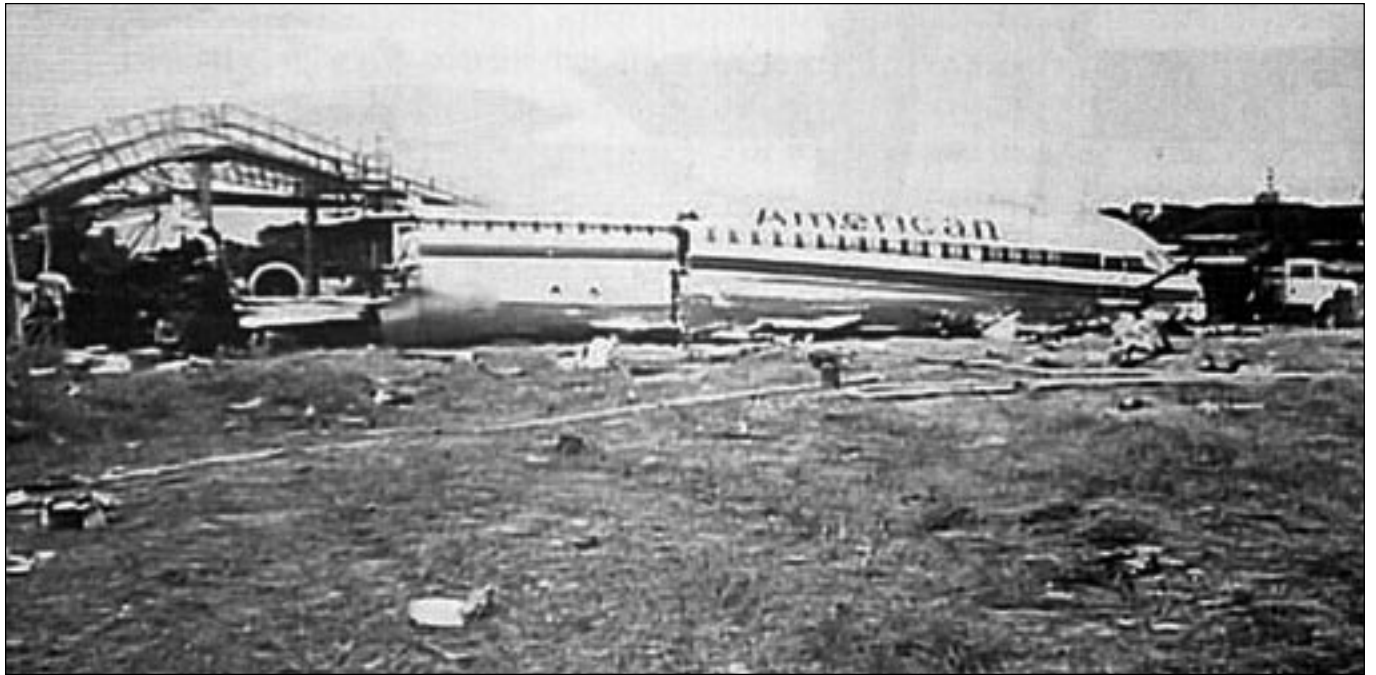
In the MD-82 accident in Little Rock, Arkansas (case 45), the crash forces caused seats to break free from their seat tracks and block aisles. In the forward portion of the cabin, passengers had to navigate around fallen overhead bins and across a severely deformed floor. Fortunately, the crash caused several gaps in the fuselage that passengers were able to use for egress. As seen in figure 5–3 (page 21), the crash forces split the cabin in two separate sections divided at the wing.

**Figure 5-3.** View of the McDonnell Douglas MD-82 accident scene that involved evacuation on June 1, 1999, Little Rock, Arkansas (case 45).

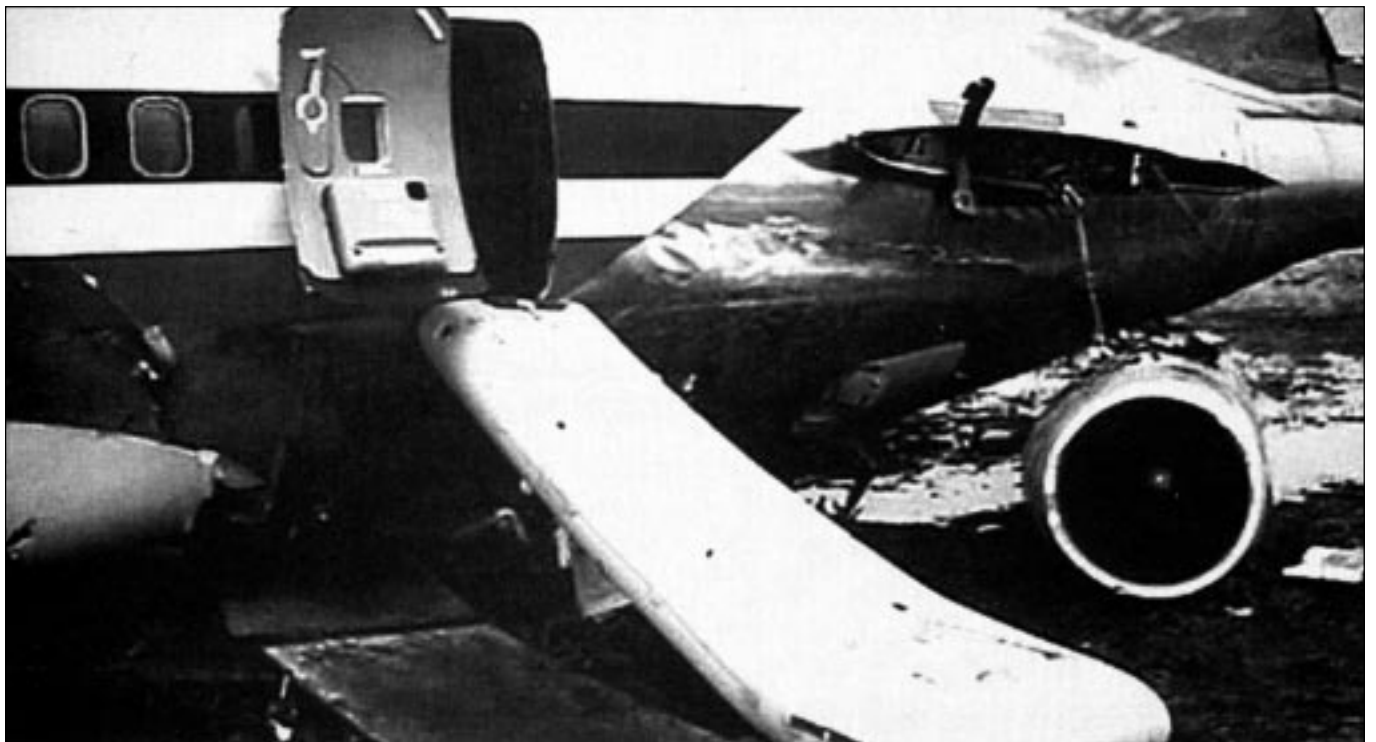
threshold. A liferaft ceiling panel door<sup>53</sup> fell open, blocking the main aisle to the L1 exit.<sup>54</sup> The flight attendant assigned to the L1 exit decided not to use the exit because the ceiling panel blocked access to the exit. Passengers evacuated through the R1, overwing, and L2 exits (figure 5-4).

**Figure 5-4.** View of a slide used in the Boeing 727 evacuation on February 9, 1998, Chicago, Illinois (case 9).

Based on the circumstances of the evacuation in this accident, the Safety Board recommended that the FAA

Identify all airplanes operated under Title 14 *Code of Federal Regulations* Part 121 with liferaft ceiling

stowage compartments or compartments that formerly stored liferafts that open downward and issue an airworthiness directive to limit the distance that those compartments can open. (A-99-10)<sup>55</sup>

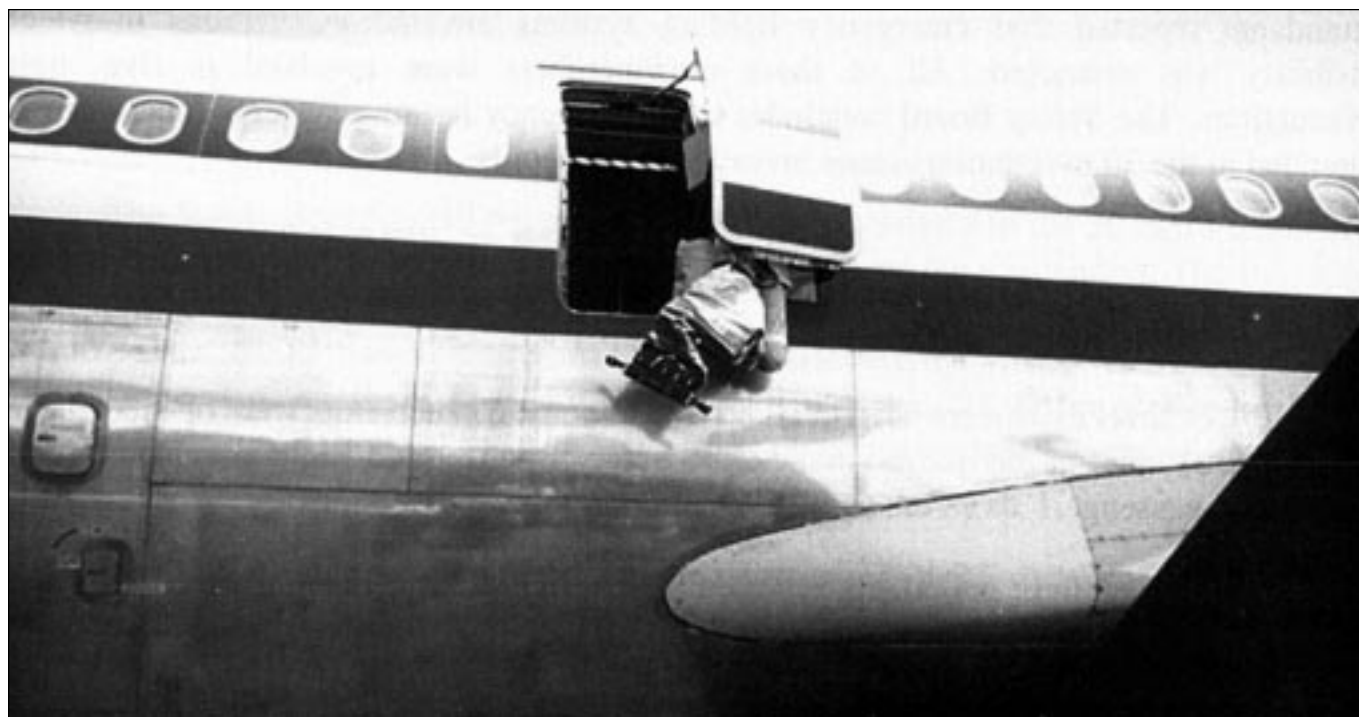
**Figure 5-5.** View of the R3 door that failed to operate as intended following the Airbus 300 accident on July 9, 1998, in San Juan, Puerto Rico (case 24).

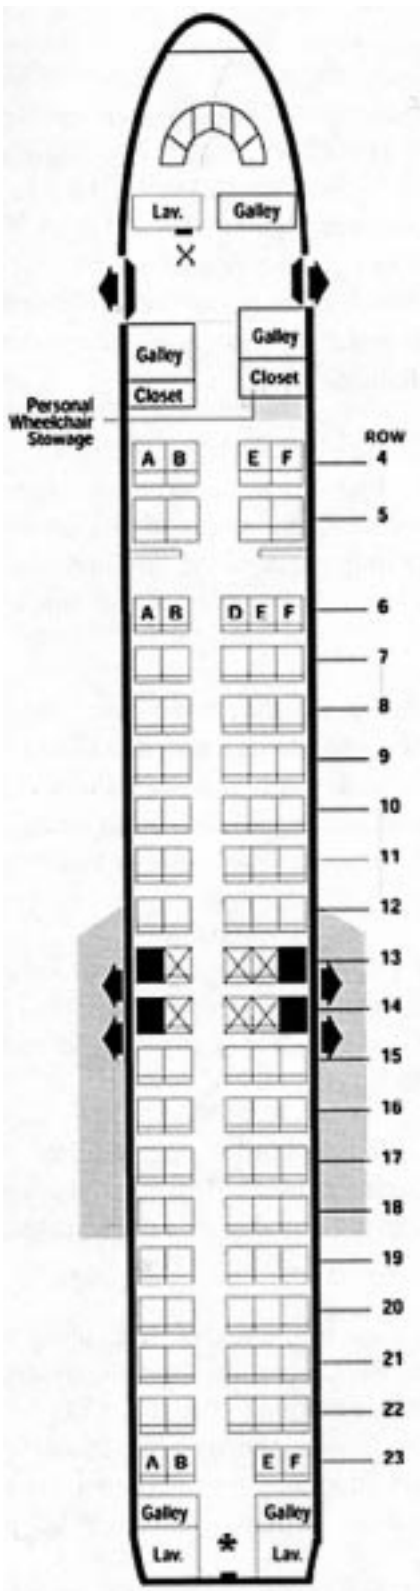
**Figure 5-8.** The Fokker 100 exit configuration. The aft flight attendant position is marked by the \*. The forward flight attendant position is marked by the X.

evacuation of an F100 in Charlotte, North Carolina (case 41) indicated that passenger evacuation in this case would have been helped had there been an emergency exit in the rear of the aircraft. The F100 on which the flight attendant was working was equipped with floor level exits in the forward part of the cabin and four overwing exits. The aft flight attendant's assigned primary exit was a forward overwing exit. The two right overwing exits were blocked by a fire on the right main gear. Passengers from the middle and rear of the airplane were evacuating from the two left overwing exits. The passengers at these exits operated their exits prior to the flight attendant reaching the overwing area.

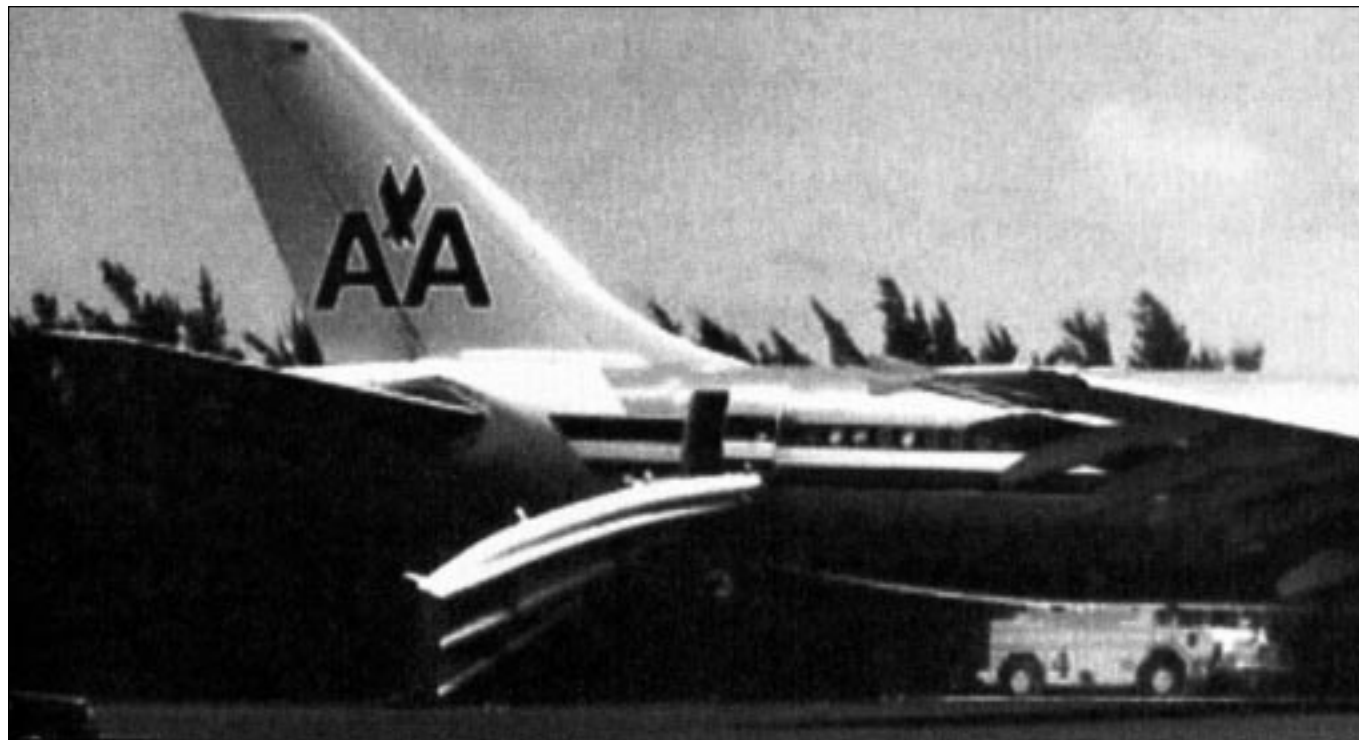
The failure of the R1 slide in the above evacuation reduced to one the number of exits originally selected by the flight crew for the 144 passengers and crew to evacuate the airplane. This occurrence was not unique to the study. On July 9, 1998, an A300 (case 24) experienced a fire in its No. 1 engine shortly after takeoff. The airplane returned to the airport and an emergency evacuation was executed on the runway. The captain ordered the evacuation on the right side of the airplane. The flight attendants were able to open and deploy the slides at R1, R2, and R4. However, there was a delay in deploying the R1 slide because of a failure of the power assist in the door. Also, the R3 door partially opened before jamming. The flight attendant tried repeatedly to open the door, but reported that he "knew [the slide] was caught up" in the pack. Postincident testing conducted by the Safety Board indicated that the malfunction might have been caused by a Velcro® fastener that became hooked on a clip on the inside of the decorative cover. In addition, the slide deployed at R4 was unusable for a period of time because winds were blowing the slide against the airplane (figure 5-9). During this time, the 234 passengers were exiting from only two of the eight exits on the A300.

**Figure 5-9.** View of the wind's effect (25-knot gusts) on the evacuation slide used following the Airbus 300 accident on July 9, 1998, in San Juan, Puerto Rico (case 24). Passengers were able to use this exit after a person on the ground held the slide in place.

Following the Safety Board's investigation of the A300 accident in San Juan on July 9, 1998, described earlier, the Board recommended that the FAA,
