JANUARY 1996

FLIGHT SAFETY

D I G E S T

Pilots Can Minimize the Likelihood of Roll Upset in Severe Icing

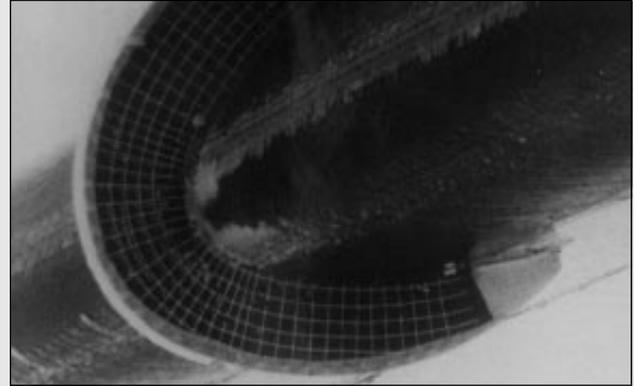
The severe icing conditions caused ice to form on, and aft of, the deicing boots while the accident airplane was holding with the flaps extended. The ice aft of the boots could not be shed, because the ice was not affected by the deicing boots, which were functioning normally. When the flaps were retracted while the aircraft’s airspeed remained constant, the airplane suffered a roll upset.

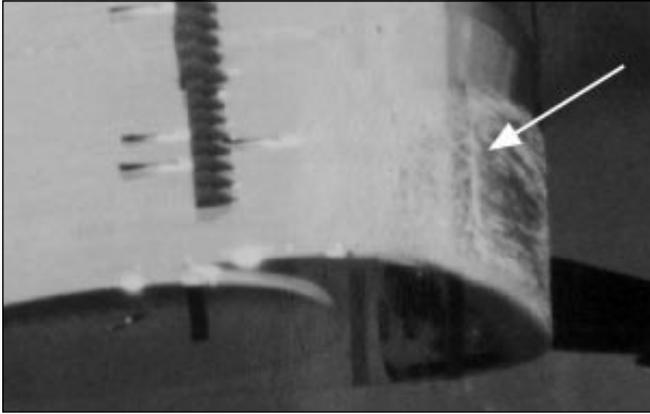
Ice tends to accrete more on the upper surface (arrow) at low angle-of-attack associated with higher speeds or flap extension.

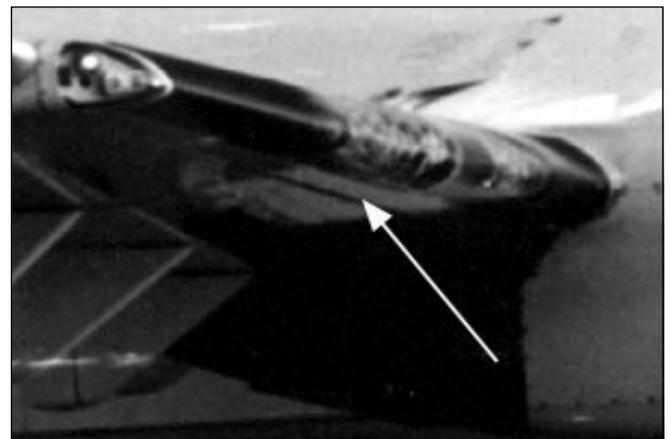
Ice tends to accrete more on the lower surface (arrow) at higher angle-of-attack (slower air speed).

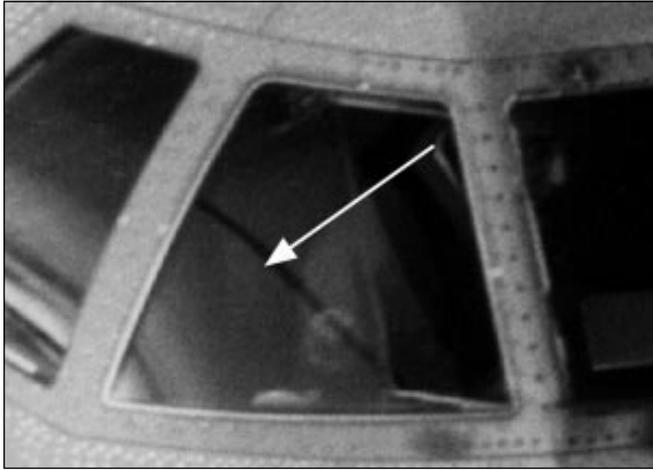
Granular pattern on the unheated portion of a window (arrow) indicates freezing drizzle drops.
