# Flight Safety

MARCH 2004

**Bracing the  
Last Line of Defense  
Against Midair Collisions**

### Bracing the Last Line of Defense Against Midair Collisions

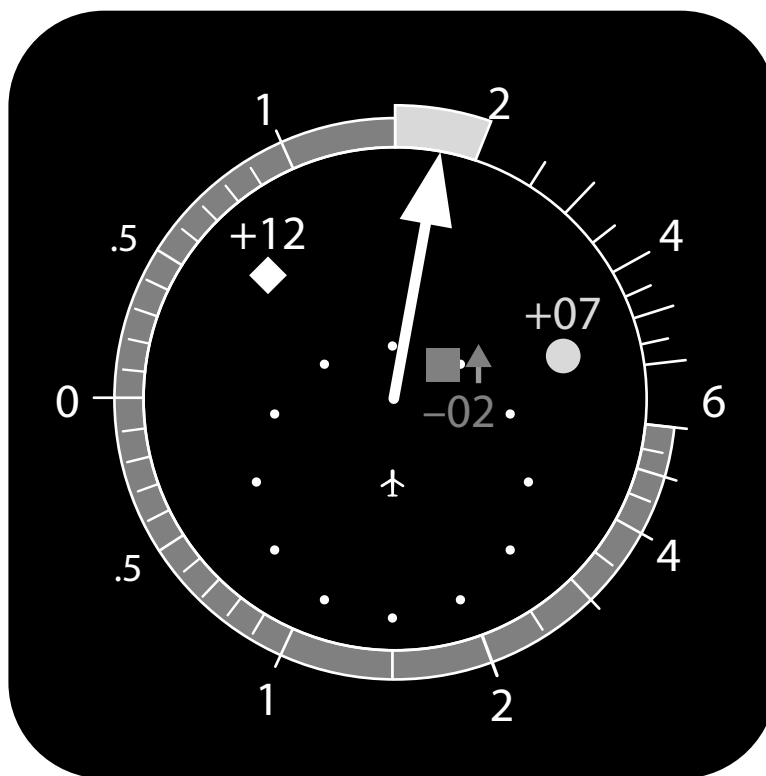
A resolution advisory displayed on a vertical speed indicator advises the flight crew to climb between 1,500 feet and 2,000 feet per minute.

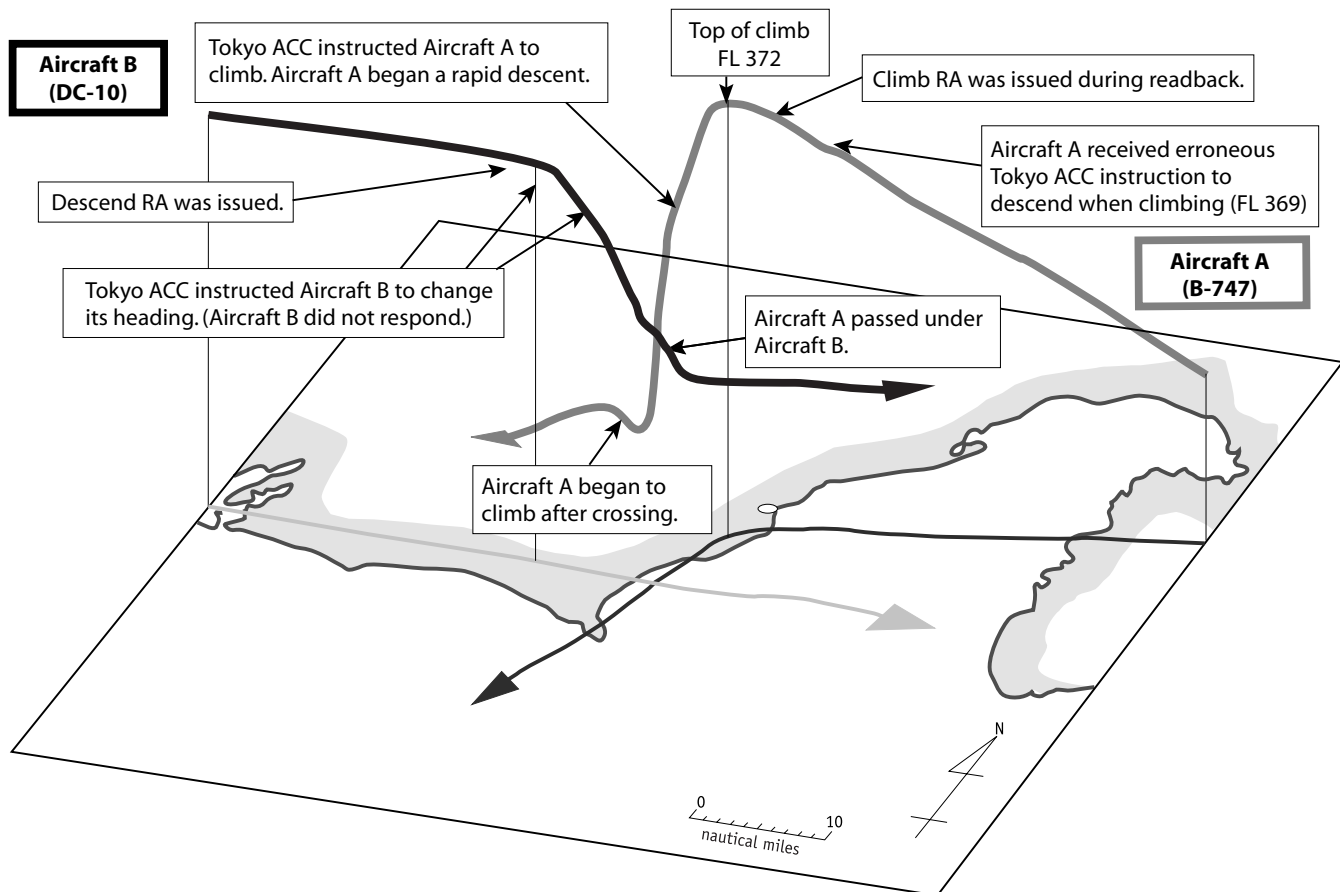
**Figure 2**  
**Near Midair Collision Near Yaizu, Japan; Jan. 31, 2001**

The B-747 captain told investigators that at this time, he observed a contrail at a relative bearing of 11 o'clock.

"Because [the B-747] pitched down around the time that the aircraft crossed and afterward pulled up, its vertical acceleration varied considerably between positive and negative," the report said. "Consequently, persons and objects were tossed and fell, and as a result many persons were injured and ceiling panels, etc., in the cabin were damaged."

made the following recommendations to ICAO:
