FLIGHT SAFETY FOUNDATION

Limitations of See-and-Avoid Concept Cited in Fatal Midair Collision

Vol. 13 No. 3 March 1994

by
John A. Pope
Aviation Consultant

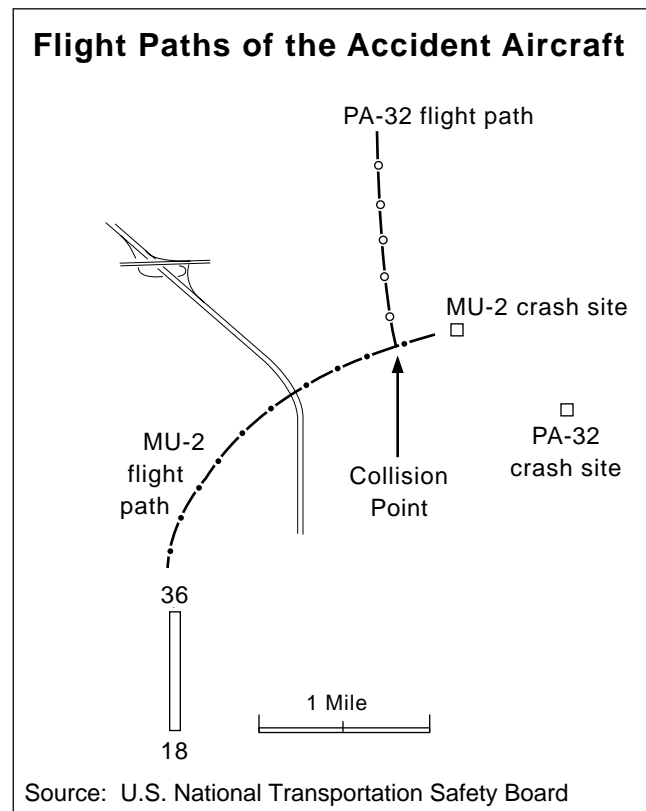
Figure 1

Collision geometry was determined by the NTSB using radar data (Figure 1). That geometry showed a closure rate of 234 knots between the two airplanes on a 038-218 degree magnetic bearing. For the MU-2, the relative bearing of the other airplane was 30 degrees to the left of straight ahead, and for the PA-32, the other airplane was 45 degrees to the right. The collision angle was 105 degrees just before the collision.

The collision angle at impact was very close to 90 degrees because the PA-32 made a steep bank to the left (about 45 degrees) just before the collision. This action was supported by evidence that there was no contact between the left wings of either airplane. Examination revealed that there was contact between the belly of the PA-32 and the leading edge deicing boot of the MU-2’s

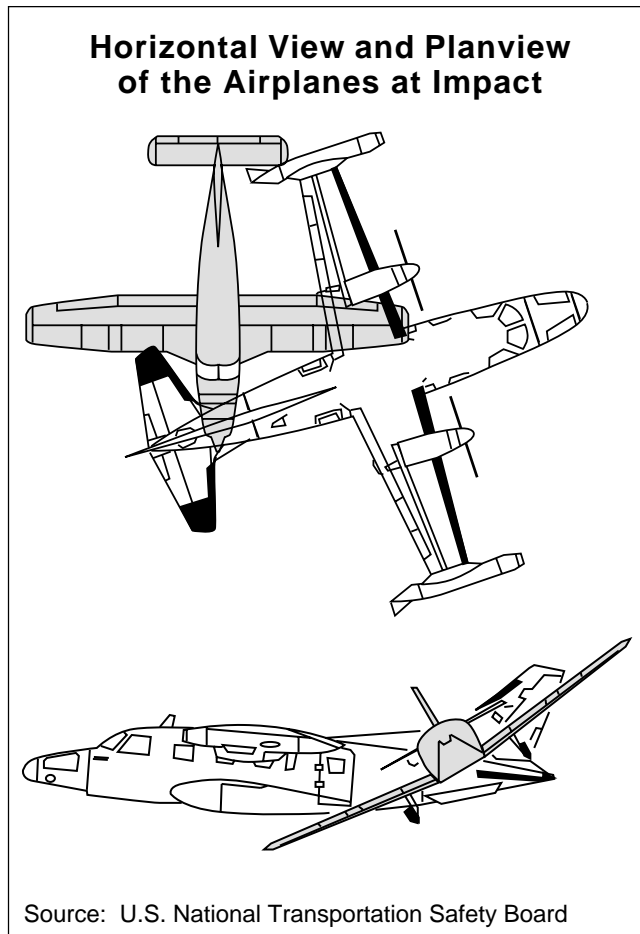
Figure 2

left horizontal stabilizer. The nose landing gear of the PA-32 made contact with the elevator torque tube of the MU-2 (Figure 2).

The collision occurred as the MU-2 climbed through 2,100 feet (640.5 meters) on a course of 070 degrees at a ground speed of 168 knots, climbing at approximately 1,200 feet (366 meters) per minute. The collision damage on the MU-2 was confined to the empennage. Most of the structure forward of the empennage was consumed by a post-impact fire. Structure that was not destroyed showed no evidence of collision damage.

Radar data showed the PA-32 was on a track of 174 degrees, at a ground speed of 127 knots, with a rate of descent of 390 feet (118.9 meters) per minute. Collision damage to this airplane involved the propeller, propeller spinner, engine cowling and belly skin.

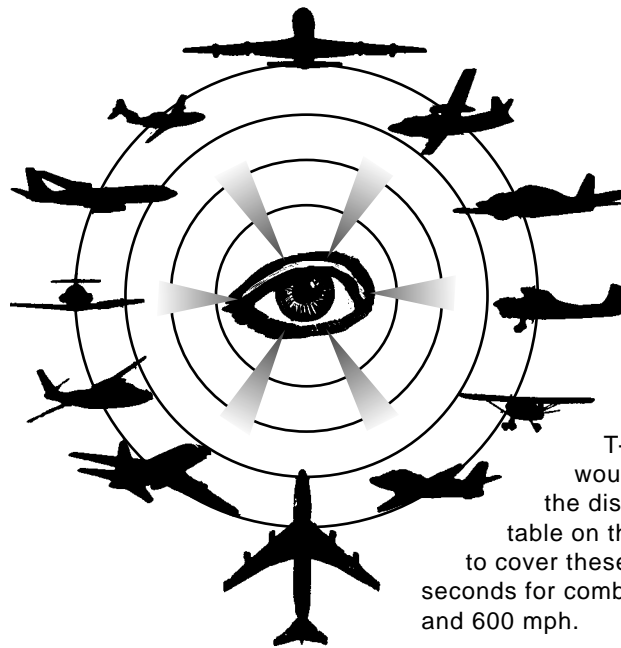
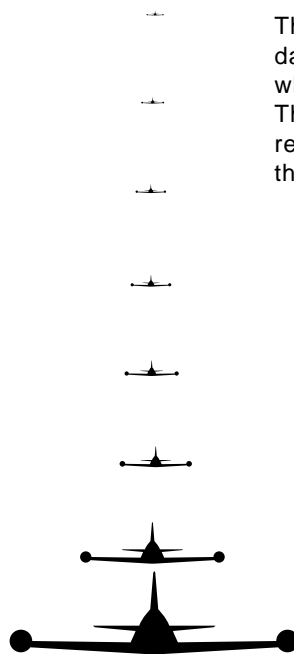
**Table 1
Recognition and Reaction Times**

Move back 12 feet from this illustration. From that position, the silhouettes represent a T-33 jet aircraft as it would appear to you from the distances indicated in the table on the left. The time required to cover these distances is given in seconds for combined speeds of 360 mph and 600 mph.

The blocks on the lower left mark the danger areas for the speeds quoted, when aircraft are on a collision course. This danger area is based on the recognition and reaction times shown in the table on the lower right.

see object	0.1
recognize aircraft	1.0
become aware of collision course	5.0
decision to turn left or right	4.0
muscular reaction	0.4
aircraft lag time	2.0
total	12.5
