MAY-JULY 2000

# FLIGHT SAFETY

## Controlled Flight Into Terrain Korean Air Flight 801 Boeing 747-300, HL7468 Nimitz Hill, Guam August 6, 1997

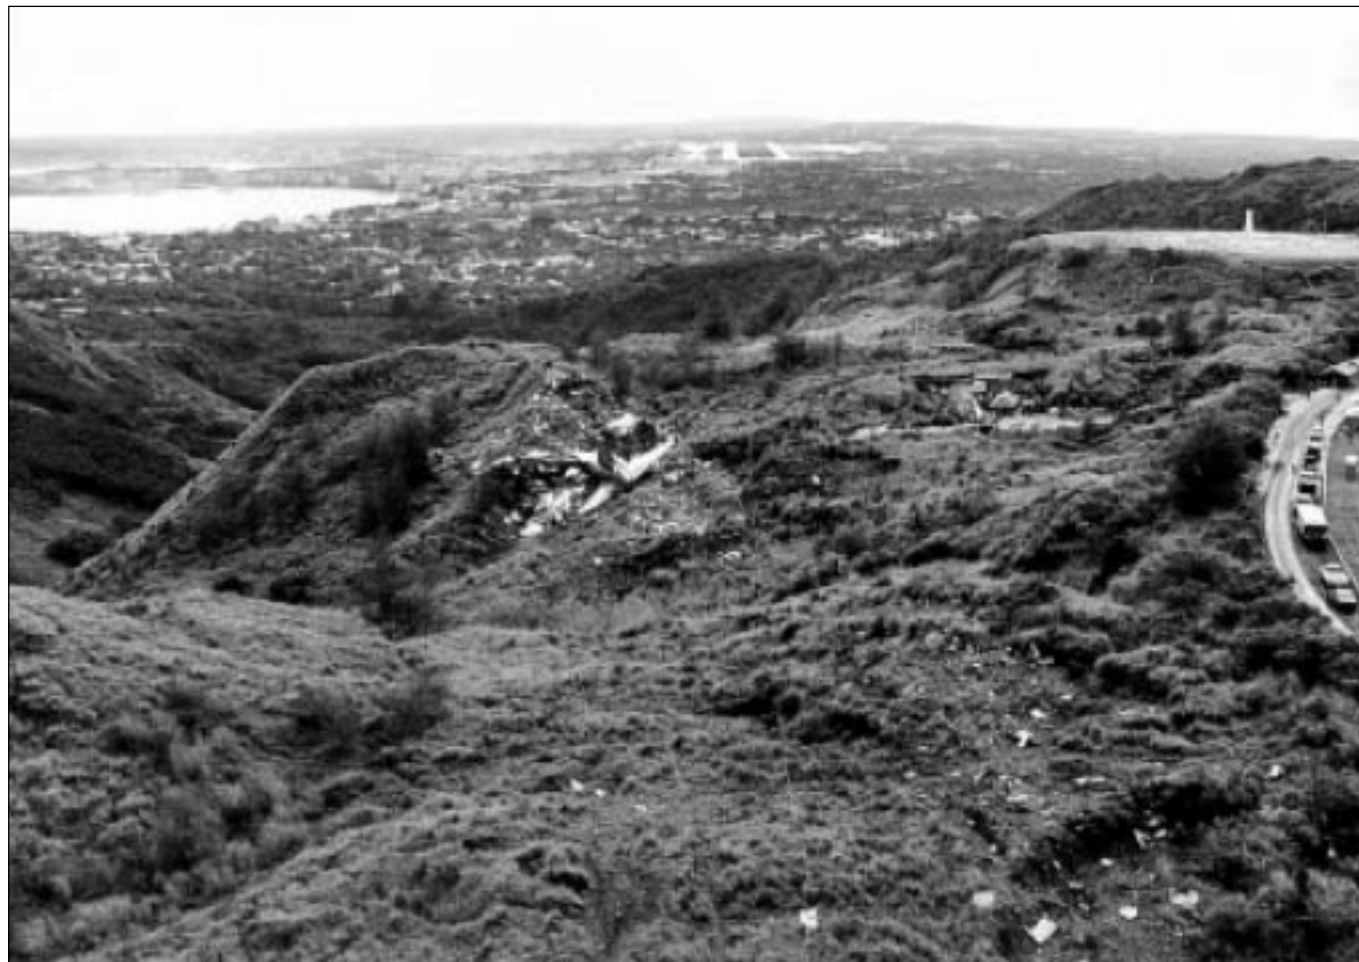
The initial point of impact was evidenced by several cut treetops that extended along the wreckage path. Several ground impact marks, consistent with the main landing gear, were found in the vicinity of the broken oil pipeline, located about 400 feet from the point of initial impact. A ground scar, about 89 feet long, 6 feet wide, and 2 feet deep, was found about 415 feet from the point of initial impact, and several pieces of the No. 1 engine cowl were found embedded in this area, along with parts of the left wing leading and trailing edge flap structure.

Numerous parts of the left main landing gear, including two wheels and tires, were found embedded in a small berm about 1,430 feet from the initial impact point. Most of the fuselage structure was located in the main wreckage area and was found separated into five major sections: the empennage, the aft fuselage, the center fuselage, the forward fuselage, and the cockpit.

**Figure 8a.** Wreckage from Korean Air flight 801 in relation to Guam International Airport runway 6L (upper middle), the NIMITZ VOR (upper right) and Apra Harbor (upper left).

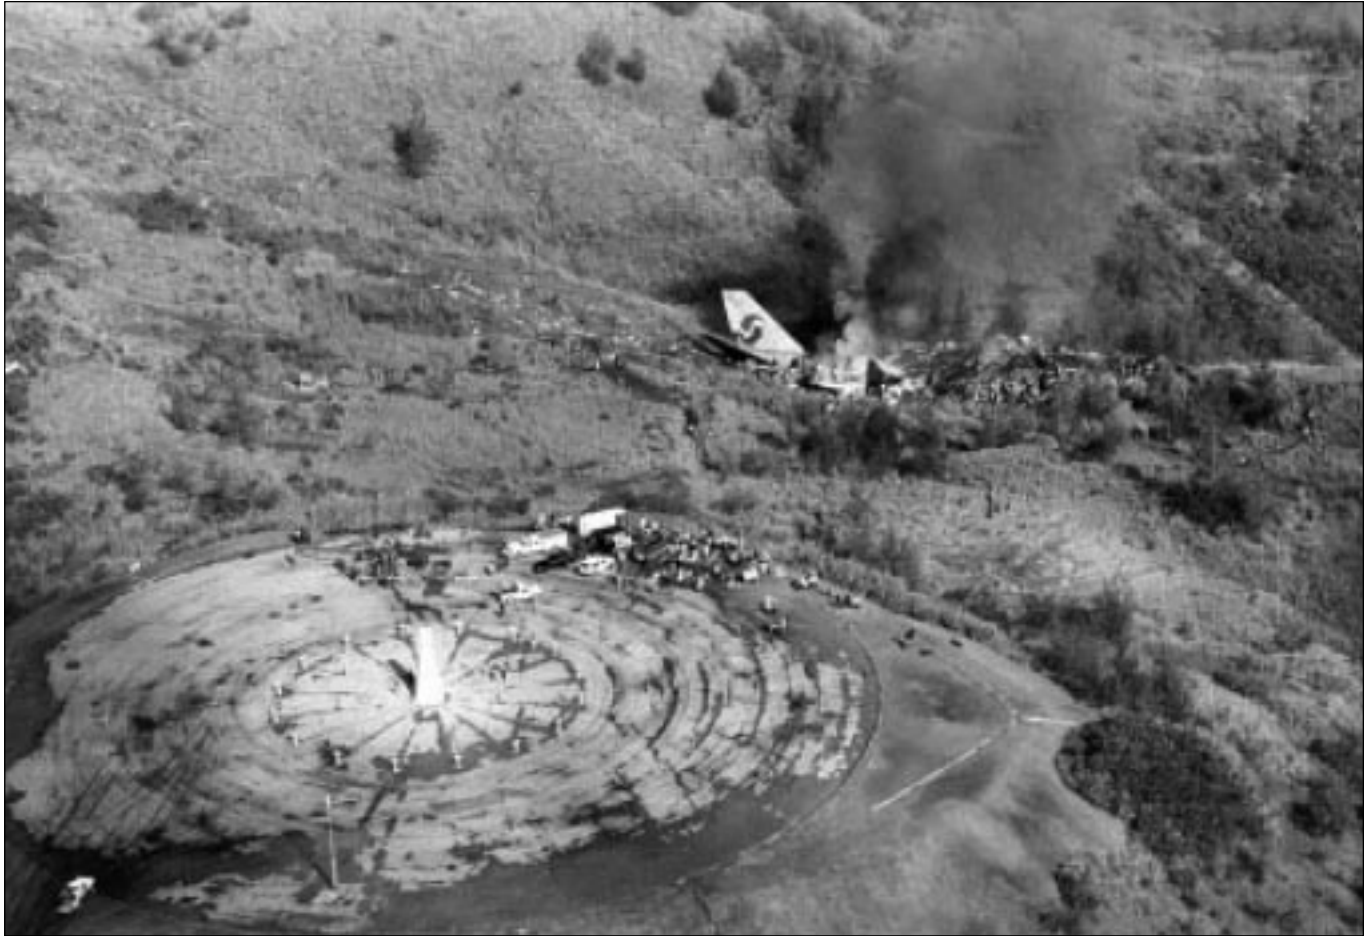
**Figure 8b.** Closer view of the wreckage from Korean Air flight 801 and the NIMITZ VOR.

wreckage in relation to runway 6L, the NIMITZ VOR, and Apra Harbor.<sup>65</sup> Figure 8b provides a closer view of the wreckage and the VOR.

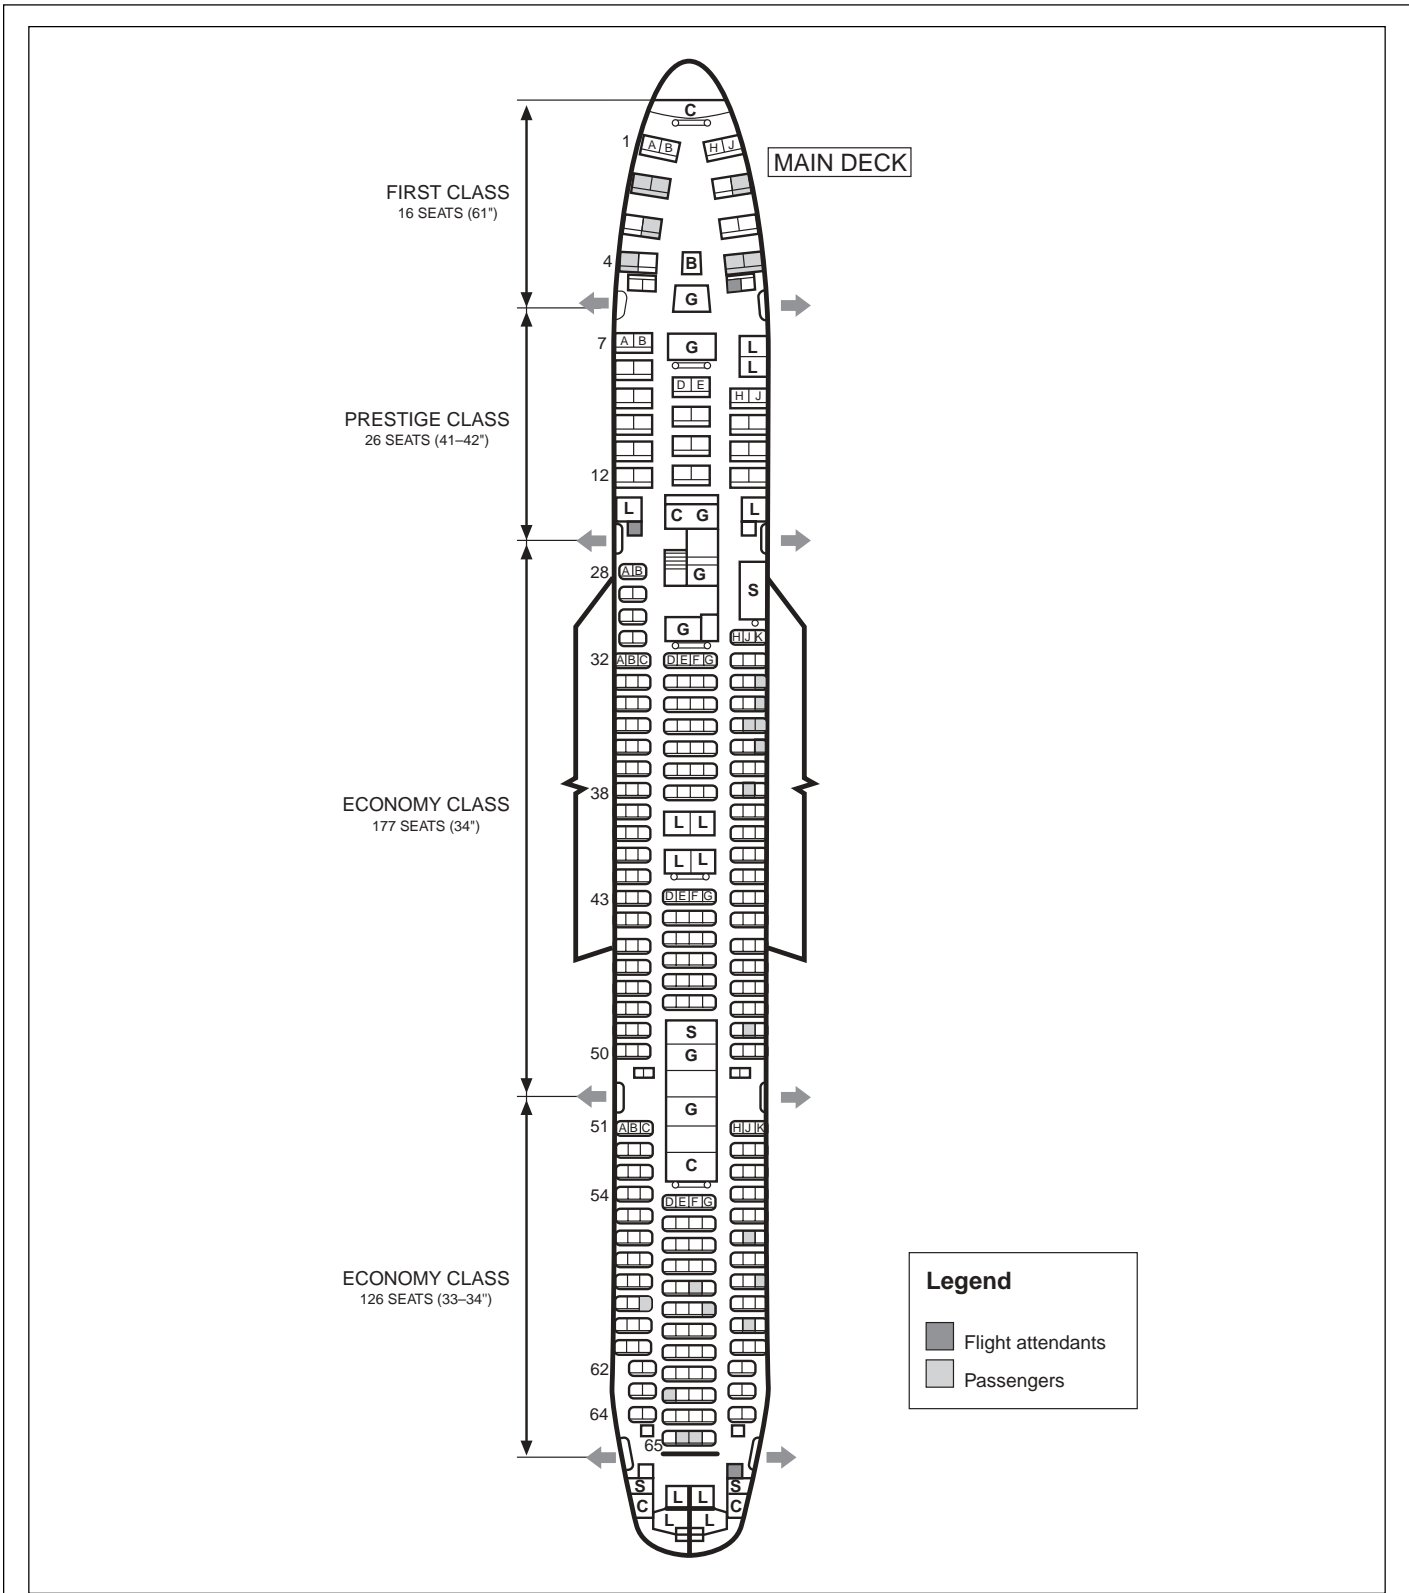
A flight attendant who was seated in the R1 jumpseat (in the first class section) stated that she heard a loud “boom” before the airplane began shaking violently and breaking up. The flight attendant said that she was thrown from the airplane in her jumpseat during the impact. She then unfastened her restraint system, walked about 30 feet beyond the right side of the airplane, and assisted a female passenger.

**Figure 9.** Korean Air flight 801 cabin configuration and survivor seat locations.

“intense flames and heat swept through the cabin.” One survivor, who was seated in the aft economy class section (row 34), stated that her husband was engulfed by fire in the seat next to hers. Another passenger, a professional helicopter pilot, stated he felt what he thought was a “hard landing” but that
