Descent Below Normal Surveillance Altitude Ends in Fatal Wire Strike

While flying over a frozen river in search of illegal fishing operations, the Canadian Coast Guard helicopter struck an unmarked power line. The pilot was killed and three passengers were injured in the accident.

Editorial note: This article is based on the official accident investigation report, *Wirestrike — Government of Canada, Canadian Coast Guard, Bell 206L, C-GCHN, Margaree River, Nova Scotia, 25 February 1995*, by the Transportation Safety Board of Canada, Report no. A95A0040. The report includes figures and appendices.

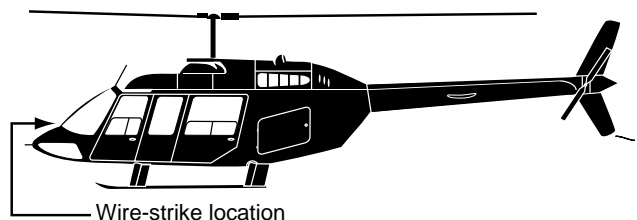
Figure 1

The report said that the bottom area of the main windscreen of the helicopter struck the power line (Figure 1, page 2). "The helicopter was in a level attitude, about 70 feet [21 meters] above the river and at about the midpoint of the width of the river, flying at an estimated airspeed of 80 knots [148

kilometers per hour (kph)], when it struck the power line," the report said. "The power line broke in two places: where it contacted the helicopter and where it joined onto the western pole. The broken section of the power line made contact with one main rotor blade and [the main rotor blade] was then thrown forward. It was found [324 meters (1,063 feet)] from the initial point of the power-line contact."

Power-line Contact on Accident Helicopter, Feb. 25, 1995, Nova Scotia, Canada
