Data Show Same U.S. Fatal-accident Rate for Single-turbine and Twin-turbine Helicopters

Statistics for 1993 through 1997 show a relatively low accident rate for U.S.-registered twin-turbine helicopters. Nevertheless, almost half of the accidents were fatal, and 70 percent of the accidents involved pilot error.

—
*Joel S. Harris
FlightSafety International*

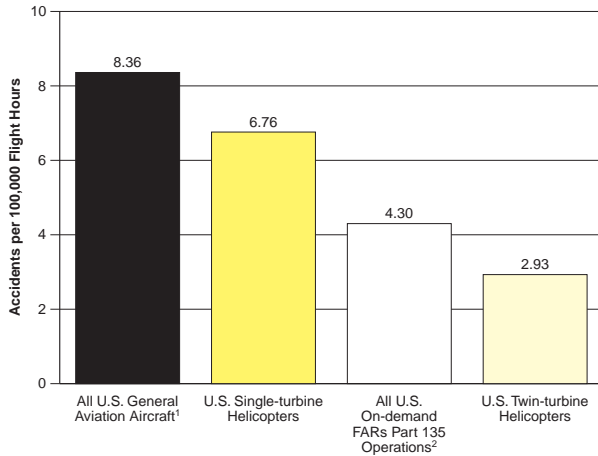
Figure 1 (page 5) shows that the twin-turbine-helicopter accident rate was lower than the accident rates of general aviation aircraft (fixed-wing and rotary-wing aircraft involved in pleasure flying, business travel, corporate travel, training and other operations that are not governed by U.S. Federal Aviation Regulations Part 121 or Part 135), single-turbine helicopters and air-taxi aircraft (those involved in on-demand Part 135 operations).

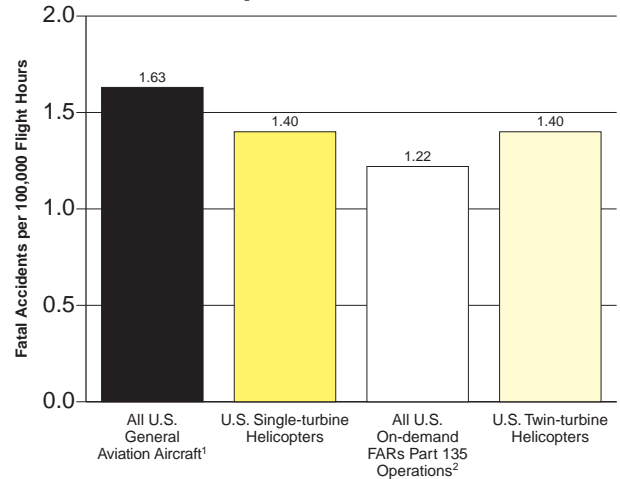
Almost half (48 percent) of the twin-turbine-helicopter accidents were fatal. Twin-turbine helicopters were involved in 23 fatal accidents, or 1.4 fatal accidents per 100,000 flight hours. Figure 2 (page 5) shows that the twin-turbine-helicopter fatal-accident rate was lower than the fatal-accident rate of general aviation aircraft, equal to the fatal-accident rate of single-turbine helicopters and higher than the fatal-accident rate of air-taxi aircraft.

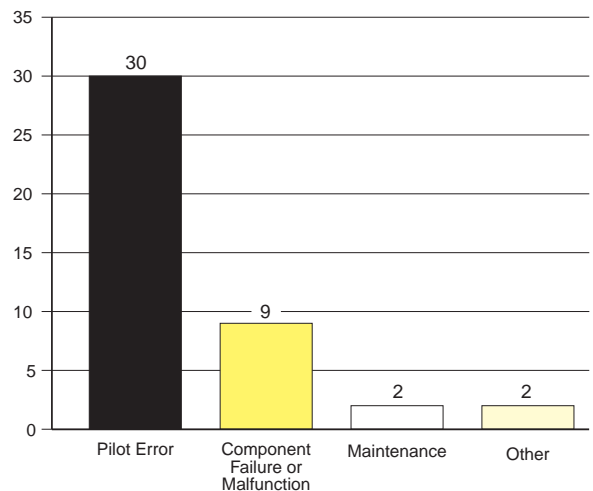
Figure 3

NTSB final reports were available on Jan. 1, 1999, for 43 of the 48 twin-turbine helicopter accidents; only preliminary reports were available for five accidents. The final reports show that pilot error was a probable cause of 30 (70 percent) of the 43 accidents (Figure 3, page 5).
