Data Show 50 U.S.-registered Helicopters Involved In Wire-strike Accidents From 1996 Through 2000

In each of the accidents, the helicopter was either destroyed or damaged substantially. Fifteen accidents resulted in at least one fatality; nine other accidents resulted in serious injuries.

Helicopter Safety

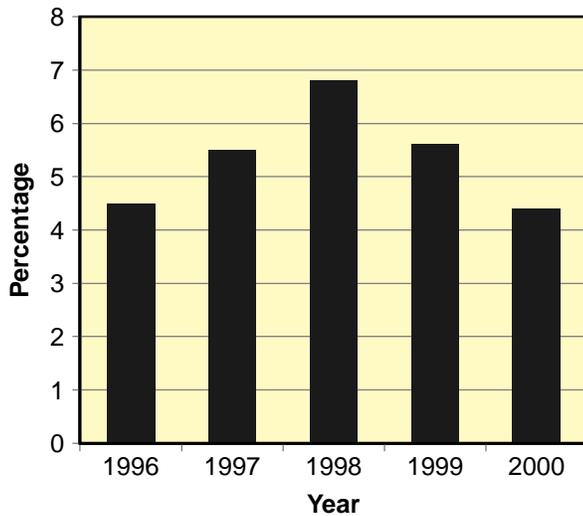
Figure 1

Data show that, of 934 U.S.-registered helicopters involved in accidents from 1996 through 2000, 50 accidents (5.4 percent) were classified as wire-strike accidents.¹ The number of wire-strike accidents was highest in 1998, when 13 accidents (6.8 percent of the year's total of 191 helicopter accidents) were recorded. Fewer wire-strike accidents occurred in 2000 than any other year during the five-year period — nine accidents, or 4.4 percent of the 206 helicopter accidents that occurred that year (Figure 1, page 2).

Wire-strike Accidents as a Percentage of All U.S. Helicopter Accidents, 1996–2001

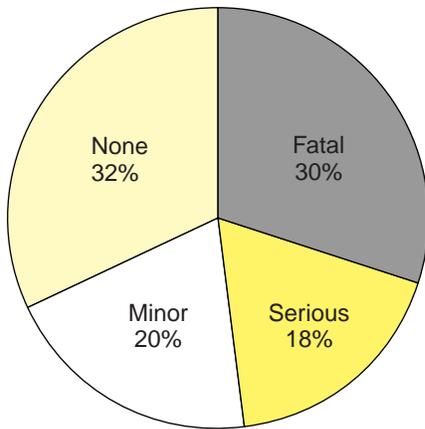
Figure 2

Fifteen of the 50 accidents resulted in at least one fatality, and nine accidents resulted in serious injuries (Figure 2, page 2). Ten other accidents resulted in minor injuries; in the remaining 16 accidents, there were no injuries. (An accident is classified according to the highest level of injury. For example, if one occupant is fatally injured and one receives minor injuries, the accident is classified as a fatal accident.)

Types of Injuries Resulting From U.S. Helicopter Wire-strike Accidents, 1996–2001

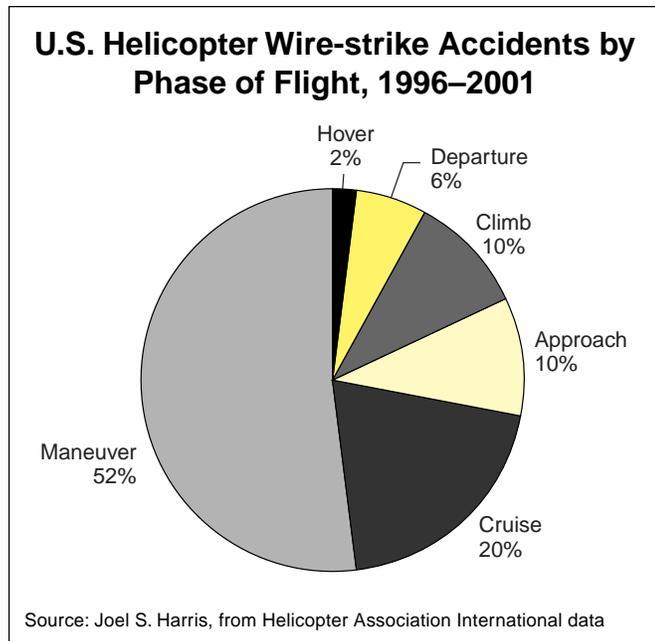
Figure 3

The data show that more than half of the helicopter wire-strike accidents occurred during the maneuvering phase of flight (26 of the 50 accidents). Ten accidents occurred during cruise, five accidents occurred during climb, five accidents occurred during approach, three accidents occurred during departure, and one accident occurred during hover (Figure 3).
