Records Show 27 U.S.-registered Helicopters Involved in Midair Collisions During 1990s

The collisions represented 1.4 percent of all accidents involving helicopters registered in the United States throughout the decade.

—
Joel S. Harris

Helicopter Safety

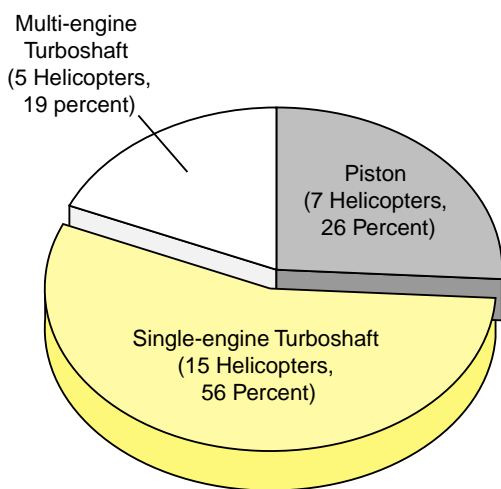
Figure 1

The review of the accident data showed that seven of the accident helicopters were equipped with piston engines; the other 20 helicopters had turboshaft engines, and that number included five multi-engine turboshaft helicopters (Figure 1).

Helicopter Types Involved In U.S. Midair Collisions, 1990–1999

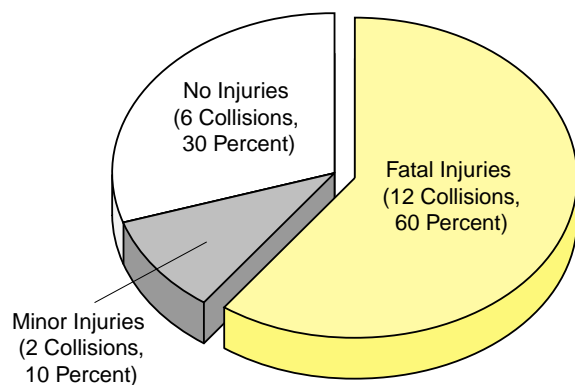
Figure 2

Accident data showed that 12 of the 20 midair collisions (60 percent) involved fatalities; a total of 30 people were killed. Two of the collisions involved minor injuries, and six collisions involved no injuries (Figure 2).

Extent of Injuries Sustained In 20 U.S. Helicopter Midair Collisions, 1990–1999

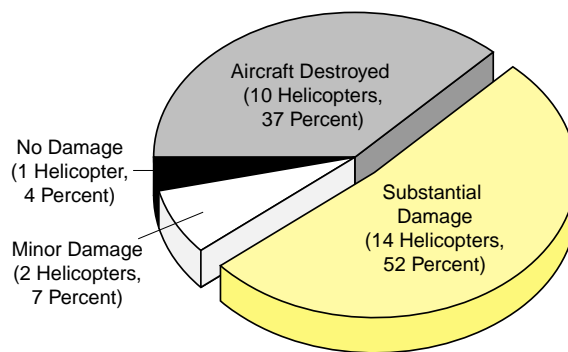
Figure 3

NTSB reports said that 10 of the 27 helicopters involved in the midair collisions were destroyed, 14 helicopters were damaged substantially, two received minor damage and one was not damaged (Figure 3). (Nevertheless, the report narrative on the helicopter that was listed as undamaged said that the helicopter’s tail-rotor drive shaft was severed in the accident; the discrepancy was not explained.)

Helicopter Damage Sustained In 20 U.S. Midair Collisions, 1990–1999
