Helicopter Strikes Water on Approach After Pilots Lose Altitude Awareness

The controlled-flight-into-terrain (CFIT) accident, which killed a passenger and necessitated an underwater escape by the pilots, was also attributed to flight crew failure to set their altimeters correctly.

—
FSF Editorial Staff

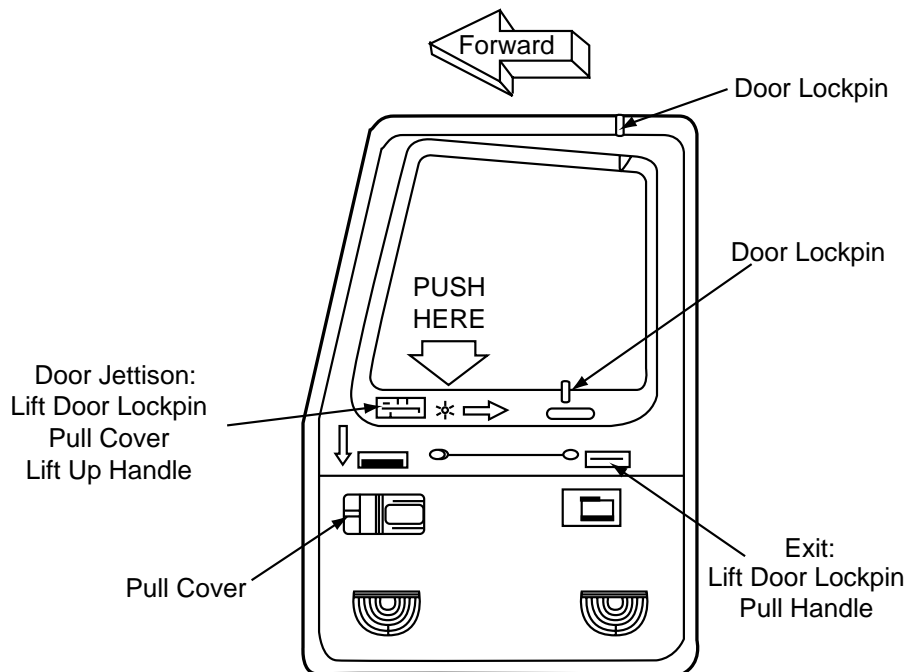
Figure 1

Sikorsky S-76A Captain's Door

The PIC's next sensation was of being upside down, under water, in pitch-black conditions, with no idea where he was.³ He described unsuccessfully attempting to open his [right] door (Figure 1). The S-76A has a door lock-pin mechanism that must be released before the door handle will open from the inside. The PIC said that he did not remember attempting to release the locking pin. Nor did he attempt to use the emergency exit handle to jettison the door.

[The NTSB report said: a right cockpit-door emergency jettison test was conducted on an in-service S-76A in the Morgan City hangar. The door was locked. The emergency door release handle was pulled without first pulling the unlock ring or the locking button. The door fell away unimpeded with gravity pulling the door off the upper lock pin. When (the) aircraft is inverted, this pin will remain engaged.]

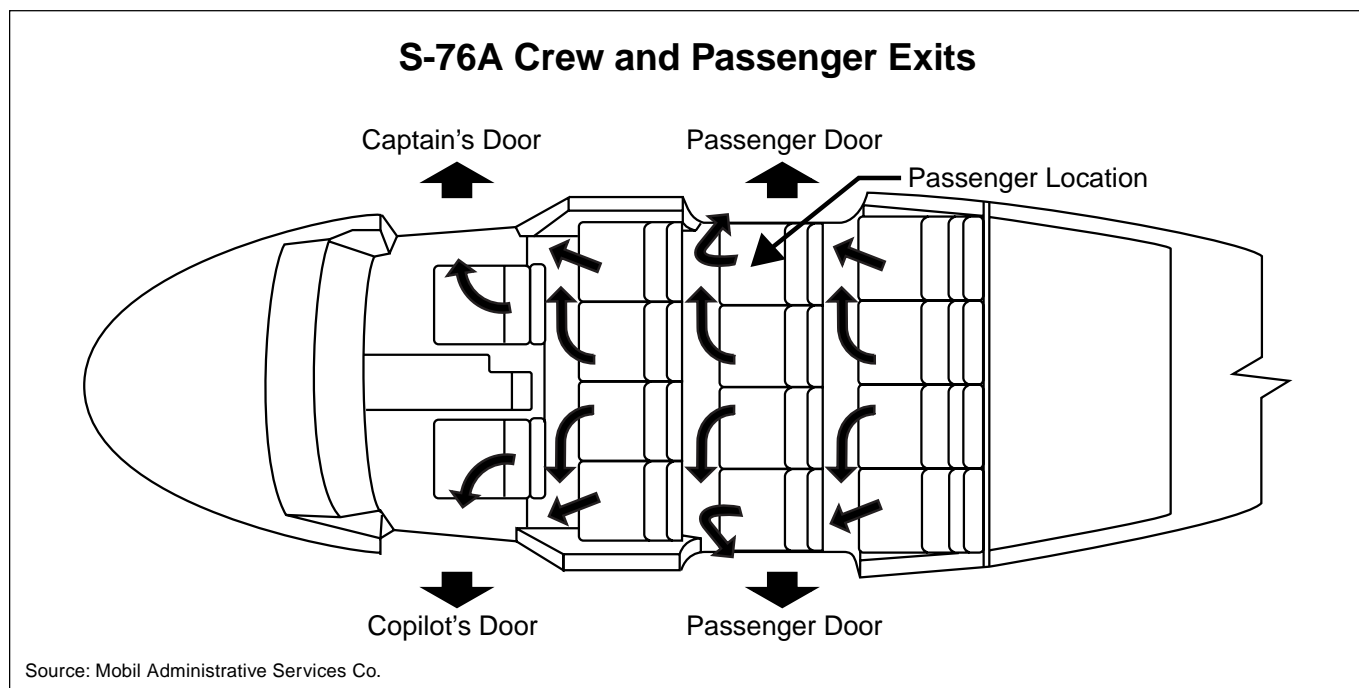
Figure 2

Found, unrestrained in the passenger cabin of the helicopter after recovery, were two 4.6- by 4.6-meter (15-foot by 15-foot) sheets of plastic, two aluminum deck plates measuring 0.9 meter by 1.2 meters (three feet by four feet), 11 life jackets and a variety of small items normally carried in the cabin.

The PIC said that he gave the inbound passenger a safety-and-egress briefing and told him he could move from the aft-left seat to the forward-right seat, directly behind the PIC (Figure 2). The PIC said that the passenger was told that his emergency exit was the PIC’s door. While the PIC was briefing the passenger, the copilot supervised unloading of the tool. Both pilots later said that they believed that all plastic and loose gear had been removed from the helicopter.

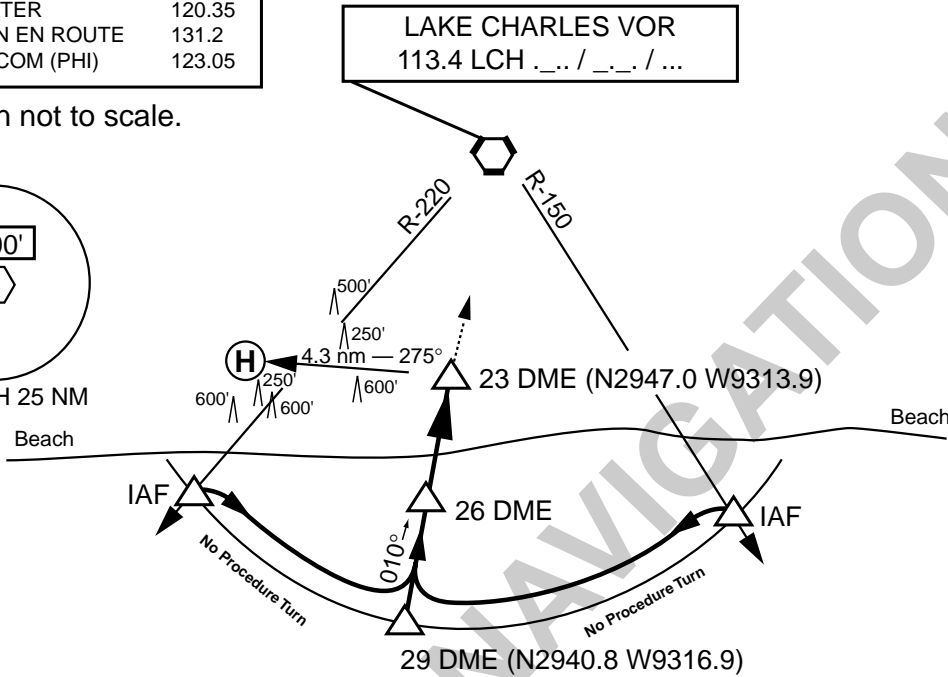
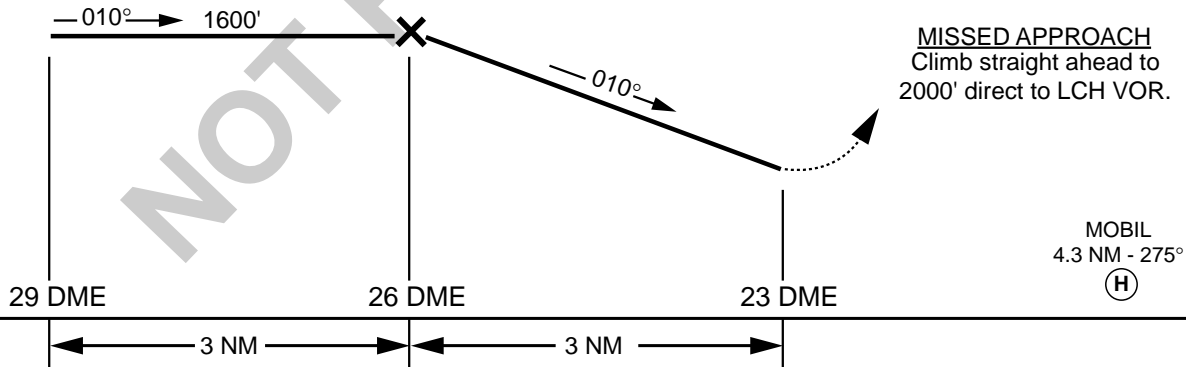
Figure 3

Cameron Copter VOR/DME 010 Approach

contacted Lake Charles approach and requested an IFR clearance for the Cameron Copter VOR/DME 010 approach (Figure 3, page 6). The crew entered IMC.

The NTSB report said: "The crew went visual at the termination of the Copter approach. ... The point where the crew went visual was over the water, one mile offshore. The only visual references available were several lights on land, approximately 6.4 kilometers [four miles] ahead. ... The copilot [pilot flying] transitioned from instruments to an outside visual scan, for a transition to the landing site. The [PIC] [pilot not flying] was looking down while changing radios. Neither pilot was aware of a descent until the level impact with the water."
