Pilot Asphyxiated by Headset Cable After Surviving Failures of Seat and Harness

The failure of the seat reduced the pilot's probability of surviving the accident, the official accident investigation report said. Yet the seat met the specifications that were in effect at the time the helicopter had been certified in the United Kingdom, and which still applied to the accident aircraft, although current specifications were more stringent.

FSF Editorial Staff

HELICOPTER SAFETY

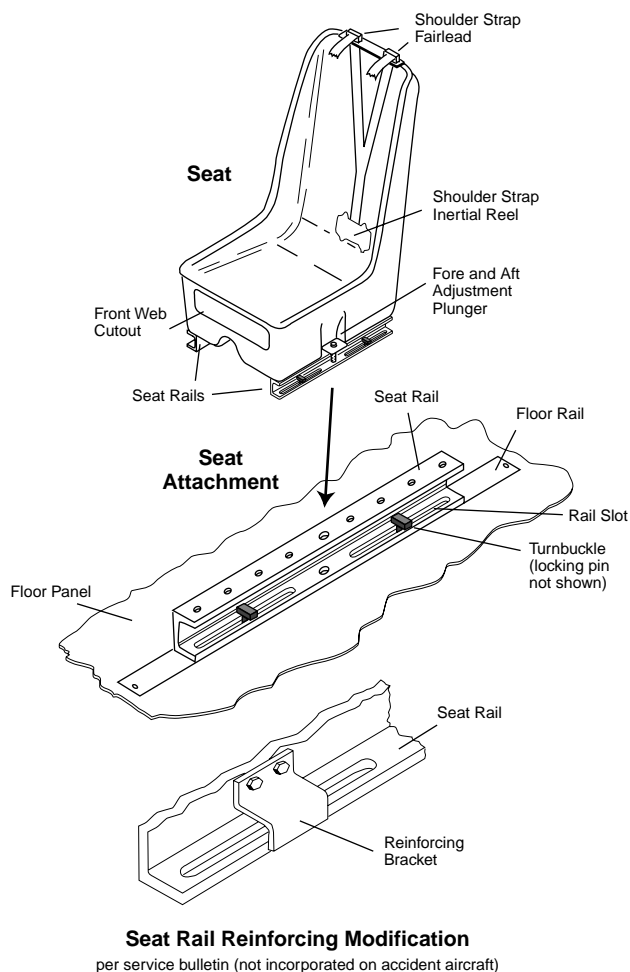
Figure 2

The pilot's seat (Figure 2, page 4) had separated from the helicopter and was found on the ground adjacent to the cabin. The seat was tethered to the aircraft by the remains of the pilot's harness. The unoccupied left forward seat had also detached from the cabin floor.

considered the seat detachment "unsurprising in view of the apparent lack of robustness of the seat and its attachments."

Pilot's Seat and Attachment On Accident Aircraft

The SB revision included “the addition of bonded reinforcement strips at the bucket/base junction and the installation of rail reinforcements,” the report said (Figure 2).

The rail reinforcements required the addition of an “angled bracket bolted to the seat rail web at the center of each slot and overlapping the outer edge of the rail,” the report said. “No classification was entered on the SB, reportedly signifying that the manufacturer classified the modification as optional.” The report said that “the modification had clear implications of survivability enhancement and no information was available as to why the manufacturer had not classified it as mandatory.”

Modifications to strengthen the seat and attachments in the AS 350 had been published by Aérospatiale in a service bulletin (SB) on Aug. 2, 1984, with a revision issued on April 2, 1987.

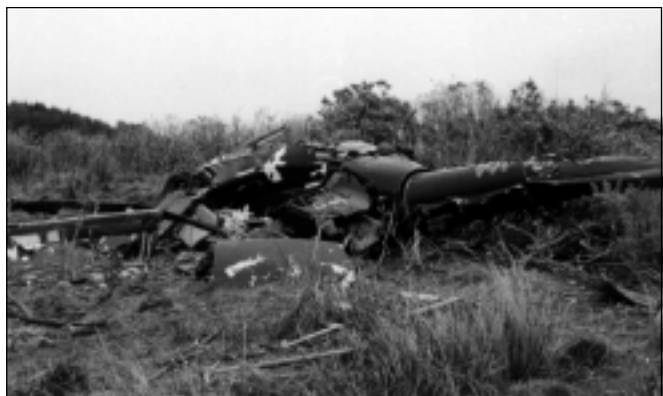
The resulting out-of-balance forces on the tail rotor caused the tail-rotor gearbox to separate from the tail boom. The helicopter became uncontrollable and struck the shore of Loch Gilp, destroying the aircraft (photo, page 5) and killing the pilot, who was its only occupant.

The aircraft struck the ground with little forward speed and a moderately high descent rate, while banked to the right, pitched nose-down and yawing to the left. The area of impact was rocky and initial ground contact caused the right landing-gear skid to detach. "The aircraft then rolled right, contacting the ground with the main rotor blades and the right horizontal stabilizer, before inverting," the report said. "It came to rest on its left side [seven meters (23 feet)] from the initial ground-impact point."

The accident aircraft, an Aérospatiale AS 350B, struck the ground at a moderately high descent rate, banking to the right and nose-down. The main rotor blades contacted the ground and the aircraft inverted, coming to rest on its left side seven meters (23 feet) from the initial impact point.
