## Boost Pump Failure Starves Bell 214B Engine of Fuel

*Canadian investigators said that the aircraft flight manual did not adequately describe the potential consequences of a boost pump failure and that the pilot's lack of recurrent training might have affected his ability to conduct an autorotation.*

[FSF editorial note: This article, except where specifically noted, is based on Transportation Safety Board of Canada Aviation Investigation Report no. A99P0075, *Power Loss—Fuel Starvation, East West Helicopters Ltd. Bell 214B Helicopter C-GEWT, Kaslo, British Columbia, 35 NM NW, 4 July 1999*. The 26-page report contains illustrations and appendixes.]

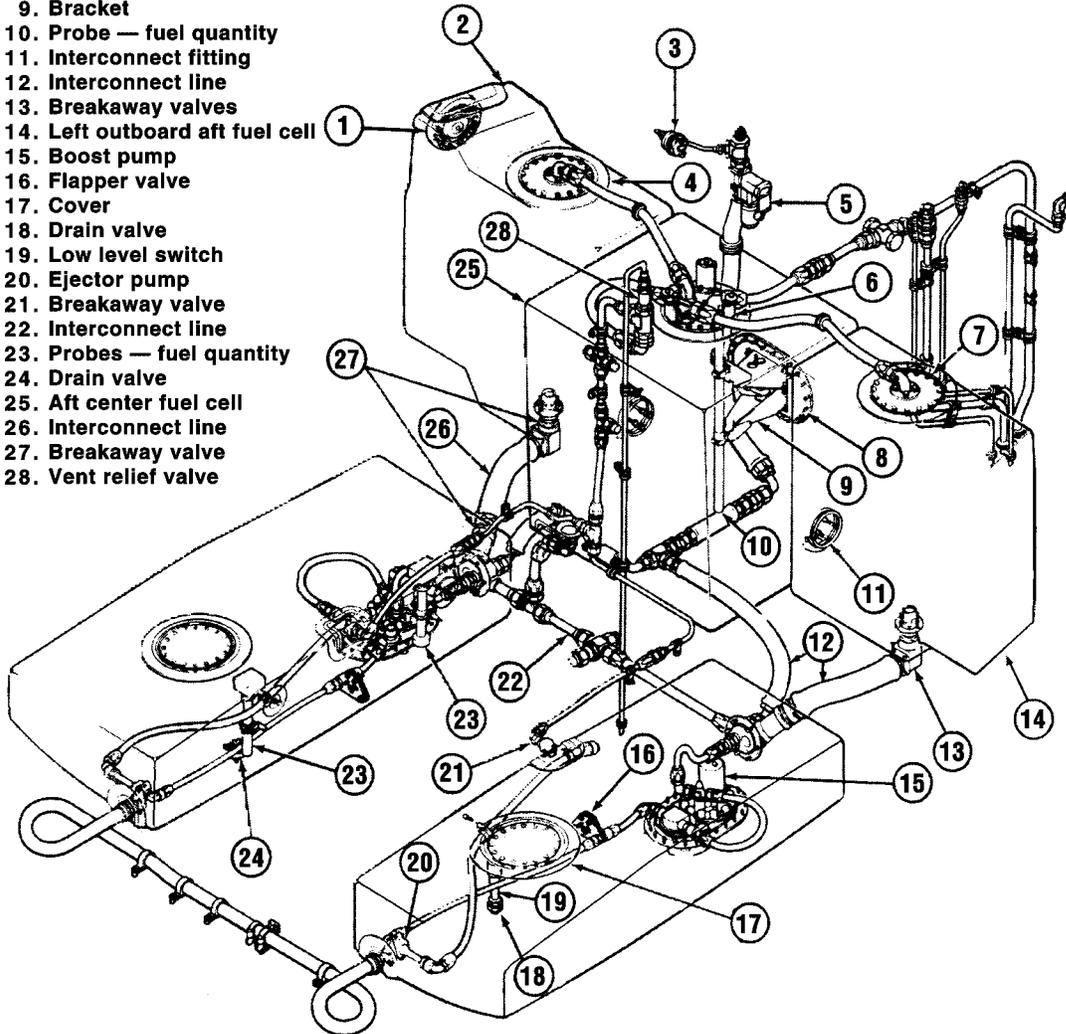
**Figure 1**

The Bell 214B has five interconnected fuel cells (see Figure 1, page 4). An electrically driven fuel-boost pump in each of the two forward cells supplies fuel to the engine.

“A fuel-cell interconnect line runs between the left-[forward fuel cell] and the right-forward fuel cell, normally ensuring that the fuel level in the two forward cells remains equal,” the report said. “The fuel-quantity gauge is operated by probes located in the center cell and [in] the right-forward fuel cell. If the center fuel cell does not contain any fuel, the fuel-quantity gauge is operated solely by the probes in the right-forward cell. The fuel-quantity gauge does not directly register fuel in the left-forward cell.”

The report said that the fuel-quantity indication in the Bell 214B is accurate when the right-forward cell and the left-forward cell contain an equal amount of fuel.

“The forward-fuel-cell interconnect [line] is unable to flow fuel between the cells as rapidly as the engine can consume fuel from the cell with the operable boost pump,” the report said.

Investigators estimated that when the helicopter struck terrain, the left-forward fuel cell was nearly empty, and the right-forward fuel cell contained about 250 pounds (113 kilograms) of fuel.

The Bell 214B and Bell 205 flight manuals [should] be modified to provide information regarding the inaccuracy of fuel-quantity indications, thereby allowing pilots to make informed decisions in the event of a loss of fuel-boost-pump pressure. [The fuel system in the Bell 205 is similar to the fuel system in the Bell 214B.]
