Cracked R22 Main-rotor Blade Results in Warning on Vibration

The U.K. Air Accidents Investigation Branch said that the blade was near catastrophic failure because of the crack, which was 80 millimeters (three inches) long, in a main-rotor blade root-end fitting.

Helicopter Safety

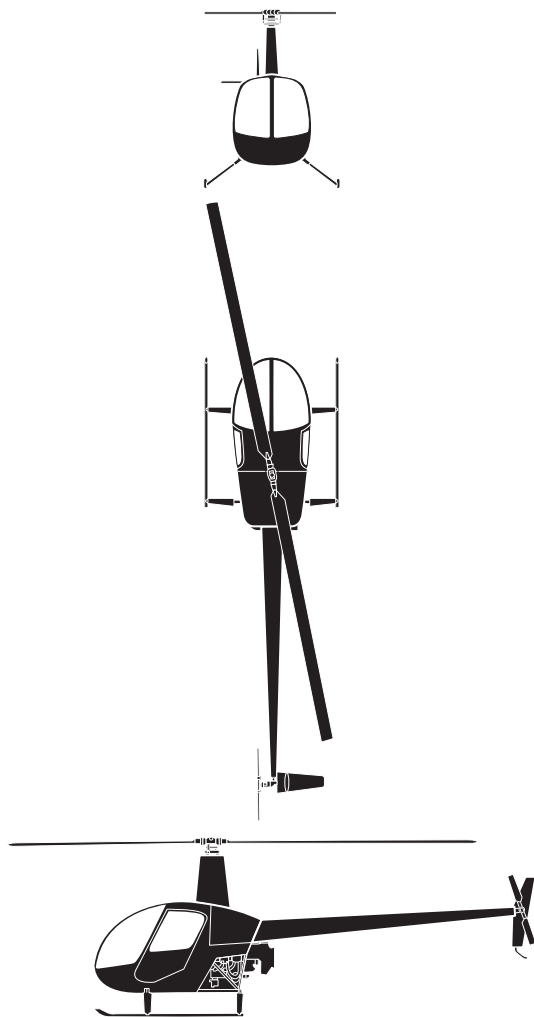
The Robinson R22 Beta is a light two-seat helicopter with a two-blade main rotor and a two-blade tail rotor. The R22 first was flown in 1975, the R22 Alpha was certificated in 1983, and the R22 Beta was certificated in 1985.
