HELICOPTER SAFETY

Vol. 17 No. 2

March/April 1991

The Cockpit-to-Shop Communications Link

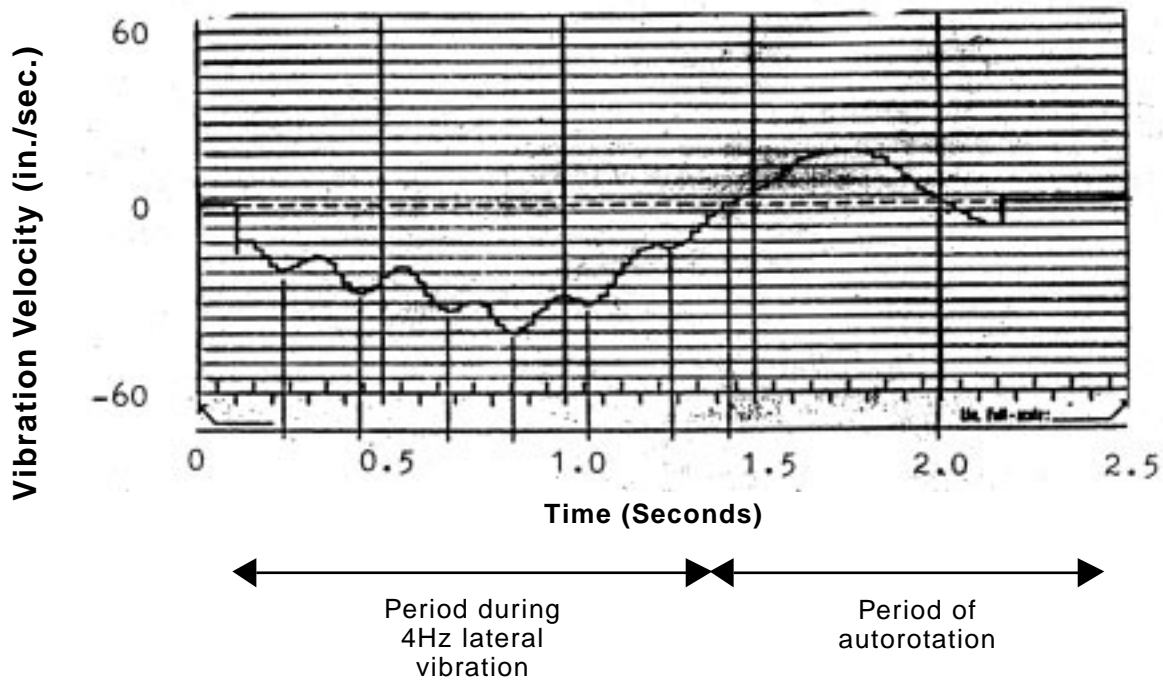
In-flight Disturbance

The entire event was captured in real-time on the instruments that had been installed for that purpose. What remained to be discovered was an explanation of what had occurred. The 12.5 seconds of digitized data revealed a 4 Hz modulation of the 6.56 Hz main rotor rotation. The 4 Hz frequency coincided with the rotor head and mass assembly first resonance, which had been determined during the modal analysis conducted two weeks previously. Each time these two frequencies would be in phase, or in sympathetic vibration, the gyroscopic effect of the rotor would force the airframe side to side.

Test bench data from the suspect governor originally on the client's aircraft, showed that under very specific series of circumstances the fuel pressure would modulate at a 4 Hz frequency. Hence the pulsating fuel delivery was converted to a pulsating torque which excited the main rotor and mass assembly at that same frequency.

An example of a recorded trace produced by a vibration episode similar to that described in the text. A normal zero-vibration condition would have produced a level trace (dotted horizontal line), but the vibration episode produced the variable pattern that was brought back to the original zero-vibration line only after the aircraft was put into the autorotation flight mode.

The governor originally installed on the test aircraft was then installed on the client's aircraft. The 4 Hz problem was gone without a trace.
