FLIGHT SAFETY FOUNDATION

Vol. 19 No. 2

March/April 1993

Canadian Safety Report: Recent Crash Shows Effectiveness of Egress Safety Recommendations for Wide-body Helicopters

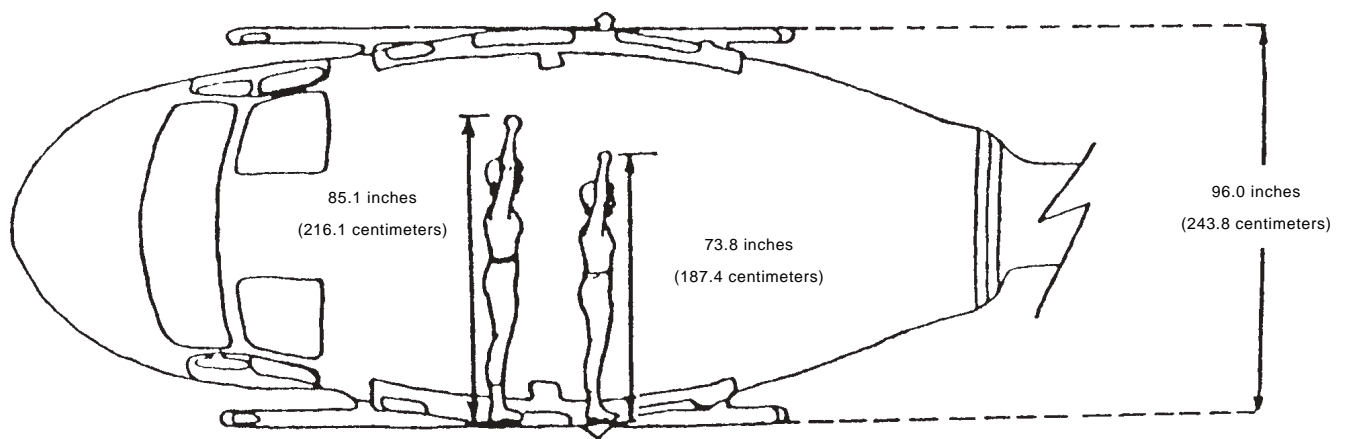
Figure 1

“After striking the ground, the helicopter rolled onto its left side, prohibiting the use of the left side exits,” the TSB said. “The passengers released their seat belts and fell to the left side of the cabin. The Bell 212 passenger compartment is eight feet wide, which made passenger access to the right side emergency exit (now some distance overhead) very difficult (Figure 1, page 3).

When a wide-body helicopter is resting on its side, many passengers may have difficulty reaching emergency exit grips.

- Measures be taken to improve passenger access to the emergency exits of Bell models 204, 205, 212, 214 and 412 helicopters when the aircraft are resting on their sides.

- TC sponsor modifications to the design standards for egress from wide-body helicopters to ensure that passengers can quickly access an emergency exit when the aircraft is resting on its side. “The design standards for evacuation did not take into account the propensity for wide-body helicopters to rollover, and therefore did not address the difficulties of egressing from a wide-body helicopter when the aircraft is resting on its side.”;
