Helicopter Strikes Wires While Installing Cable on Tower

**McDonnell Douglas 530F;
Shoshone, Idaho, U.S.; June 2, 1998**

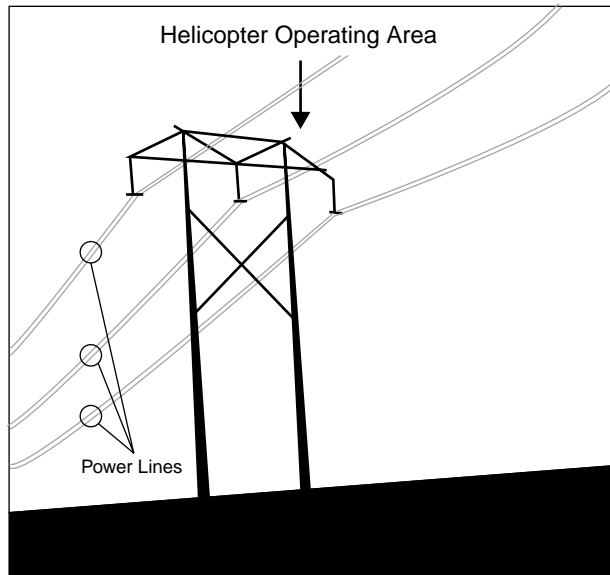
Figure 1

The fiber-optic cable was being installed near the tops of the towers, which were approximately 85 feet (26 meters) tall. Six electric-power transmission wires were suspended eight feet to 10 feet (2.4 meters to three meters) below the fiber-optic cable; each wire was approximately 1.1 inches (2.8 centimeters) in diameter. (Figure 1, page 3, shows a tower and the approximate position of the helicopter when the wire strike occurred.)

The witness said that the helicopter twisted sideways and "went over on its side." The rotor blades struck the transmission lines, and the helicopter descended between the transmission lines. The tail boom separated, and the helicopter spun about two times before striking the ground.
