## Unapproved Modification of Cyclic Trim Switch Cited in Offshore Landing Accident

*Pilot lost control of helicopter while approaching to land on a ship after experiencing hard-over lateral-trim runaway during fish-spotting operation.*

FSF Editorial Staff

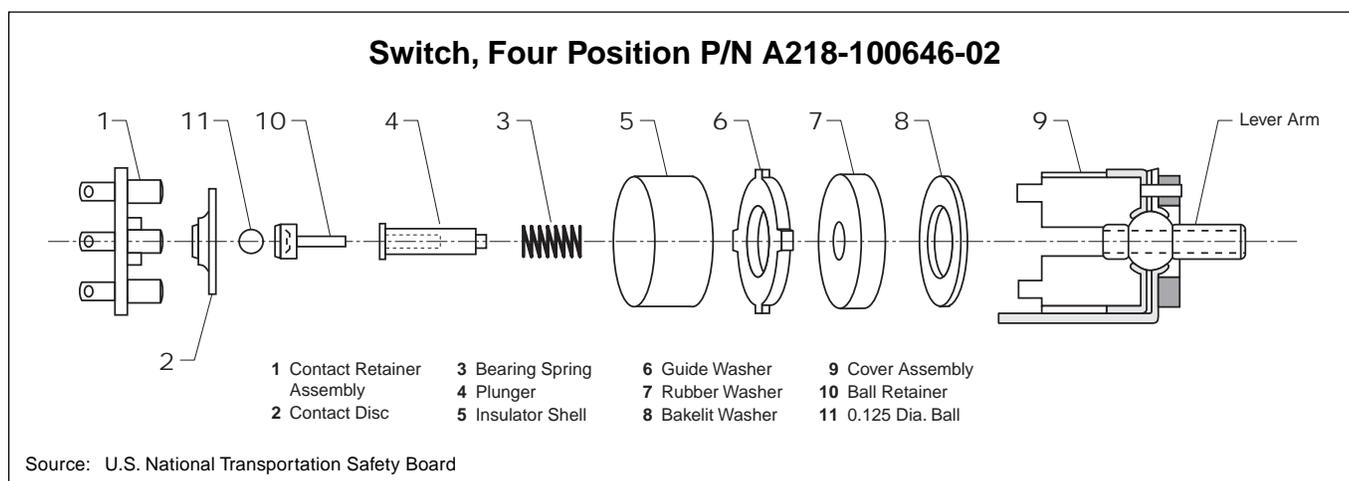
**Figure 1**

During the examination of the switch by the NTSB, Boeing Helicopter and Guardian Electric personnel noted that the stainless-steel ball inside the switch had worn grooves into

the contact disk. Investigators discovered that the surface of the contact disk was made entirely of silver and had no protective liner (Figure 1).

"Guardian has never produced a version of this switch which had a ball on the plunger unless there was a copper-beryllium liner in the contact to prevent wear," said the switch manufacturer. "Coupled with the evidence of tampering and damage on the contact retainer assembly, [this] clearly indicates this switch had some sort of modification or parts 'swap-out' done to it in the field."

"This switch is not a repairable item," said Guardian. "No repair manual or spare-parts program exists for this switch. The disassembly and reassembly using alternate 'mixed-design' parts created a mismatch of technologies which, coupled with the damaged contact retainer assembly [and] loose contact, caused the switch to function abnormally."
