## Unsecured Fasteners in Tail-rotor System Faulted for Bell UH-1H Loss of Control

*New Zealand investigators said that the failure to install split pins during maintenance likely caused nuts and bolts in a tail-rotor-blade pitch-control mechanism to become loose, leading to the pilot's loss of control of the ex-military helicopter during approach and landing.*

—  
*FSF Editorial Staff*

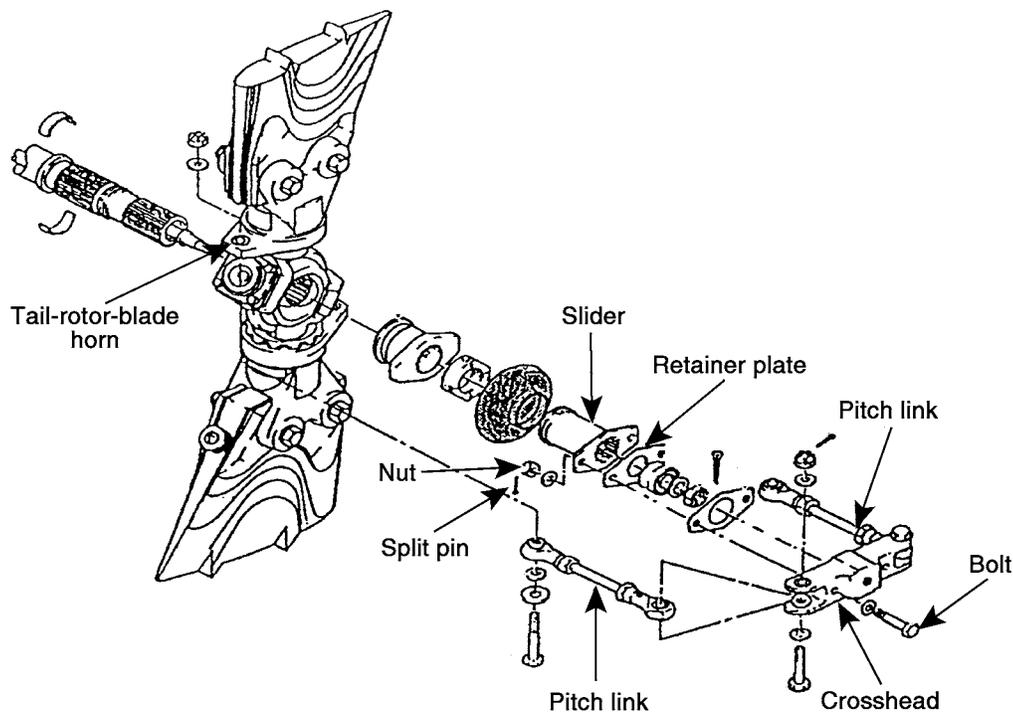
**Figure 1**

Among the tail-rotor-assembly components is the crosshead (Figure 1, page 3). The two rods (pitch links) that control tail-rotor-blade pitch are attached to the arms of the crosshead and to the tail-rotor-blade horns. The crosshead is secured with two bolts and two nuts to the slider and retainer plate, which are part of an assembly — called the stack — that is fitted to the tail-rotor hub.

Investigators found a bolt and a washer embedded in a tail-rotor blade. The bolt was a type that is used only to attach the tail-rotor-blade pitch links to the tail-rotor-blade horns and to attach the crosshead to the slider. (The crosshead and parts of the tail-rotor-blade pitch links were not found.)

Investigators concluded that the loss of tail-rotor control probably resulted from the crosshead becoming loose.

The report said that the presence of debris in the bolt hole indicated that a split pin had been absent for “some time” and that omission of split pins during the inspection of the helicopter was the most likely reason for the loss of tail-rotor control.
