FLIGHT SAFETY FOUNDATION

HELICOPTER SAFETY

Too Fast and Too Low

A fatal chain of events began with inadequate preflight preparation and ended with insufficient inflight safety precautions.

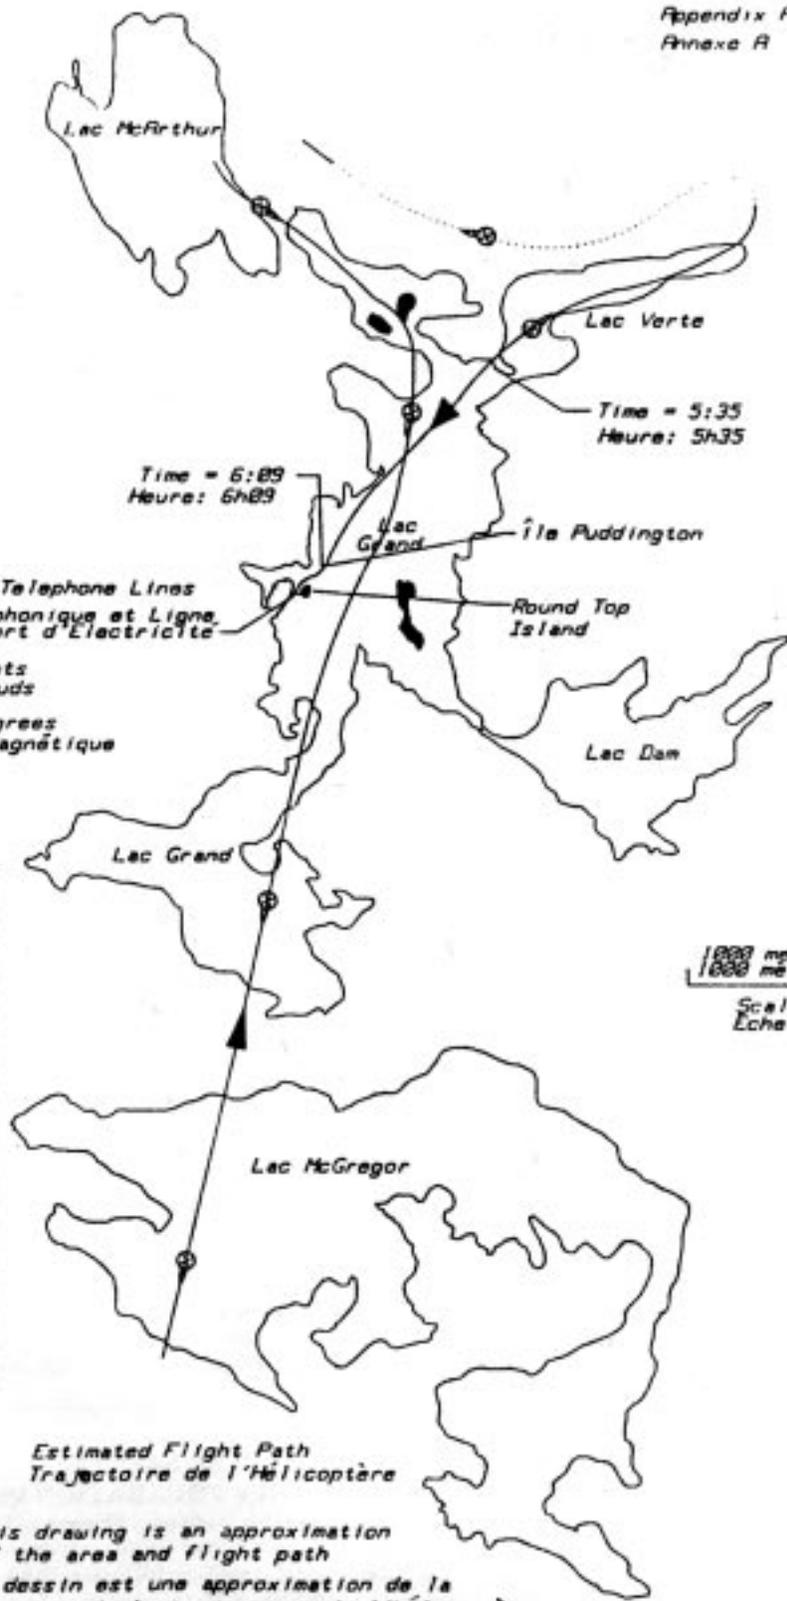
Estimated Flight Path
Trajectoire de l'Hélicoptère

Once clear of the trees, the pilot again descended to about 20 feet and headed toward the bay north of Round Top Island and Puddington's Island. Left and right turns were made to pass between Puddington's and Round Top. He then initiated a left turn, climbing slightly, and entered the channel between Round Top and the mainland. While still in the turn, at about 35 degrees of bank and in a relatively level pitch attitude, the helicopter simultaneously struck a Hydro-Quebec power line and a Bell Canada telephone line which were strung across the channel.

Hydro & Telephone Lines
Ligne Téléphonique et Ligne
de Transport d'Electricité
