FLIGHT SAFETY FOUNDATION

HELICOPTER SAFETY

Typical Helicopter Accidents Profiled; Safety Still Rests with Pilots

Researchers compiled accident data from U.S. National Transportation Safety Board and military sources to create composite scenarios of helicopter accidents at heliports and airports. The report is designed as a training aid for pilots and provides heliport design suggestions.

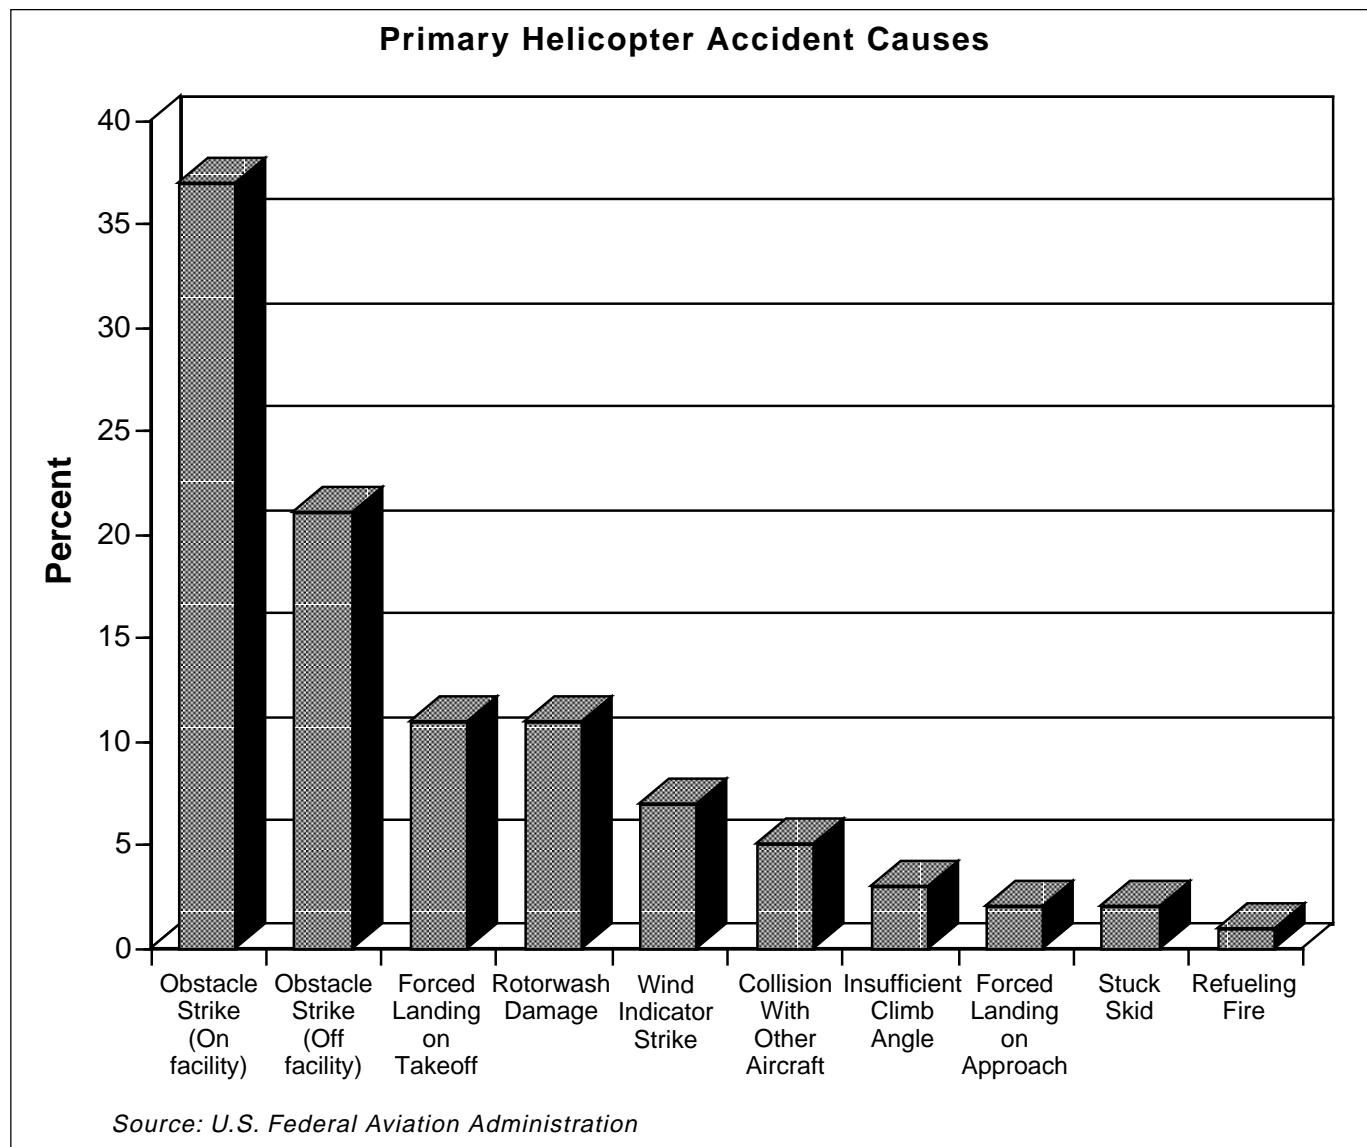
Figure 1

rotor-wash damage. The report also discussed factors that influenced pilot performance. The report suggested that the majority of helicopter accidents at heliports and airports involved obstacle strikes (Figure 1).
