FLIGHT SAFETY FOUNDATION HELICOPTER SAFETY

Vol. 20 No. 3

May/June 1994

Judgment Remains Key in Avoiding Potentially Fatal Weather Encounters

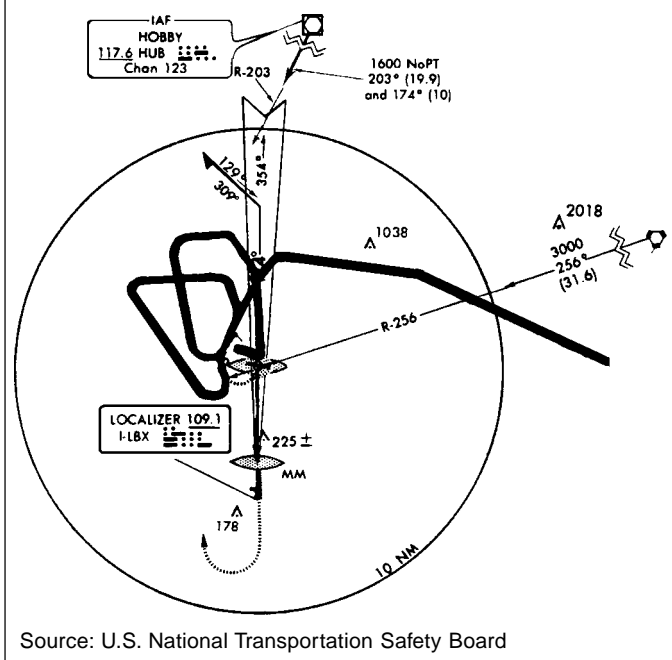
Figure 1

Attempted Approach Paths Of Sikorsky S-76A

The pilot broke out of the weather above a layer of clouds that obscured the ground. He contacted his operations base and obtained local weather and the information he needed for an ILS approach to Brazoria County Airport, Angleton, Texas (Figure 1). No approach charts were on board the aircraft, and no plans had been made to conduct the flight under IFR.

While maintaining communications with his operations base, the pilot established contact with Houston approach control on another radio to request assistance. Houston approach control established radar contact and began vectoring the helicopter for the ILS approach. During the first vector to final, however, the aircraft flew through the localizer approach course and had to be vectored back for another intercept. The second attempt was also unsuccessful; just before intercepting the final approach course on the second attempt, the aircraft entered a right turn away from the localizer and had to be vectored for another course intercept.

Vectors for the third approach attempt appeared to establish the aircraft on final. Nevertheless, just before crossing the outer marker, the aircraft turned sharply to the right. Radar contact was lost a few moments later. During the last few moments of the flight, the calculated ground speed varied between 106 knots and 28 knots. The pilot reportedly stated on his company radio frequency that he was in an unusual attitude and, after a few seconds, that he thought he was going to crash.

NTSB investigators found no malfunctioning aircraft components that could have contributed to the accident. The NTSB accident report determined that the probable causes of the accident were inadvertent VFR flight into IMC, the pilot's spatial disorientation and exceedance of the aircraft's design limits.

Loss of control because of spatial disorientation can be reduced if instrument training is emphasized and aircraft are equipped with stability augmentation systems. Procedures for coping with inadvertent IMC should be practiced frequently by VFR-rated pilots who fly in areas where poor weather is a frequent problem and inadvertent flight into IMC could occur.
