## **Engine, Transmission Failures Lead Causes of Accidents in U.S. Helicopter Logging Operations**

*More than half the accidents in U.S. helicopter logging operations in 1983 through 1999 involved failures of engines or transmission systems. Metal fatigue and external-load problems also were major causes of accidents.*

### Helicopter Safety

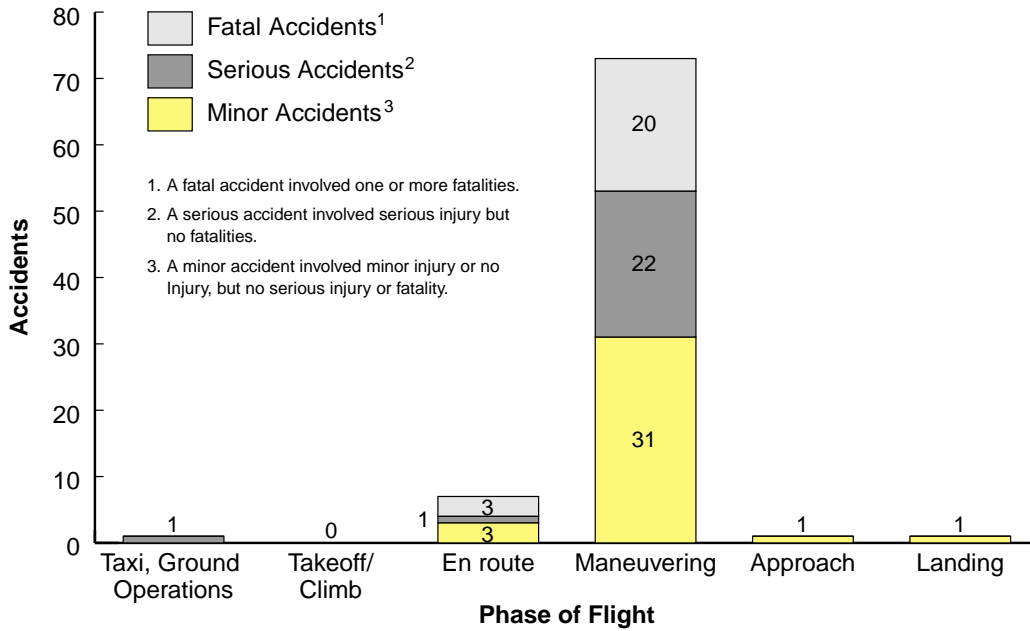
**Figure 1**

Figure 1 (page 2) shows that 73 accidents involved helicopters being maneuvered in work areas; 20 accidents resulted in fatalities, and 22 accidents resulted in serious injuries.

### Phase of Flight for 83 U.S. Helicopter Logging Accidents, 1983–1999

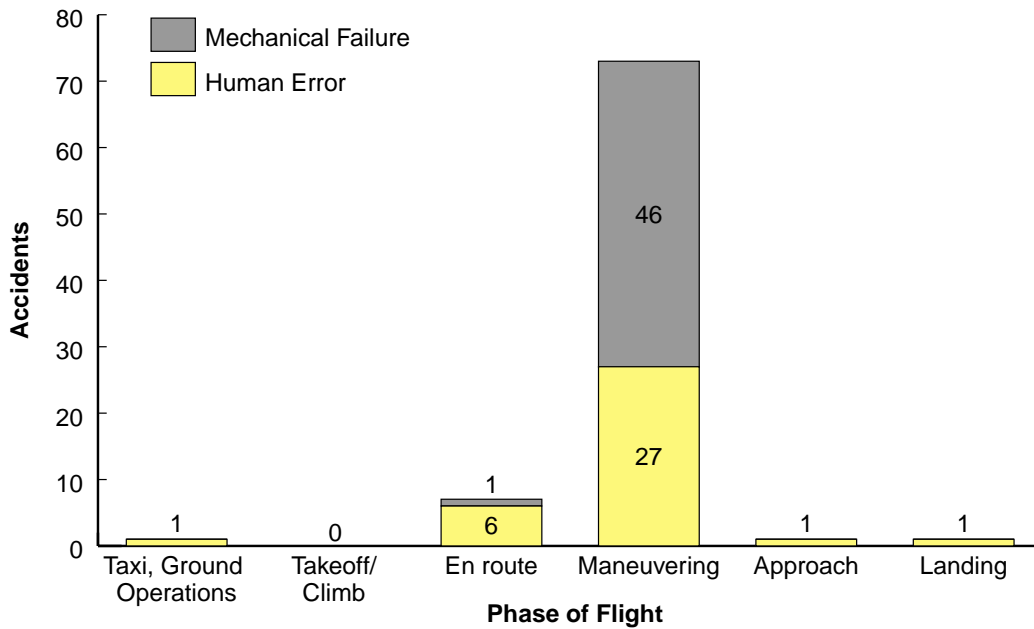
**Figure 2**

Figure 2 (page 2) shows that 46 maneuvering-phase accidents were caused by mechanical failure and that 27 maneuvering-phase accidents were caused by human error (other than human error during maintenance).

### Involvement of Mechanical Failure and Human Error by Phase of Flight in 83 U.S. Helicopter Logging Accidents, 1983–1999

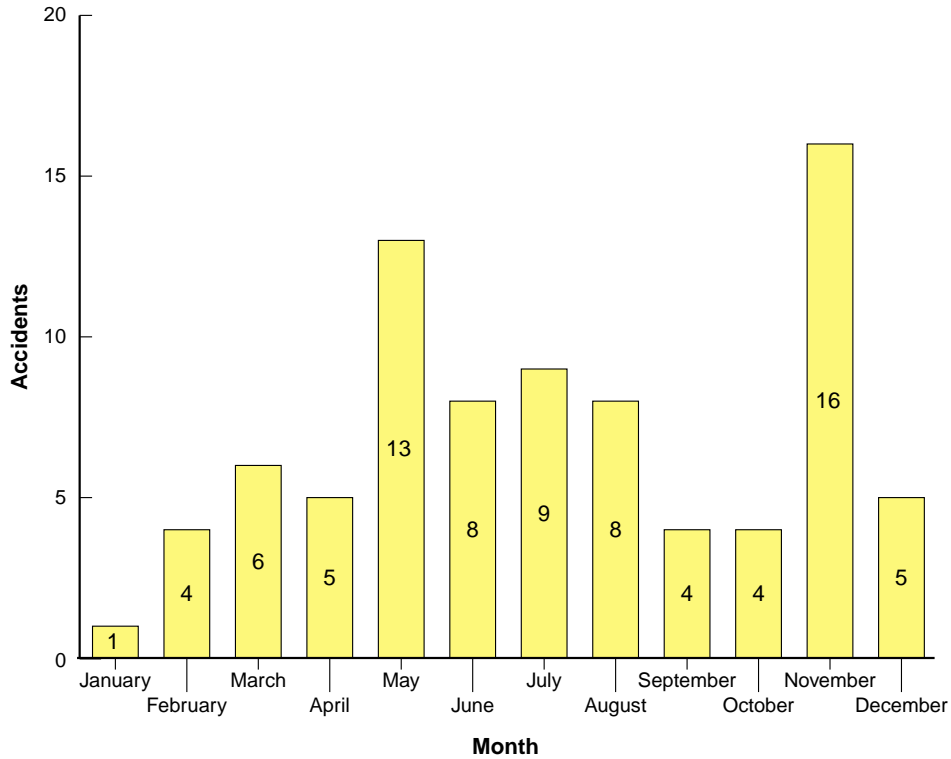
**Figure 3**

### Distribution by Month of 83 U.S. Helicopter Logging Accidents, 1983–1999

Heli-logging activities are conducted year-round. Figure 3 (page 3) shows the monthly distribution of heli-logging accidents during the study period.

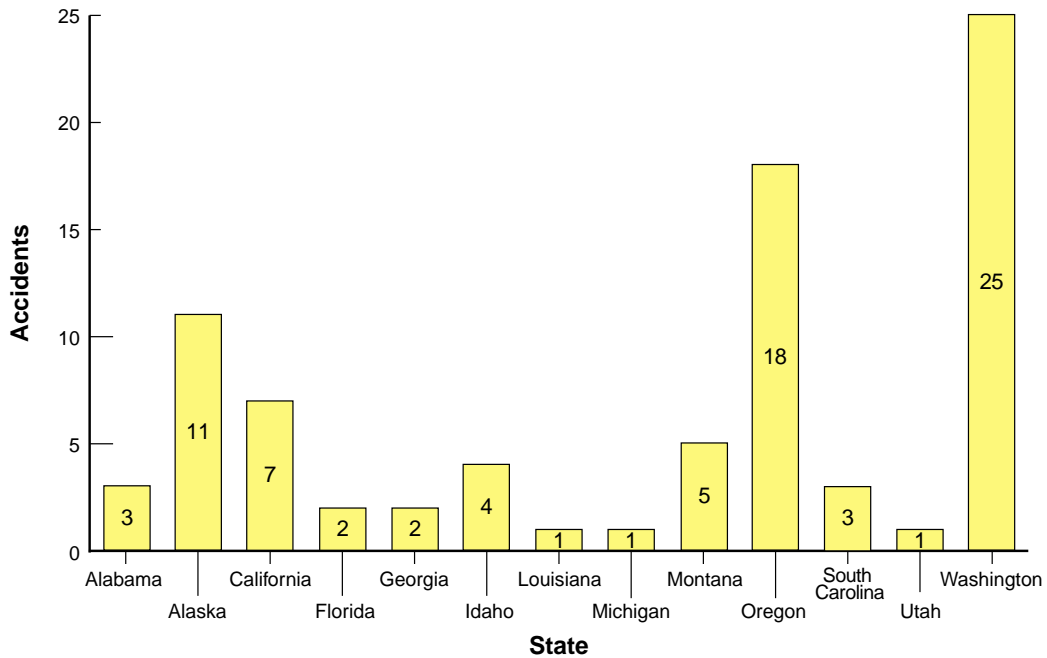
**Figure 4**

### Distribution by State of 83 U.S. Helicopter Logging Accidents, 1983–1999

Figure 4 (page 3) shows the distribution by state of heli-logging accidents. Two-thirds of the accidents occurred in Alaska, Oregon and Washington.
