Failure to Intercept Final Approach Course, Improperly Performed IFR Approach Cited in Fatal Collision with Terrain

The U.S. National Transportation Board (NTSB) report on the accident found that although the pilot had accurately followed ATC radar vectors, pilot error was the cause of the accident.

*Joel S. Harris
FlightSafety International*

HELICOPTER SAFETY

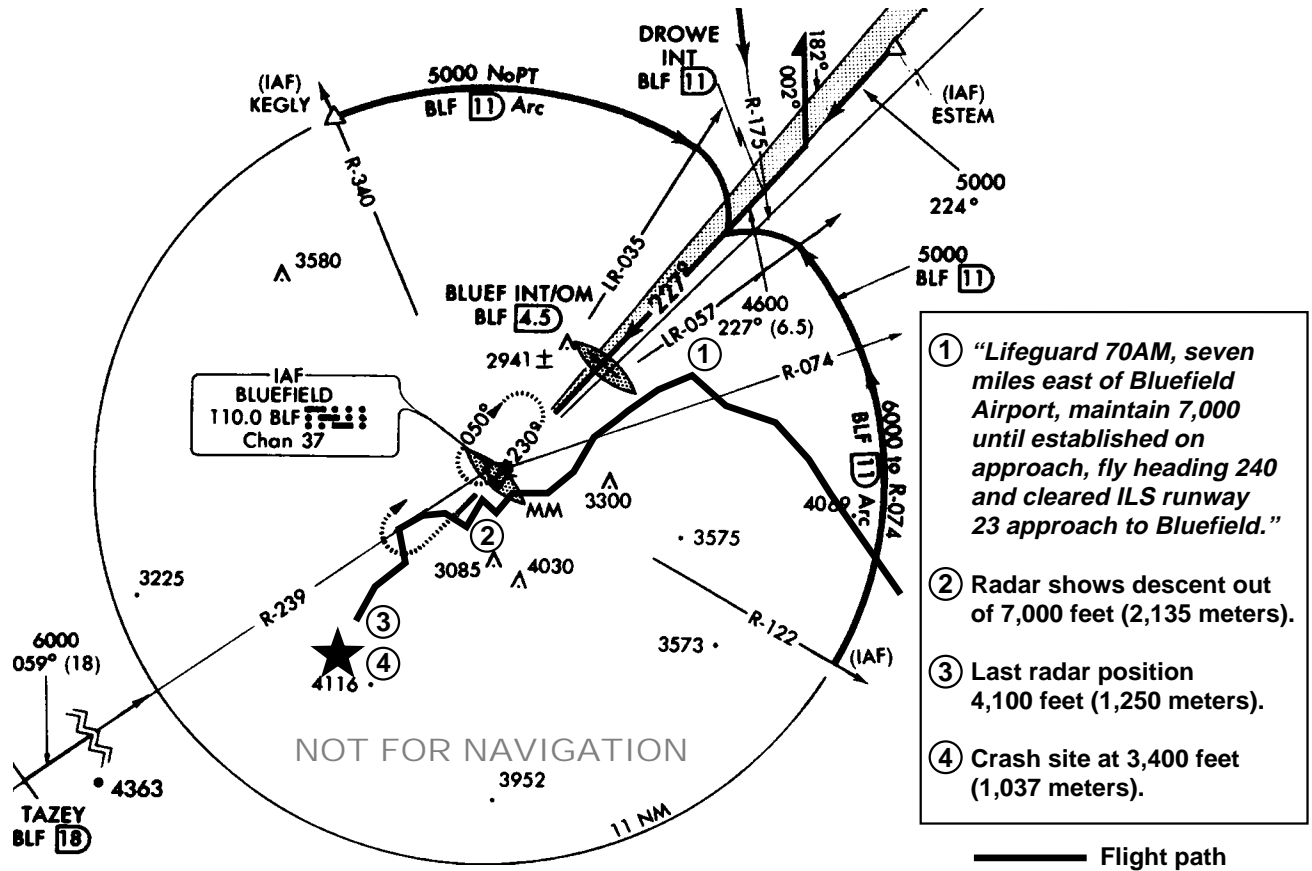
Figure 1

The report's radar data show that N70AM was northeast of the airport and less than one mile (1.6 kilometers) east of the outer marker at BLF (Figure 1, page 3).

At 1442, approximately one-quarter mile (0.4 kilometer) south of the Bluefield Vortac [VOR (very high frequency omnidirectional radio range) plus Tacan (tactical air navigation, an ultra-high frequency navigation aid)]/middle marker, N70AM began a descent from 7,000 feet. The flight's last recorded radar position was approximately two miles southwest of the airport at an altitude of 4,100 feet (1,250 meters).

Flight Path of N70AM

The accident site was seven miles (11.3 kilometers) southwest of BLF on a magnetic heading of 230 degrees. The initial point of impact was with trees on a 30- to 40-degree slope at the 3,400-foot (1,037-meter) level on East River Mountain. Wreckage was oriented on a magnetic heading of 335 degrees and strewn a distance of about 200 feet (61 meters).
