Undetected Wear of Turbine-shroud Seals Leads to Engine Failure, Emergency Landing

The accident investigation concluded that gradual deterioration of the turbine-rotor-shroud sealing rings was not detected because the helicopter operator did not comply with the manufacturer's engine-performance trend-monitoring procedures.

—
FSF Editorial Staff

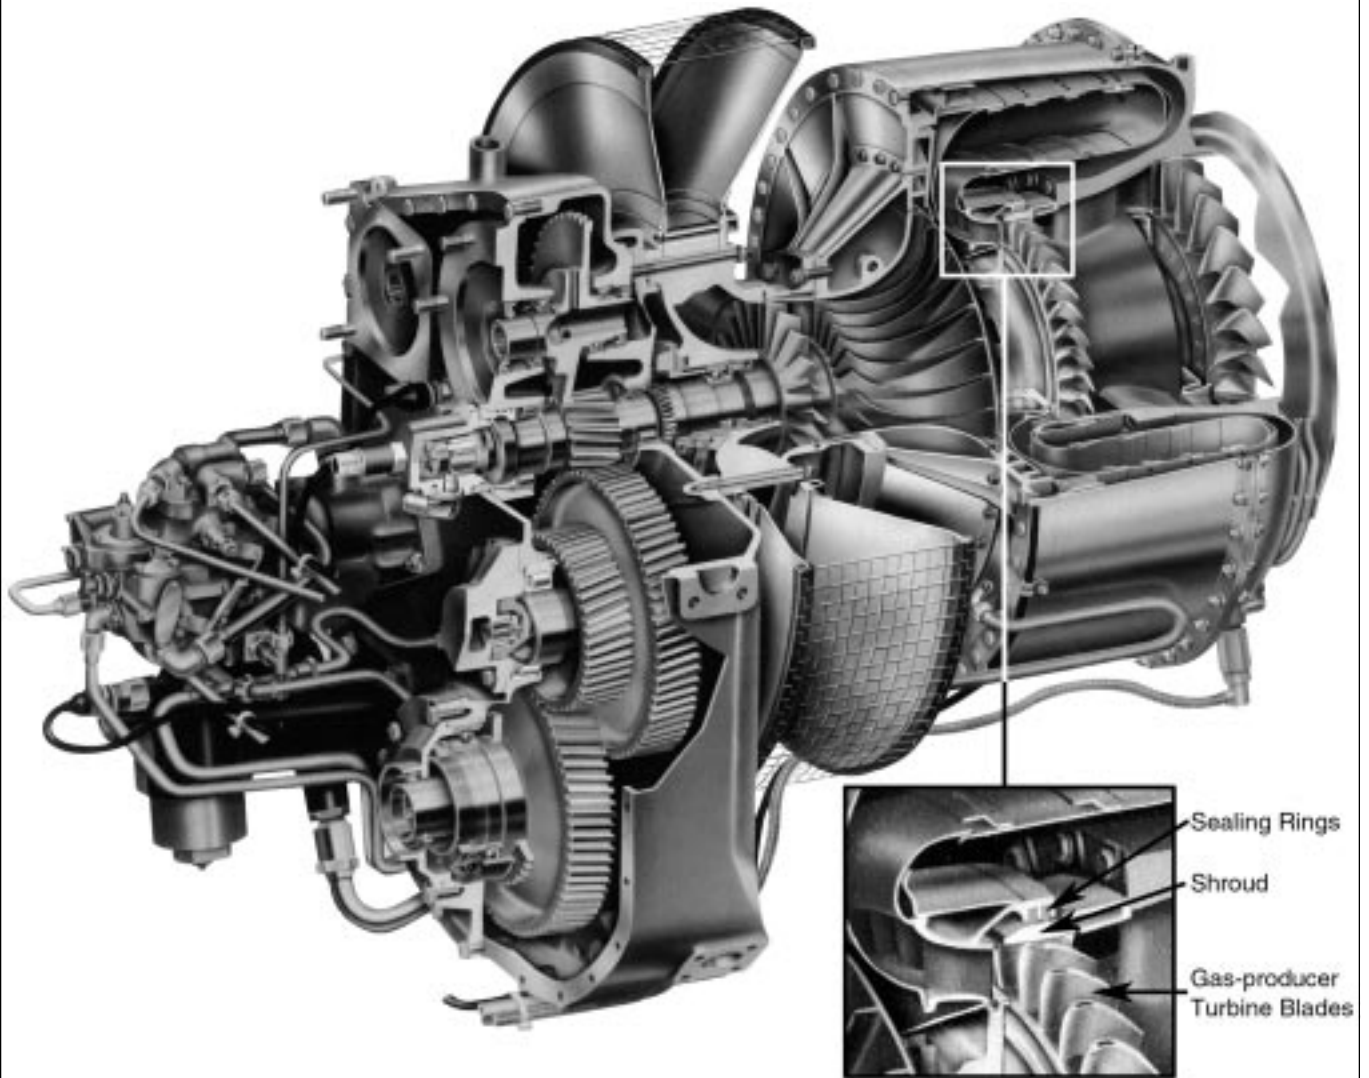
Figure 1

The final report on the accident by the New Zealand Transport Accident Investigation Commission (TAIC) said that the engine failure occurred because air leaking past worn turbine-rotor-shroud sealing rings had cooled the shroud and caused the shroud to contract and contact the turbine-rotor blades.

The tear-down inspection revealed that 14 of the 40 GP turbine-disk blades had fractured, and the remaining blades were scored. The turbine-rotor shroud had fractured into a number of pieces. The two turbine-rotor-shroud sealing rings were worn "excessively." The report said, "The wear was more than 0.06 inch [1.52 millimeters] in diameter in excess of the maximum wear allowed by the manufacturer." (Figure 1 shows internal engine components.)

The report said, "During normal operation of the engine, the GP turbine blades rotate inside the GP turbine-rotor shroud with minimal clearance or light rubbing between the blade tips and the inner diameter of the shroud."

The turbine-rotor-shroud sealing rings fit tightly against the shroud to prevent compressed air from leaking from around the outside of the combustion chamber to the turbine section. The report said that the sealing rings eventually wear from rubbing against the shroud.

Internal Components of AlliedSignal LTS101 Engine

• TAIC said, “[AlliedSignal Aerospace should] review the LTS101 engine periodic-inspection requirements regarding the GP turbine-rotor-shroud sealing rings to establish if there is a need for these sealing rings to be replaced or measured as part of the scheduled maintenance.”

– AlliedSignal Aerospace said, “AlliedSignal intends to update the hot-section-inspection requirements specified in the engine-maintenance manual to clarify which component inspections are required, including the inspection of the GP turbine-shroud seal rings. This task has been assigned and is expected to be complete by Oct. 30, 1998.”♦
