## Helicopter Impacts River After Smoke Disorients Pilot During Fire-fighting Operations

*When the pilot encountered significantly reduced visibility at low altitude, all visual cues were lost to the noninstrument-rated commercial pilot, the official Canadian accident report said.*

—  
*Joel S. Harris  
FlightSafety International*

### HELICOPTER SAFETY

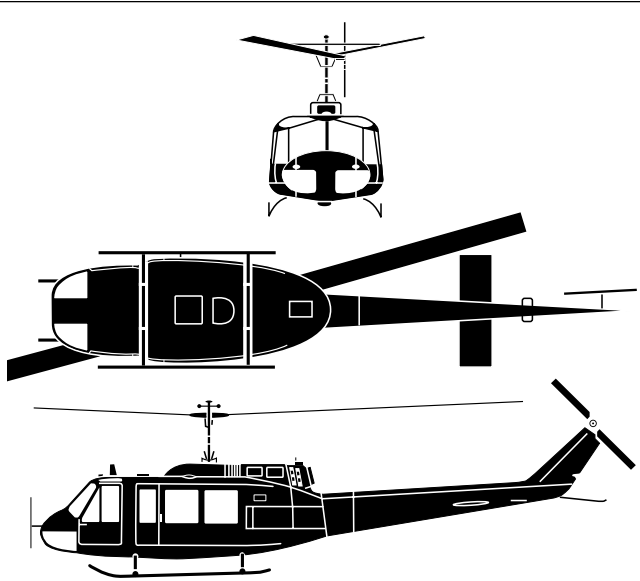
### Bell 205

The Bell 205 military general purpose turboshaft helicopter first flew in 1961. The 205A-1 is a 15-seat commercial version of the military model 205, also known as the UH-1 Iroquois.

The 205 has a maximum takeoff and landing weight of 4,309 kilograms (9,500 pounds) and a service ceiling of 12,600 feet (3,840 meters). It has a maximum level cruising speed of 110 knots (204 kilometers) per hour and a maximum no-reserves range of 276 nautical miles (511 kilometers).
