External Loads, Powerplant Problems And Obstacles Challenge Pilots During Aerial Fire Fighting Operations

U.S. accident reports from 1974–1998 show that diversion of attention was a major factor in accidents during external-load operations, which accounted for more than half of the accidents. Powerplant malfunctions and powerplant failures were involved in more than a third of the accidents. More than a quarter of the accidents occurred when helicopters struck obstacles, such as trees and wires, during fire fighting missions.

—
Patrick R. Veillette, Ph.D.

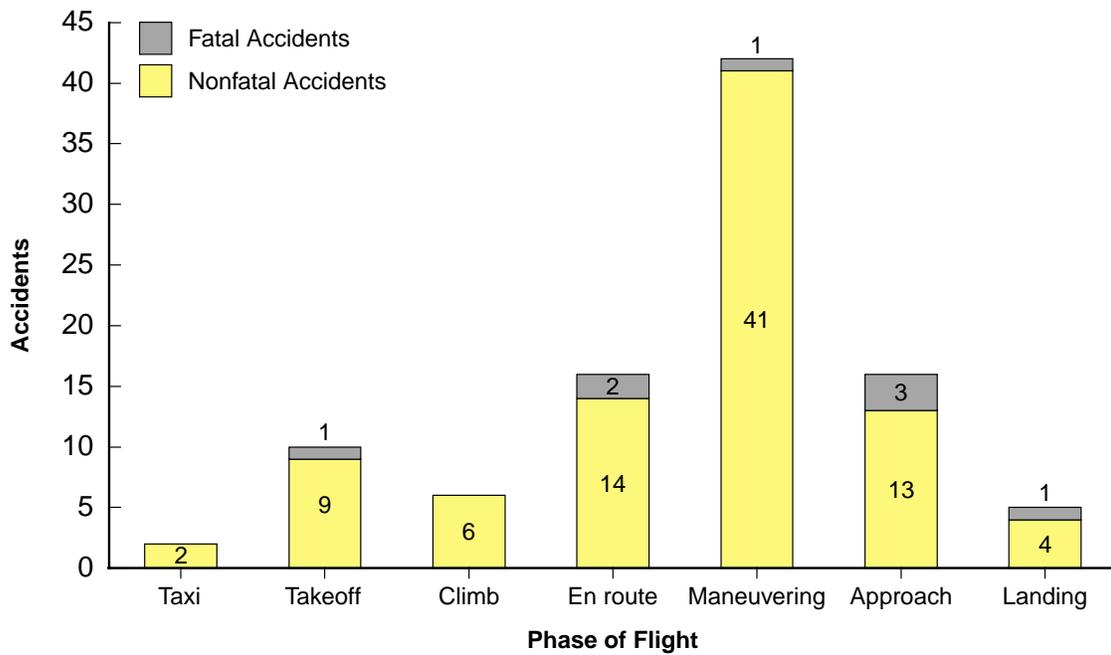
Figure 1 shows that 41 nonfatal accidents and one fatal accident occurred as helicopters were being maneuvered for reconnaissance, to drop water or chemical retardant on fires or to deliver cargo and/or firefighters to fire areas. Figure 2 shows that 17 of the maneuvering accidents were caused by

Phase of Flight for 97 U.S. Aerial Fire Fighting Helicopter Accidents, 1974–1998

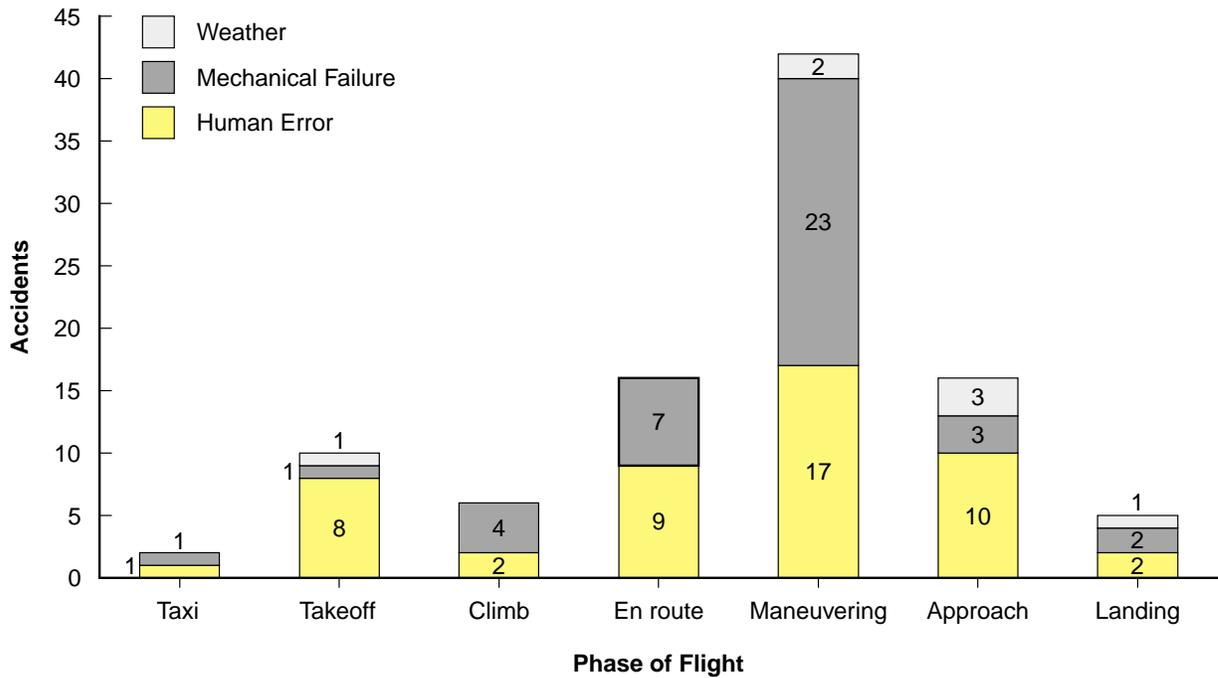
Figure 2

Involvement of Weather, Mechanical Failure and Human Error by Phase of Flight In 97 U.S. Aerial Fire Fighting Helicopter Accidents, 1974–1998

human error, 23 accidents were caused by mechanical failure, and two accidents were caused by adverse weather conditions.
