# HELICOPTER SAFETY

Vol. 17 No. 5

## Set-up for Disaster

*The helicopter was heavily laden with a sling-loaded concrete bucket, the crew had had a tiring duty day, spectators remained at the delivery site despite warnings to leave and an engine failed.*

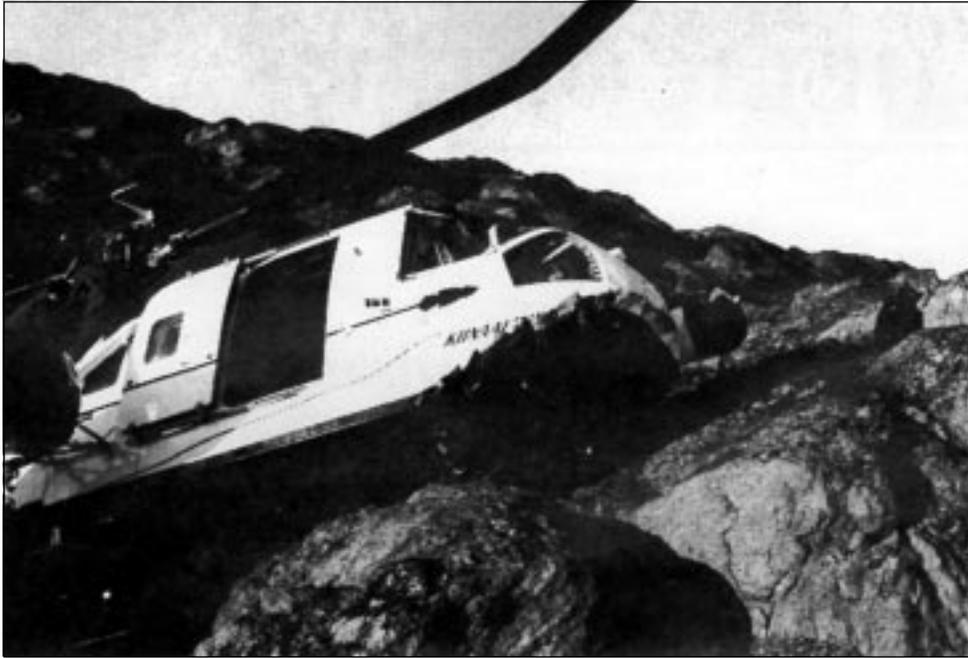
*The Sikorsky S-61N helicopter came to rest in rugged terrain after an engine failed during a sling-load delivery of concrete to a remote construction site.*

The helicopter descended and collided with the surrounding terrain several times before it came to rest at a cliff formation. Two of the main rotor blades had cut through the upper front section of the cockpit and the fiberglass engine intake ice deflectors. The radome and 20 inches (50 centimeters) of the top skin behind the cockpit were cut off.

The AAIB report stated the cause factor was that the “automatic shutdown of engine number two due to a failure of the number two engine input freewheel unit [IFWU] was not followed by an instantaneous release of the external load.” The IFWU is a clutch mechanism that allows the main rotor blades to disengage, or freewheel, during autorotation or for the main rotor blade to be driven by the operating engine if one of the two engines fails.

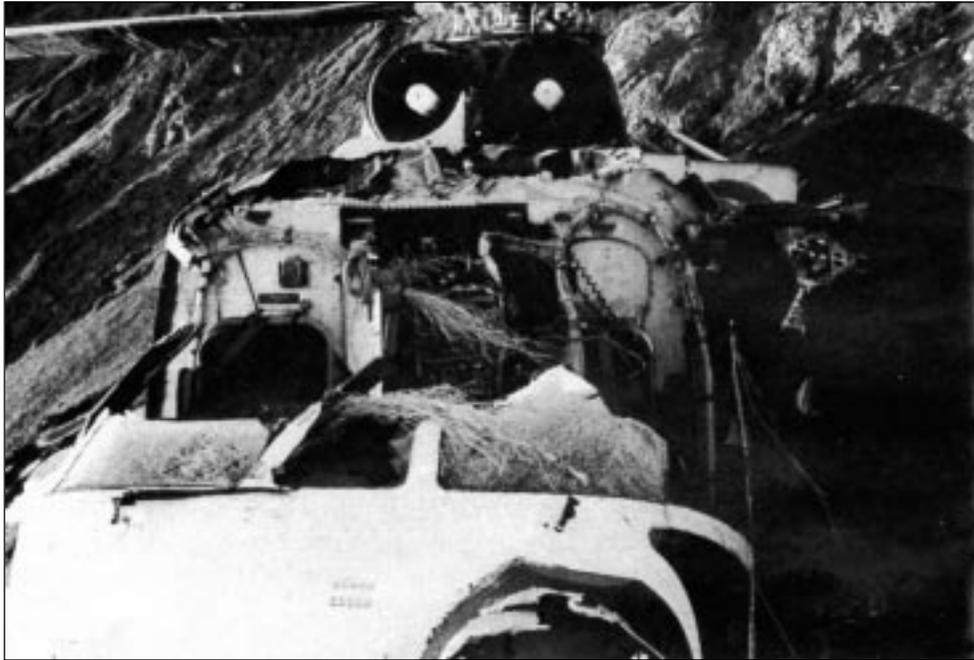
against the rear part of a metal holder for a portable strobe light that was mounted on the bulkhead behind his seat. His skull was fractured, resulting in a fatal injury.

Neither pilot was wearing protective headwear.

The AAIB was of the opinion that the PIC might have survived the accident had he been wearing a protective helmet.

*The pilot, who was not wearing protective headgear, was fatally injured when his head hit a metal holder for a portable strobe light which was situated on the bulkhead behind*

The last point to make is about protective headgear. The AAIB makes its point well. For flights that can be considered hazardous by any means, protective headgear should be worn by the crew. The PIC of the accident flight might have survived had he been so equipped. Certainly, the cost and any inconvenience of protective equipment is far outweighed by the additional safety afforded to crew members. ♦
