Spatial Disorientation Blamed for Fatal Helicopter Accident in Poor Weather

After successfully completing a night nonprecision approach in instrument meteorological conditions to a rural airport, the pilot had apparently intended to proceed visually to a nearby helipad, the official accident report said.

Editorial note: This article was based on U.S. National Transportation Safety Board Factual Report Aviation,

no. NYC95FA050. The 64-page report included charts, diagrams, photos and witnesses’ statements.

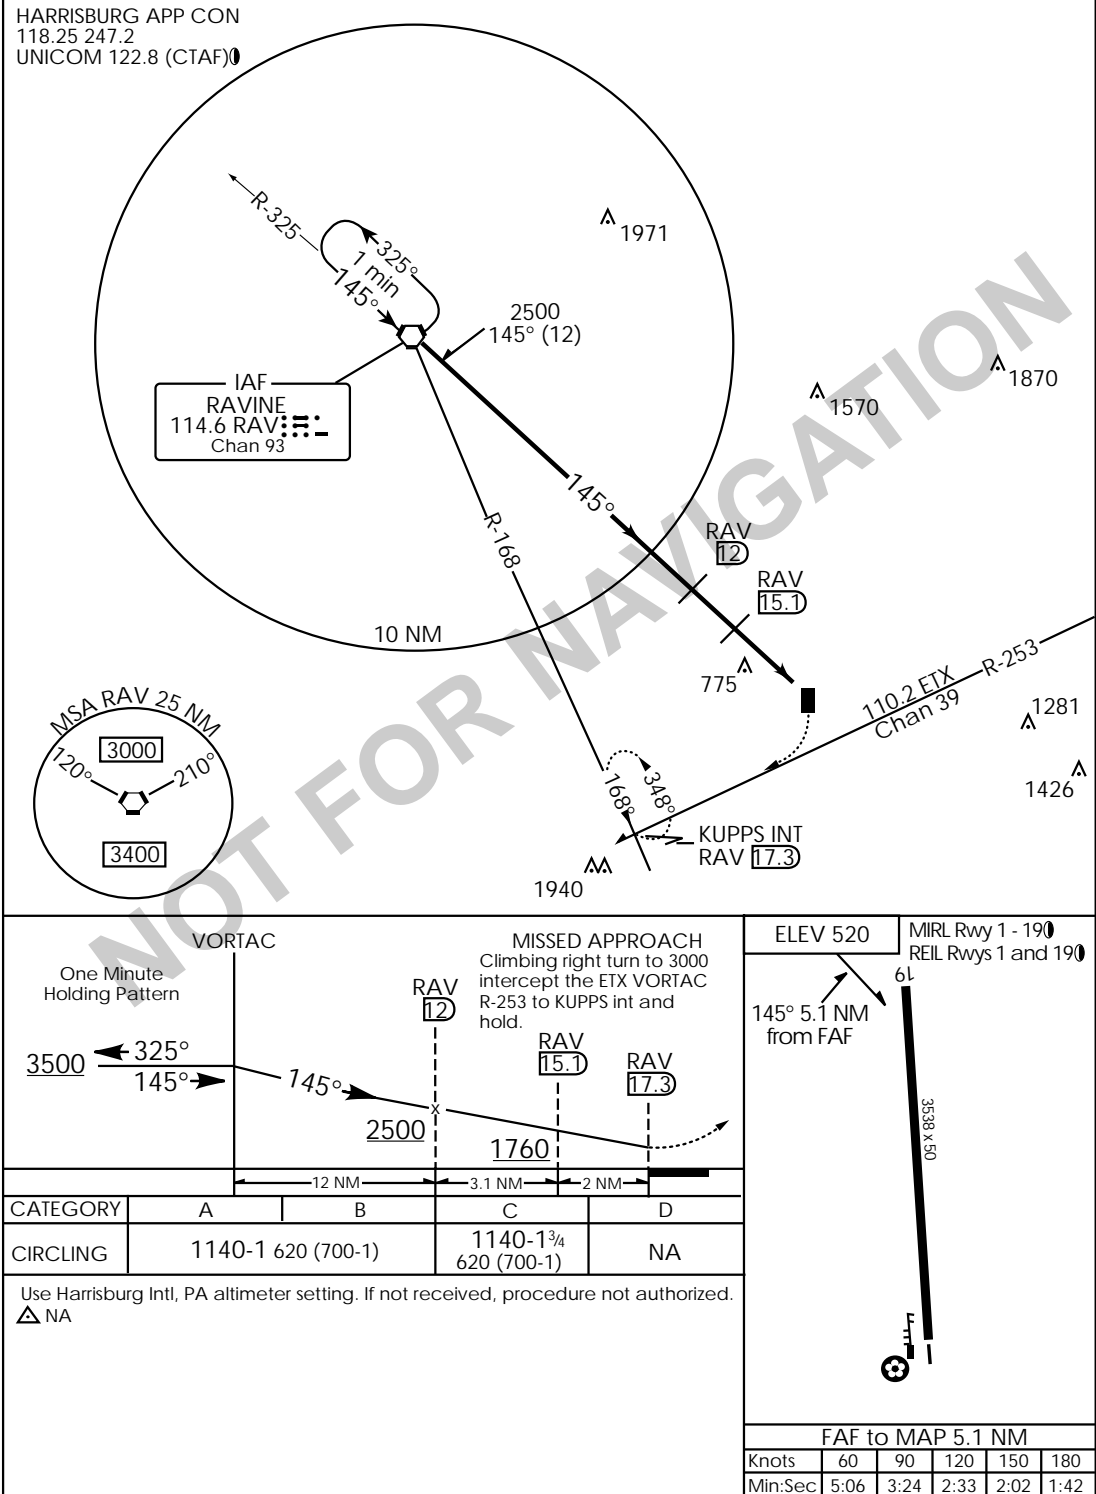
Figure 1

The helicopter impacted a field about 1.6 kilometers (three-fourths of a mile) northwest of Myerstown/Decks near the VOR/DME Alpha final approach course to Myerstown/Decks (Figure 1, page 4).

VOR/DME Alpha Final Approach to Myerstown/Decks Airport
