Federal Democratic Republic of Ethiopia
Ministry of Transport
Aircraft Accident Investigation Bureau

Aircraft Accident Investigation Preliminary Report
Ethiopian Airlines Group
B737-8 (MAX) Registered ET-AVJ
28 NM South East of Addis Ababa, Bole International Airport
March 10, 2019

Report No. AI-01/19

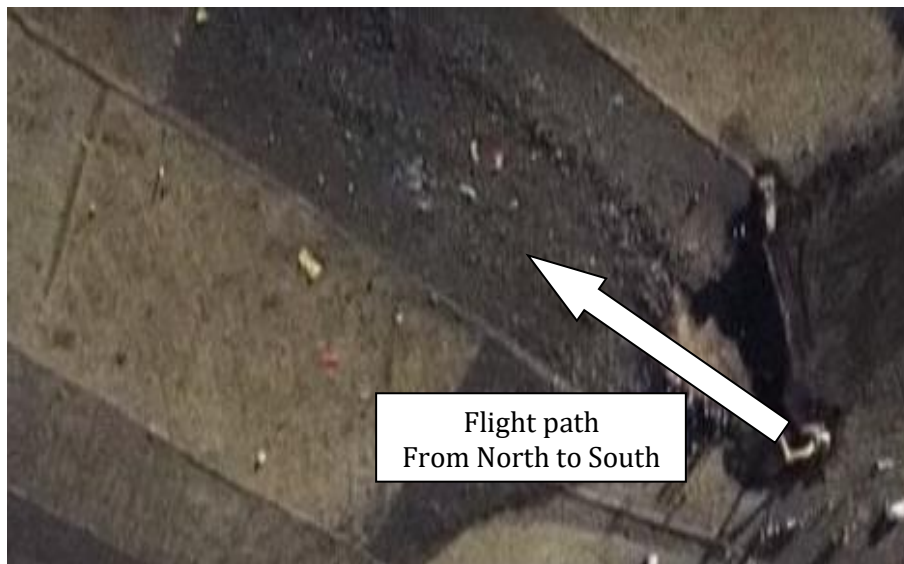
The Aircraft impacted in a farm field and created a crater approximately 10 meters deep (last aircraft part found) with a hole of about 28 meters width and 40 meters length. Most of the wreckage was found buried in the ground; small fragments of the aircraft were found scattered around the site in an area by about 200 meters width and 300 meters long.

The damages to the aircraft are consistent with a high energy impact.

Top view of the crater
