BY MARK LACAGNINA

Midair over the Amazon

Controversial Brazilian report cites loss of situational awareness by pilots and controllers.

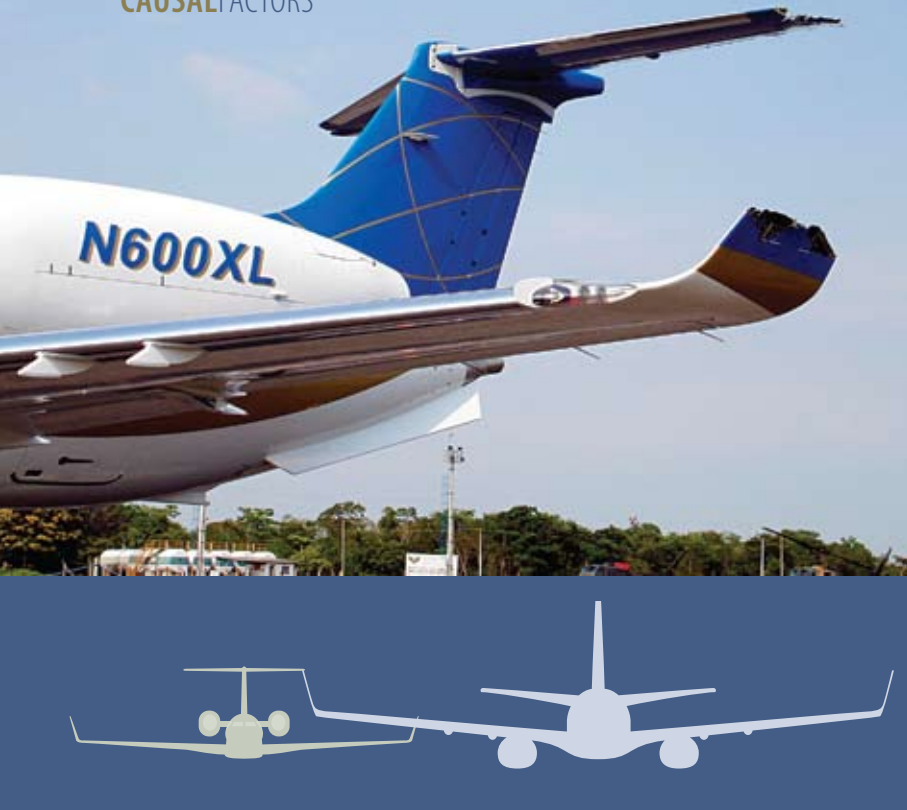
The Legacy pilots experienced control difficulties after the collision but were able to land the airplane. The 737 descended out of control after losing the outer portion of its left wing.

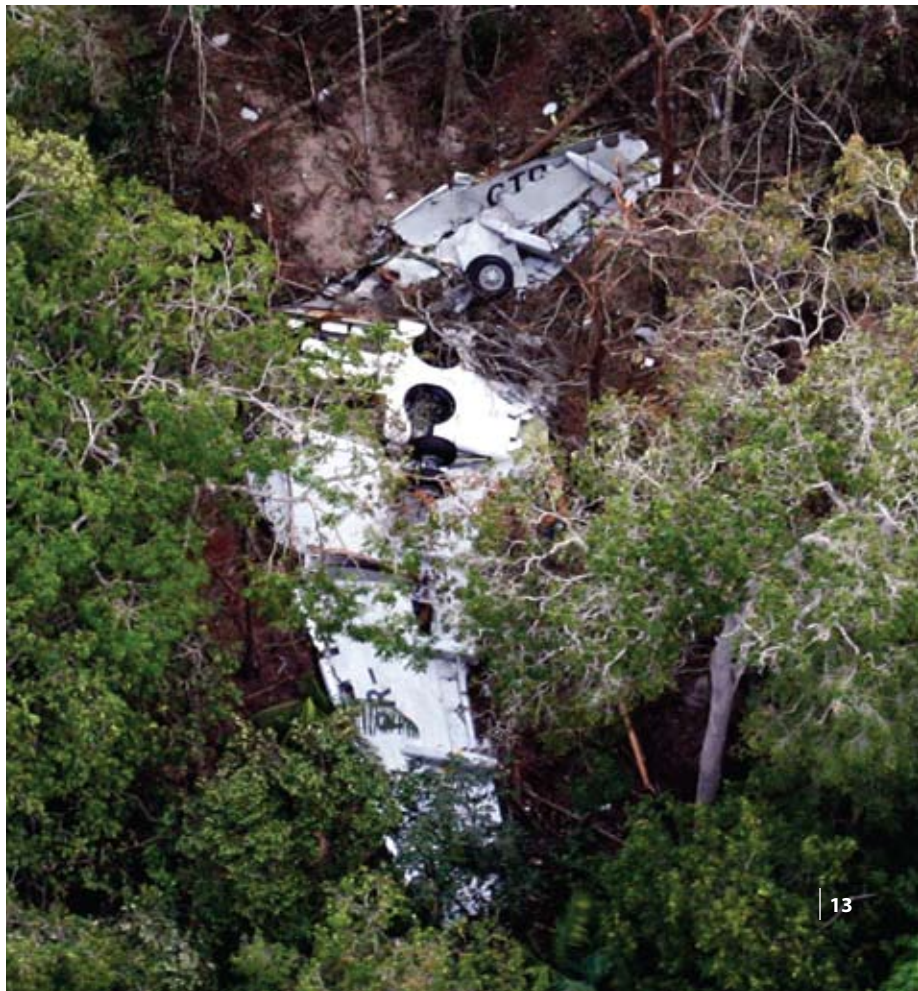
All 154 people aboard the 737 were killed when the airplane broke up during descent and crashed in the rain forest.

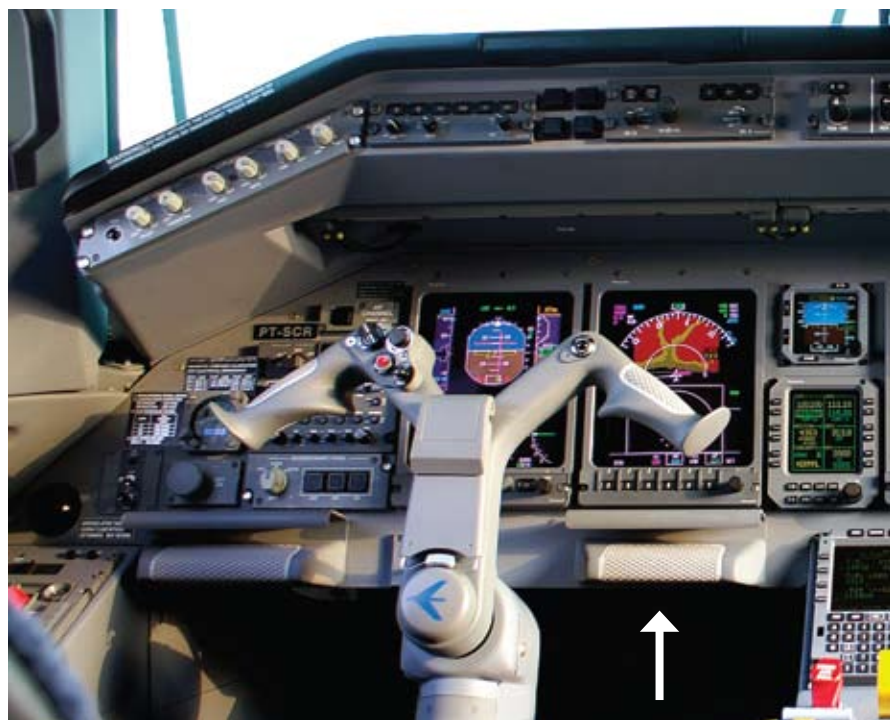
Another possibility is that the button was accidentally struck when the pilot placed a foot on the footrest at the bottom of the panel. However, “the footrest has a metal plate, called a foot protector, designed to keep the foot

away from delicate instruments which could be damaged if contacted inadvertently,” the report said.

NTSB said that misuse of the footrest is another possibility. “In certain forward seat positions, there appeared [during observation flights] to be a very comfortable resting position that involved resting the feet on top of the footrest guards rather than inside the designated footrest areas,” the board said. “This ... located the captain’s right foot in the area of the RMU so it could make unintended contact without the captain’s awareness.”

Brazilian investigators considered the possibility that the Legacy’s transponder might have been deactivated when the captain’s foot, when placed on the footrest shown by the arrow, inadvertently touched the radio management unit above and to the right of the footrest.
