Sustained Stall

Blocked pitot tubes, excessive control inputs and cockpit confusion doomed Air France 447.

BY MARK LACAGNINA

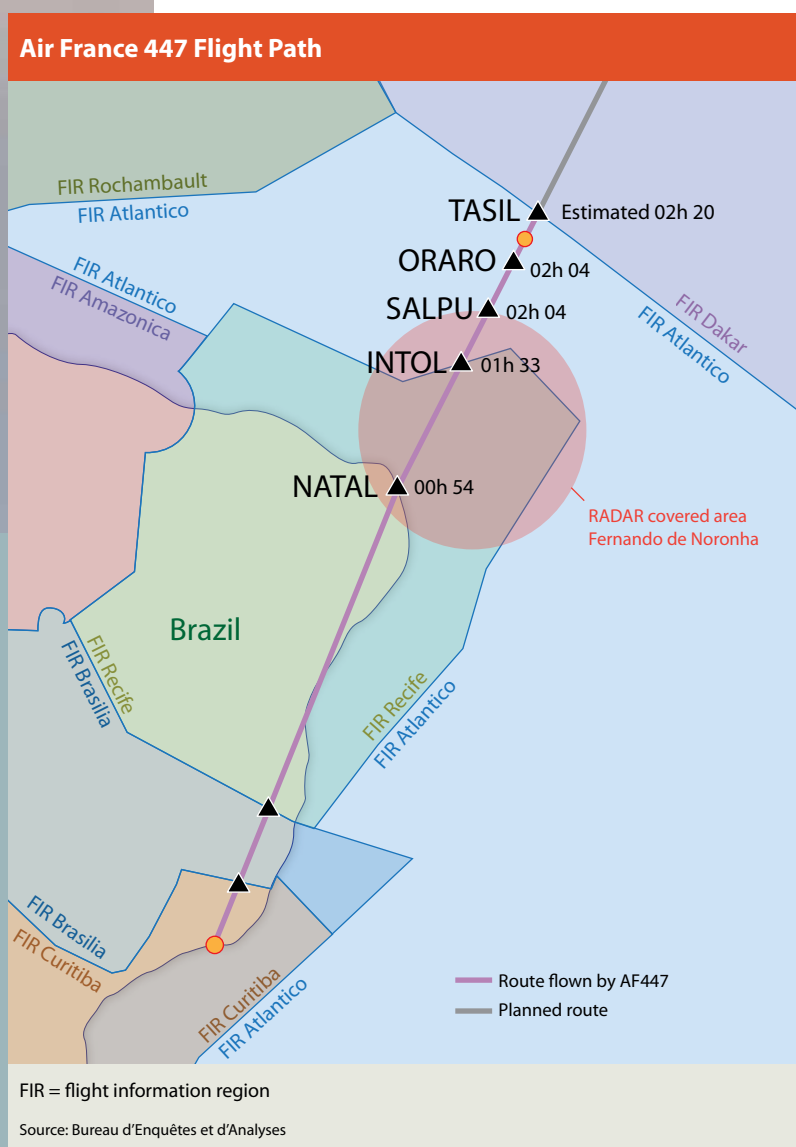
Figure 1

About two hours after departing from Rio, the flight crew received information from the airline's operations center about an area of convective activity developing along the route between the SALPU and TASIL navigation waypoints (Figure 1). Shortly thereafter, the PF remarked that the airplane was "entering the cloud layer," and the light turbulence to which the flight had been exposed increased slightly.

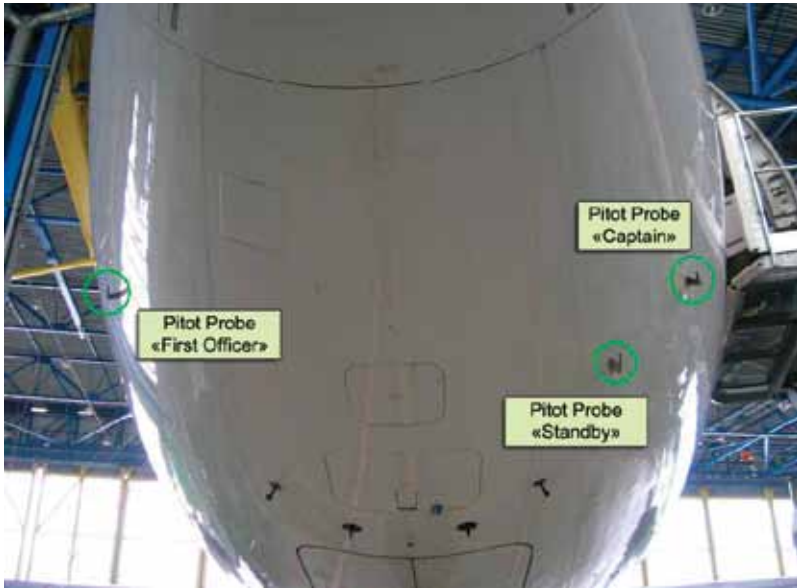
All three pitot probes were blocked by ice crystals, and airspeed information became unreliable.

The ice crystal icing that had blocked the A330’s pitot probes is a phenomenon that is not well understood, according to the report. “In the presence of ice crystals, there is no visible accretion of ice or frost on the outside, nor on the nose of the probe, since the crystals bounce off of these surfaces. However, the ice crystals can be ingested by the probe air intake. According to the flight conditions (altitude, temperature, Mach), if the concentration of crystals is greater than the capacity for deicing of the heating element and evacuation by the purge holes, the crystals accumulate in large numbers in the probe tube.” The resulting disruption of total pressure measurement produces unreliable airspeed information, causing reversion from normal to alternate flight control law.

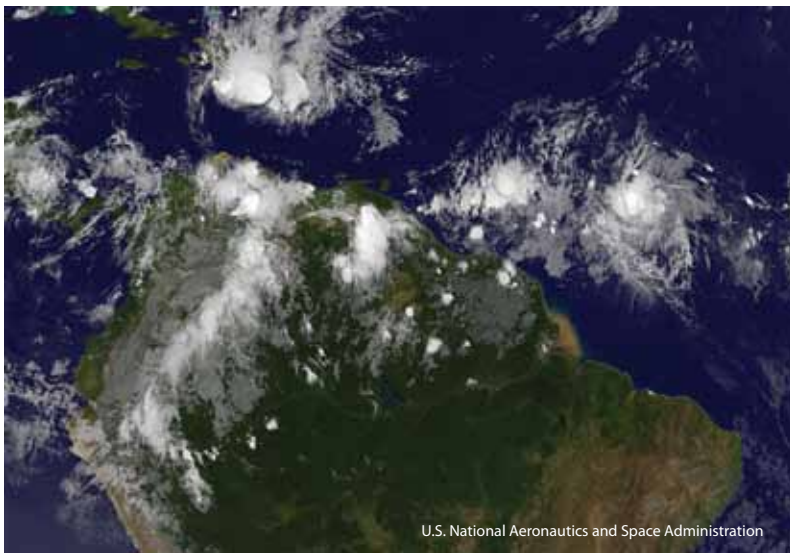
The upset occurred soon after the A330 entered clouds in the intertropical convergence zone.
