MISSED

The pilots did not notice a misset pressurization mode selector and misidentified a warning about cabin altitude. After hypoxia struck, autoflight systems kept the 737 flying until the fuel ran out.

opportunities

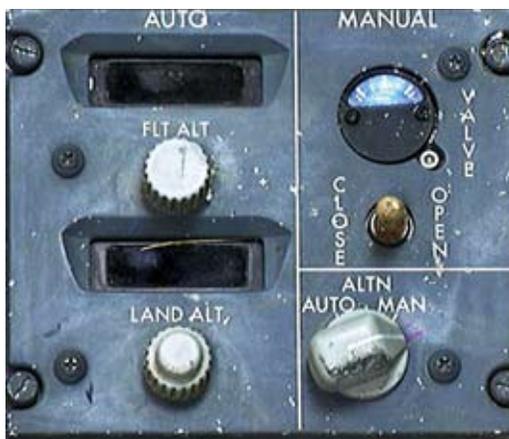
The flight crew did not reset the pressurization mode selector to automatic before departure. “The fact that the mode selector position was not rectified by the flight crew during the aircraft preflight preparations was crucial in the sequence of events that led to the accident,” the report said.

The pressurization system mode selector was in the manual, “MAN,” position during the accident flight and was moved beyond that position by impact forces.

Among actions taken in response to the findings of the accident investigation was Airworthiness Directive (AD) 2006-13-13, issued in June 2006 by the U.S. Federal Aviation Administration. The AD required revision of the 737 airplane flight manual (AFM) “to advise the flight crew of improved procedures for preflight setup of the cabin pressurization system, as well as improved procedures for interpreting and responding to the cabin altitude/configuration warning horn,” the report said. The AD also required that the following message be inserted in the AFM: “For normal operations, the pressurization mode selector should be in ‘AUTO’ prior to takeoff.” ●

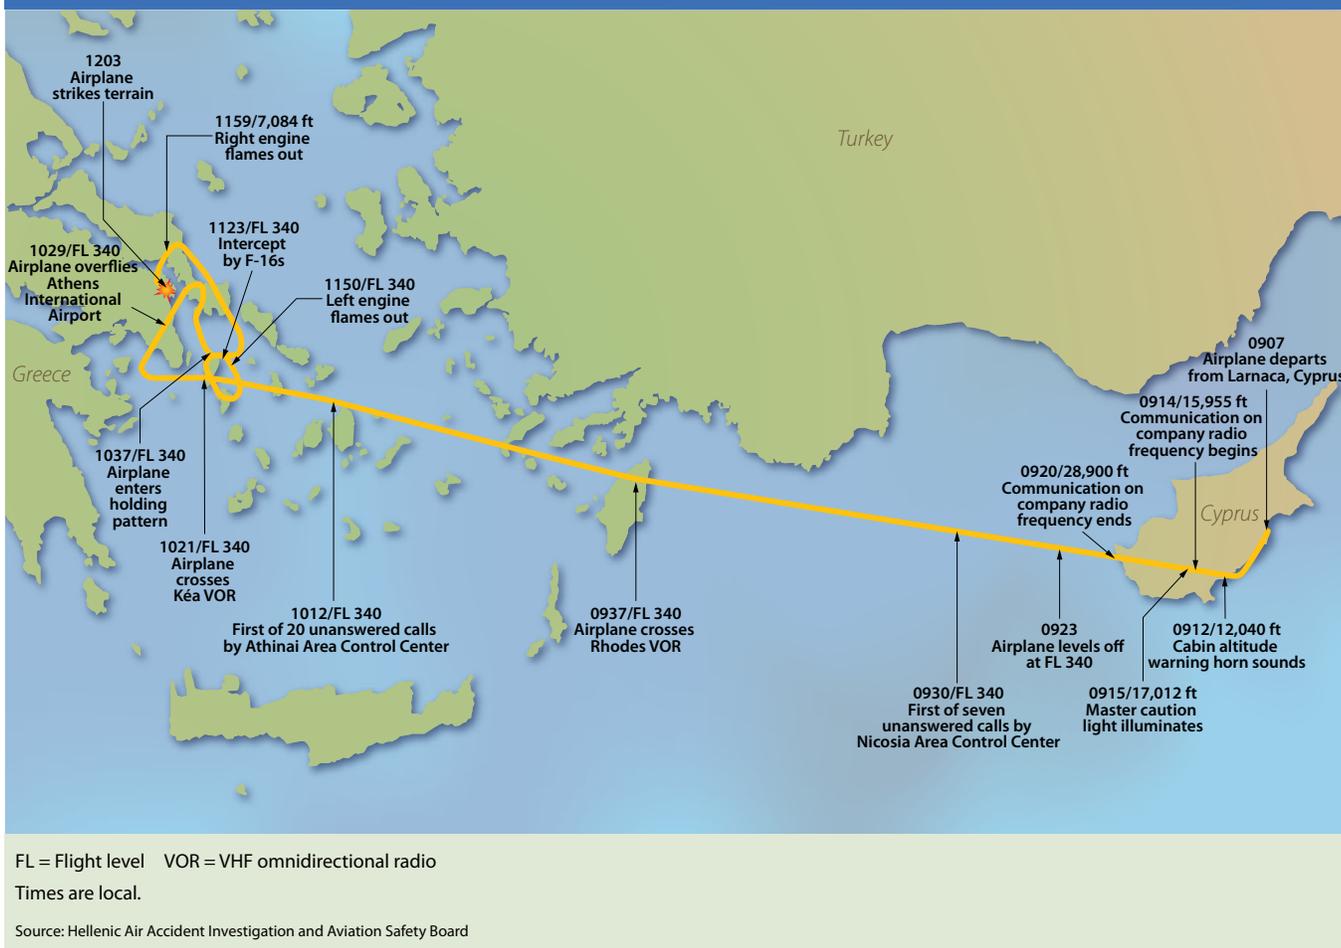
Figure 1

“The aircraft leveled off at FL 340 [about 0923] and continued on its programmed route,” the report said. The aircraft crossed the Kéa VOR about 1021 and “began what appeared to be a standard instrument approach procedure for landing at Athens International Airport, Runway 03L, but remained at FL 340,” the report said. The aircraft flew over the airport about 1029 and turned right, toward the Kéa VOR, in accordance with the missed approach procedure (Figure 1). The aircraft crossed the VOR about 1037 and entered the published holding pattern.
