Accident report questions decisions to launch  
a medevac flight in adverse conditions.

# HIGH RISK, LOW NEED

*This article is based on NTSB accident report no. ANC11TA031 and related docket information.*

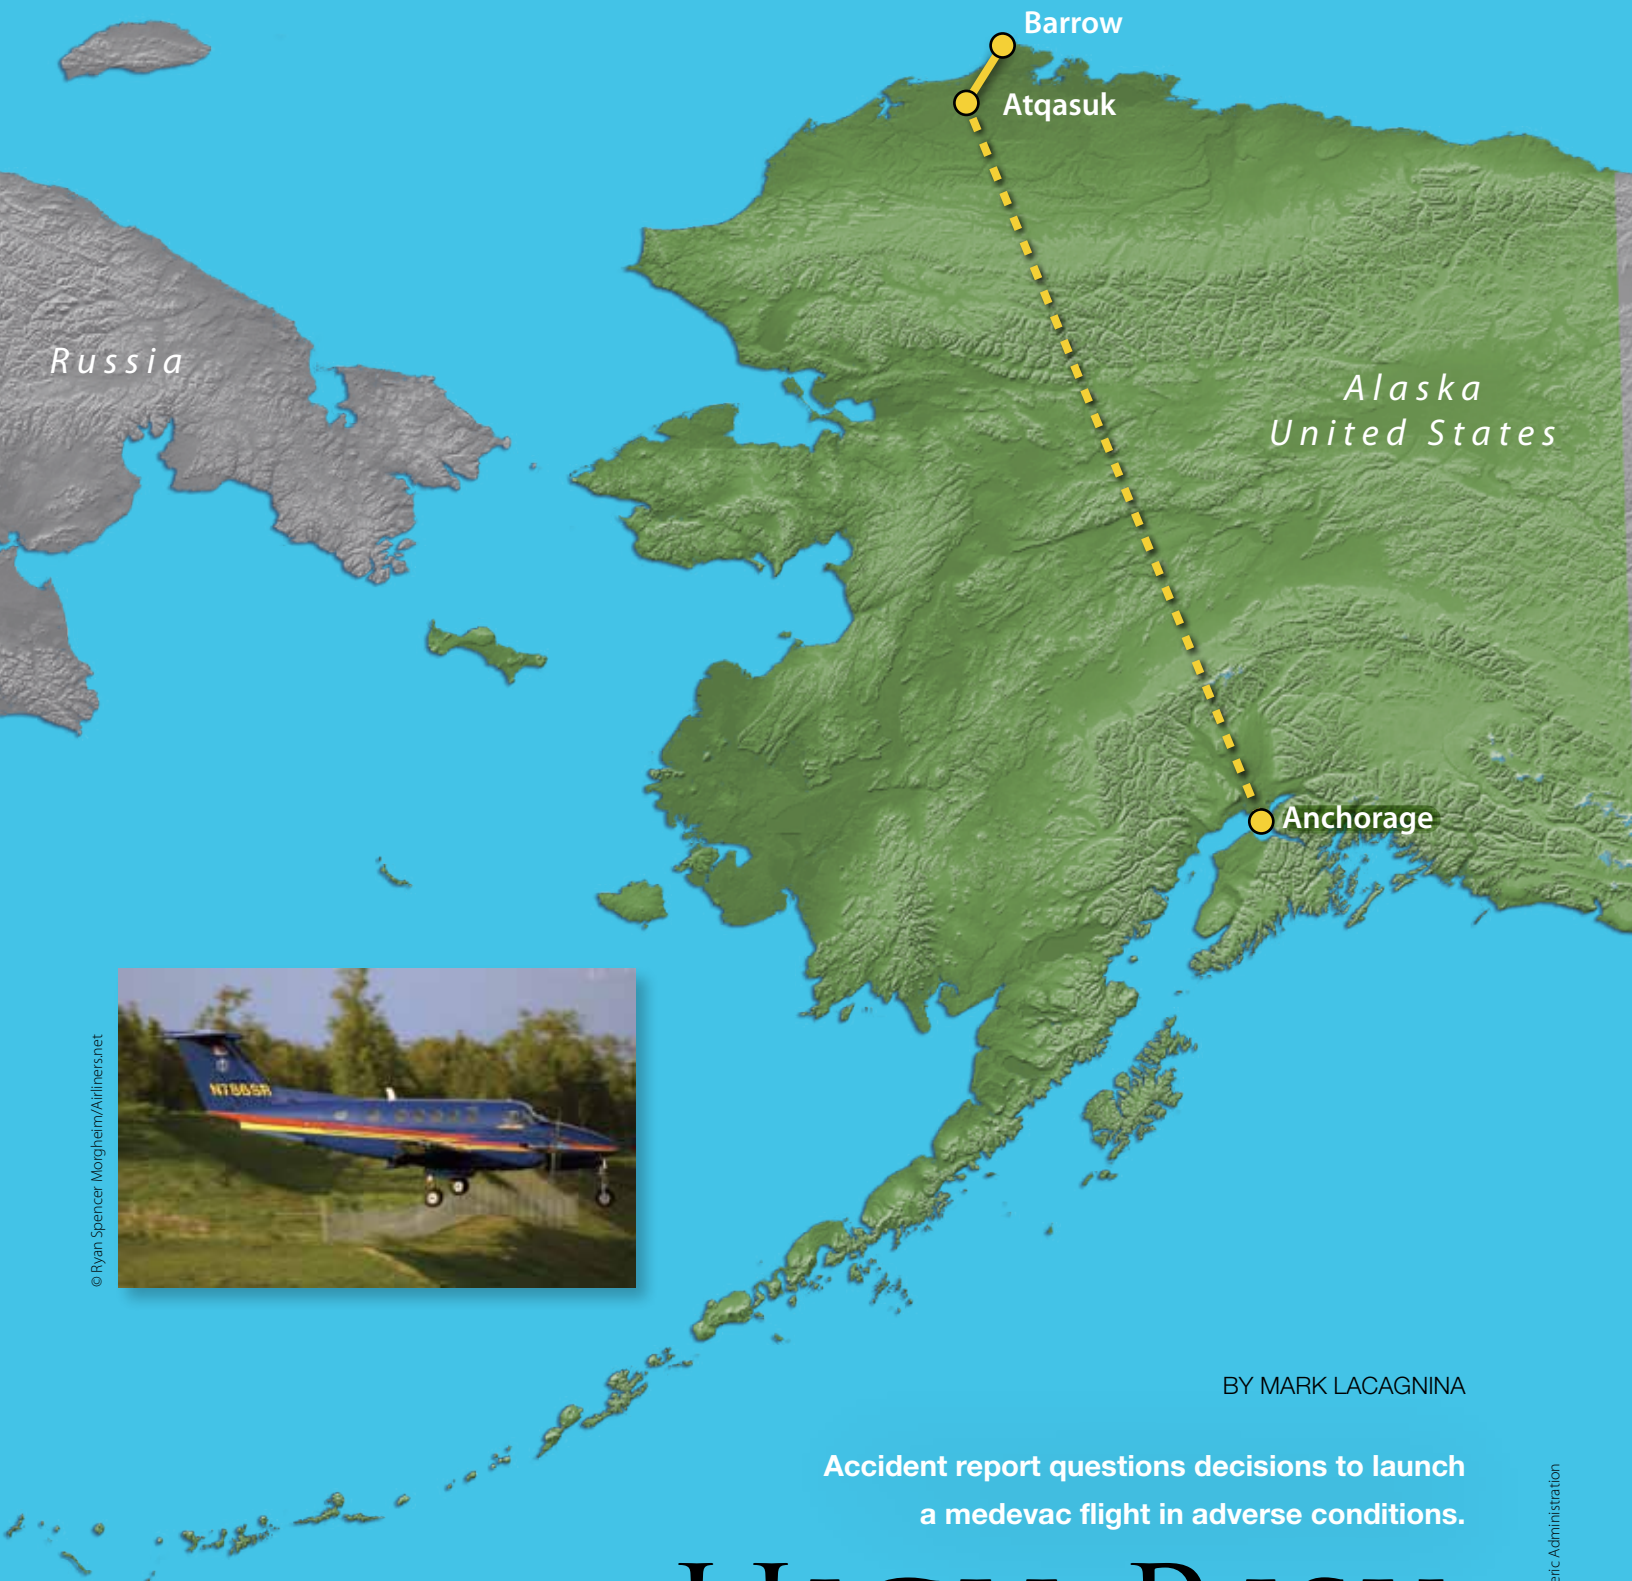
The pilot had been awake more than 14 hours  
when he lost control of this King Air during  
an attempted go-around at Atkasuk.
