# SKIDDING OFF A CLIFF

BY MARK LACAGNINA

Unnecessary engagement of the emergency brakes locked the BAe 146's wheels, reducing deceleration on a damp runway.

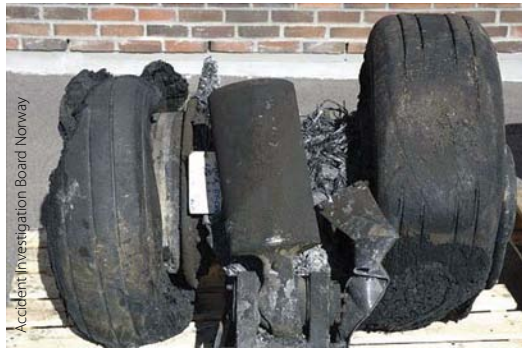
to decrease its surface slickness, and friction between the motionless tires and the pavement heated the thin layer of moisture into steam, melting the rubber in a process called *reverted rubber hydroplaning*. The aircraft skidded sideways off the end of the runway at 15 to 20 kt. The exit speed might have been slow enough to bring the aircraft to a halt *if* the paved safety area between the runway and the precipice had been just 50 m (164 ft) longer — in conformance with new Norwegian standards. The aircraft caught fire when it came to an abrupt stop at the bottom of the cliff. “The fire spread so fast that there was not enough time for everybody to evacuate the aircraft,” the report said.

Left main landing gear tires show damage consistent with reverted rubber hydroplaning.

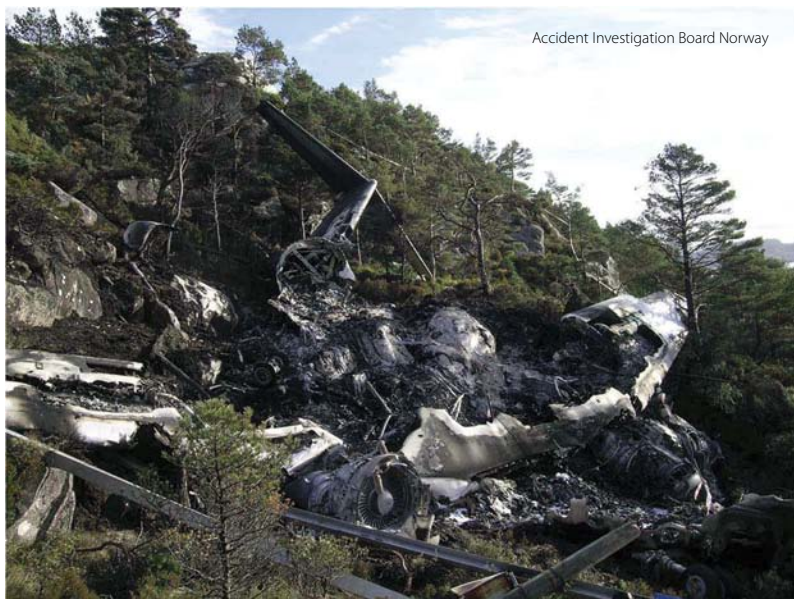
Fire consumed most of the aircraft after it plunged down the rock- and tree-covered slope.

The aircraft had struck approach lights and partially dragged them by their wiring as it plunged nose-first about 100 m (328 ft) down a 30-degree slope inside a bowl-like depression in the cliff leading to the sea. “The slope consisted of uneven rock, partially covered in low vegetation, bushes and small trees,” the report said.

When the aircraft came to a stop, the commander shut off the fuel supply to the engines and activated the engine fire extinguishers. Because of a broken mechanical connection from the fuel shut-off lever to the no. 2 (left inboard) engine, however, the engine continued running at high speed, and its exhaust flow fanned a post-impact, fuel-fed fire that rapidly intensified.
