INSTALLATION ERROR

Inadequate follow-ups failed to identify the maintenance error cited in the crash of an AS350 on an EMS positioning flight, the NTSB says.

An improperly installed part was to blame for the engine failure and subsequent crash of a Eurocopter AS350 B3 during an emergency medical services (EMS) positioning flight in Tucson, Arizona, U.S., on July 28, 2010, the U.S. National Transportation Safety Board (NTSB) says.

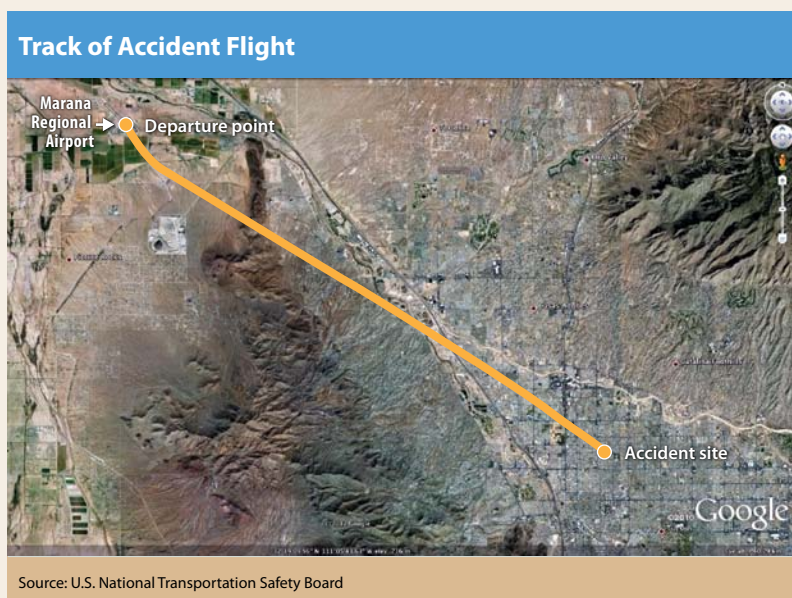
Figure 1

The accident flight originated at 1342 local time at Marana Regional Airport in Tucson, where the helicopter had undergone engine maintenance; the planned destination was the Air Methods base in Douglas, about a 55-minute flight to the southeast (Figure 1).

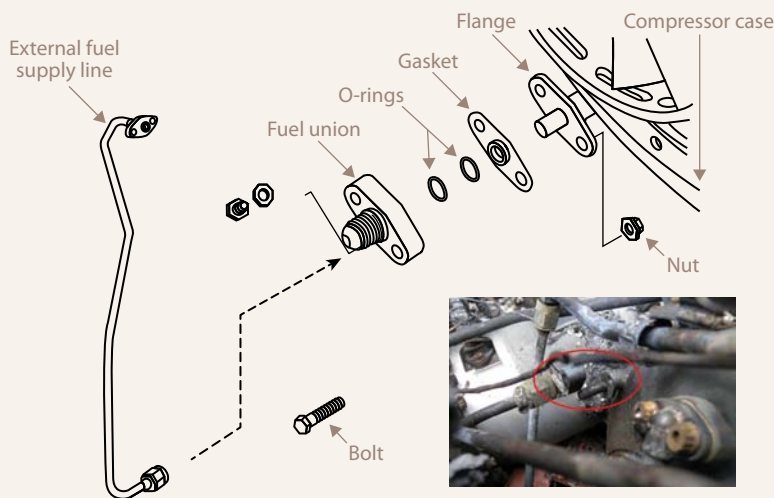
Figure 2

Replacement of the injection manifold is categorized as Level 3 maintenance, and because Air Methods maintenance personnel were authorized for only Level 1 and Level 2 maintenance, the replacement was performed by the HSN technician. The HSN technician then reassembled the engine, including the fuel inlet union (Figure 2).

An examination of the engine at the accident site revealed that the fuel inlet union, on the lower right side of the engine, had separated from the boss on the compressor case but was still attached to the fuel supply line and the hydromechanical unit. During a search of the area, there was no sign of two five-point bolts and self-locking nuts used to mount the union to the compressor case flange, the report said.

The report said it was "likely that the technician did not tighten the bolts and nuts securing the union with a torque wrench and only finger-tightened them."
