Too Late to Go

Faced with an imminent overrun, a Hawker captain attempted a go-around.

Establishing “committed-to-stop” points on landing for turbine airplanes and allowing pilots to use prescription sleep medications to counter insomnia were among the recommendations generated by the investigation of a Hawker 800A accident in Owatonna, Minnesota, U.S., that killed all eight people aboard and destroyed the airplane on July 31, 2008.

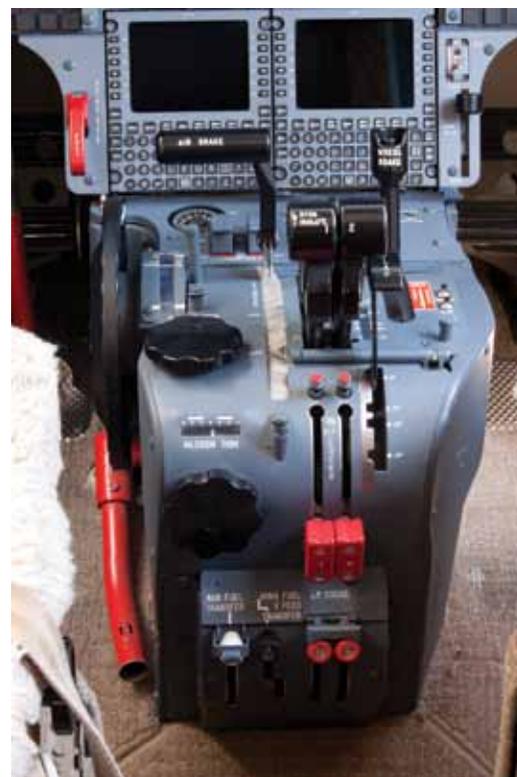
The captain pulled the 'AIR BRAKE' handle all the way back, to engage the lift-dump system, nine seconds after touchdown.

The Hawker's lift-dump system greatly increases aerodynamic drag on landing by extending the airbrake panels and the flaps beyond their normal ranges.
