# A Matter of METERS

**The Falcon 900 did not overrun by much, but the damage was serious.**

BY MARK LACAGNINA

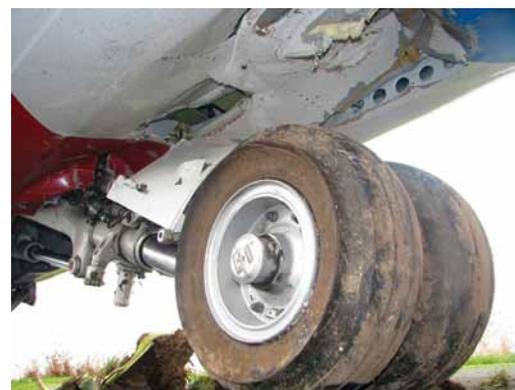
The nose landing gear struck the concrete base of an approach light.

Groundspeed was about 15 kt when the Falcon overran the runway. The nose landing gear collapsed and separated from the airframe after striking the base of the approach light, the farthest to the right among seven lights located 2.4 m (7.9 ft) from the end of the runway. “Both main landing gear were still on the runway, the left gear about 1.5 m [4.9 ft] in front of the runway end,” the report said.
