breaking the ICE jam

Directive targets frozen controls in Citations.

BY MARK LACAGNINA

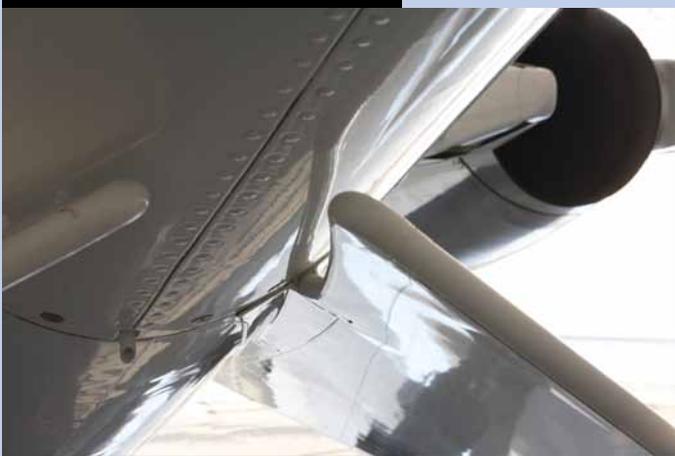
Modifications include seals to reduce the amount of water and air entering the tailcone, and holes to improve drainage.
