# Reining in the UAs

**The NTSB says the requirements for unmanned aircraft should be just as stringent as those for manned aircraft.**

The first investigation by the U.S. National Transportation Safety Board (NTSB) of a crash involving an unmanned aircraft (UA) produced 22 safety recommendations — an action that NTSB Chairman Mark V. Rosenker says illustrates the scope of the safety issues associated with UAs.

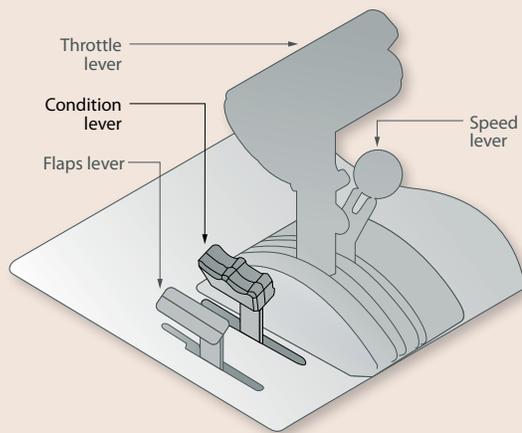
**Figure 1**

opens the fuel valve to the engine; movement to the middle position closes the fuel valve to the engine, which shuts down the engine; and movement to the aft position causes the propeller to feather,” the report said. “When the UA is controlled by PPO-1, the condition lever at the PPO-2 console controls the camera’s iris setting. Moving the lever forward increases the iris opening, moving the lever to the middle position locks the camera’s iris setting, and moving the lever aft decreases the opening. Typically, the lever is set in the middle position” (Figure 1, p. 44).

The pilot told investigators that he did not use a checklist when switching consoles and that, because he had been in a hurry, he had not matched the control positions on the two consoles. When the switch was made, the condition lever on PPO-2 was in the fuel-cutoff position; as a result, the transfer of control to PPO-2 resulted in a cutoff of fuel.

that the PPO-2 condition lever was in the fuel-cutoff position.

The safety recommendations included a call for the CBP to require GA-ASI to modify the UAS “to ensure that inadvertent engine shutdowns do not occur” and to “provide adequate visual and aural indications of safety-critical faults, such as engine-out conditions and console lockups and present them in order of priority, based on the urgency for pilot awareness and response.”
