Misconfigured MD-82 stalled on takeoff.

Lift Deficit

This aircraft struck terrain while departing with the flaps and slats retracted.

BY MARK LACAGNINA

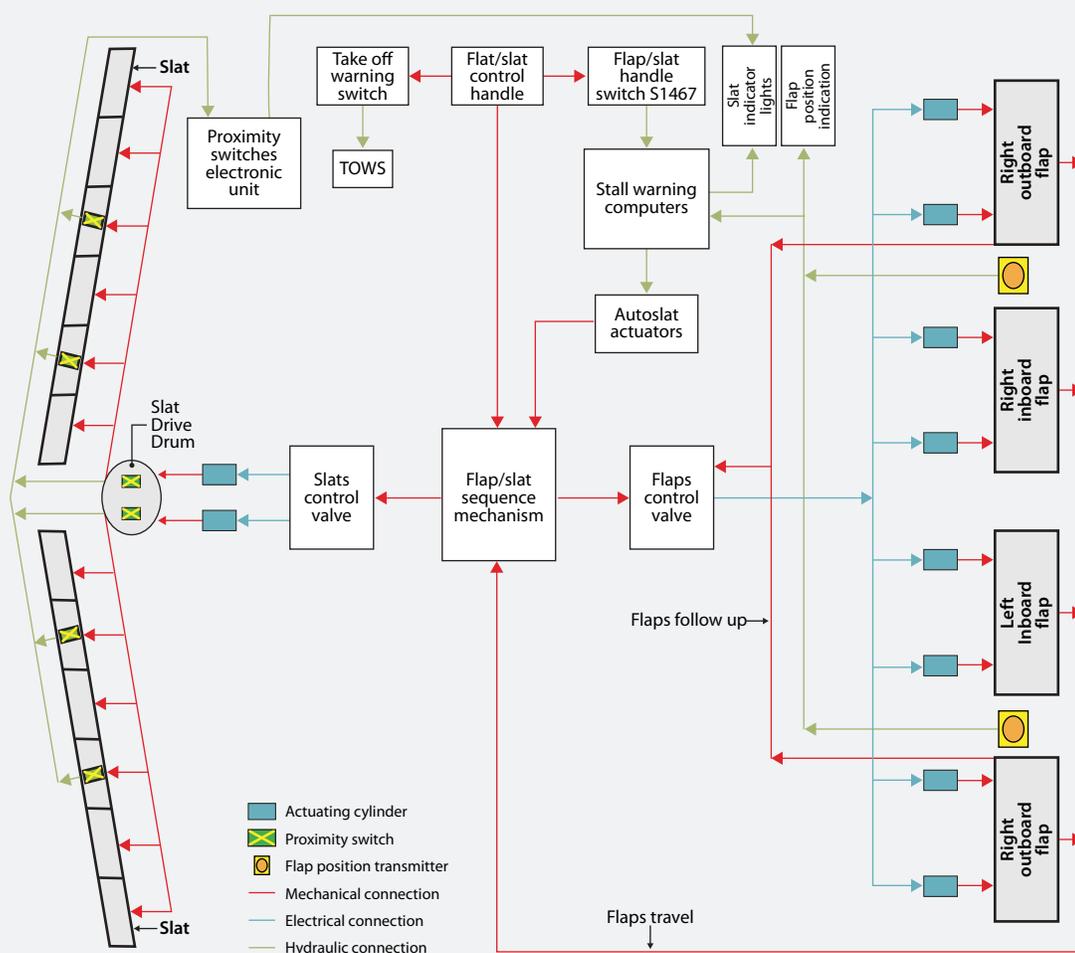
Figure 1

The MD-82 was manufactured in 1993 and had accumulated 31,963 flight hours and 28,133 cycles. The aircraft has two trailing-edge flaps and six leading-edge slats on each wing (Figure 1). “All the sections are mechanically linked so that the extension and retraction movements are synchronized,” the report said. “The flaps and slats are operated jointly on the flight deck with a single flap/slat control lever, situated on the front right of the cockpit’s central pedestal.”

Markings on each side of the control lever slot show various flap positions from 0 degrees, or fully retracted, to 40 degrees, or fully extended. Flap positions from 0 to 24 degrees

are marked for takeoff; positions from 24 to 40 degrees are marked for landing.

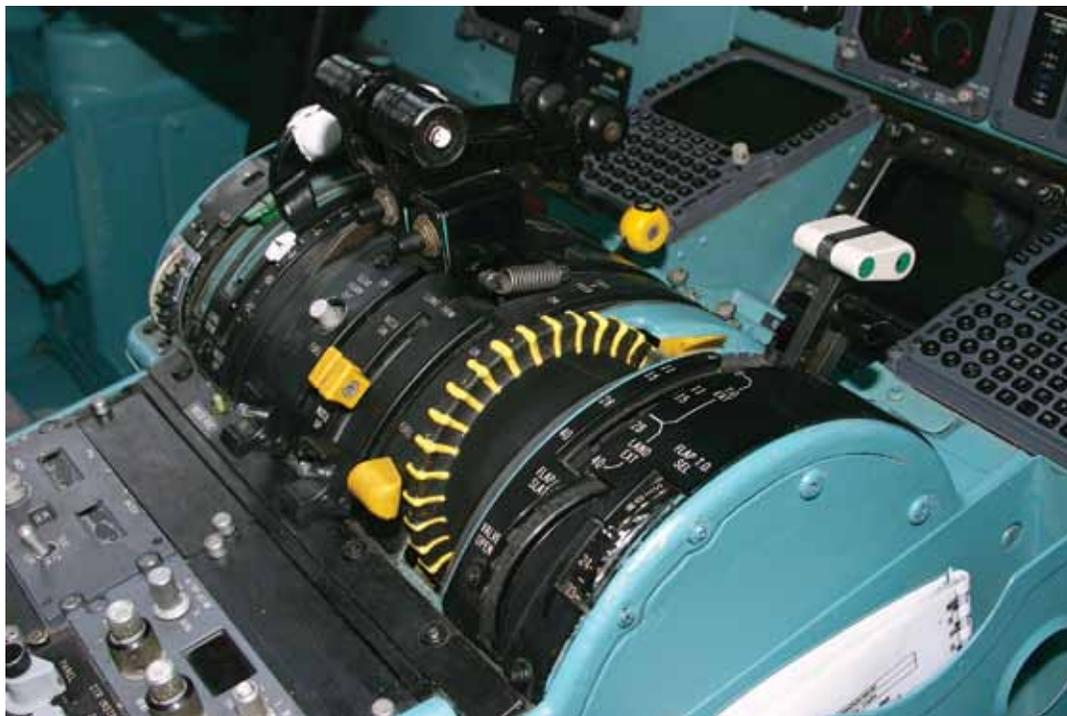
The control lever on the right side of the center pedestal is in the position at which the flaps and slats are fully retracted.
