he pilot's spatial disorientation after an inadvertent entry into dark night instrument meteorological conditions was responsible for the loss of control and in-flight break-up of a Bell 206L-1 LongRanger on an emergency medical services (EMS) positioning flight in Walnut Grove, Arkansas, U.S., the U.S. National Transportation Safety Board (NTSB) says.

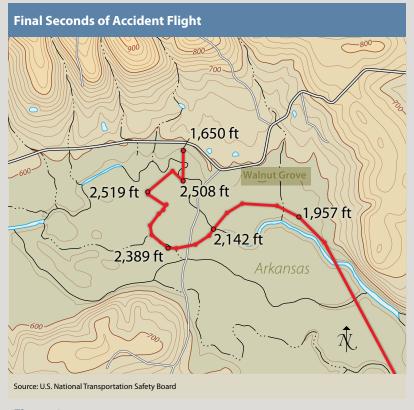
Figure 1

According to radar, global positioning system (GPS) receiver data and a witness, the helicopter had reversed course "multiple times" immediately before the crash, the NTSB said in its final report on the accident. "The flight path ... was consistent with spatial disorientation and subsequent loss of control."

The last flight data recorded by the helicopter's GPS showed that the helicopter was at 1,760 ft. The last minute of data on the GPS also showed that the helicopter had turned to the left and then to the right, followed by "a reversal to the left, a reversal back to the right and then a final reversal to the left," the report said.

The helicopter had reversed course 'multiple times' immediately before the crash,
