# 'CLASH *of* MOTIVES'

The Tu-154 pilot knew that the approach was unsafe but was strongly motivated to land.

BY MARK LACAGNINA

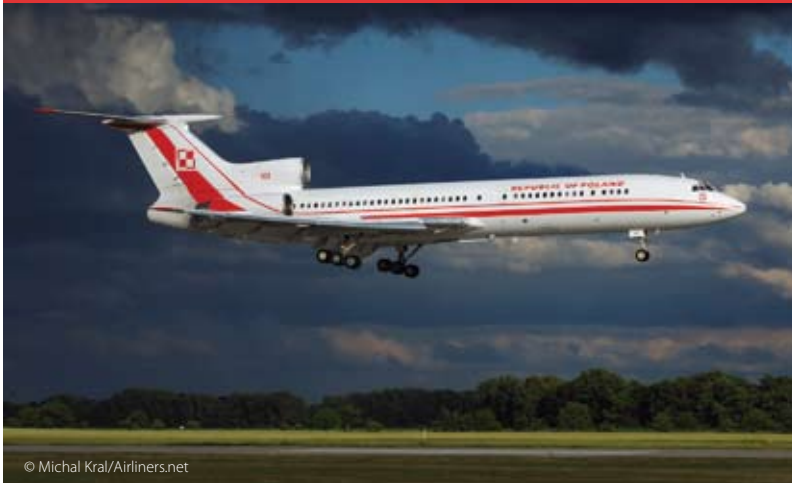
## Tupolev Tu-154M

The accident airplane, shown above, was built in 1990. Nearly 900 Tu-154s were built before the airplane was replaced in 1995 by the Tu-204, which has two engines mounted under the wings.

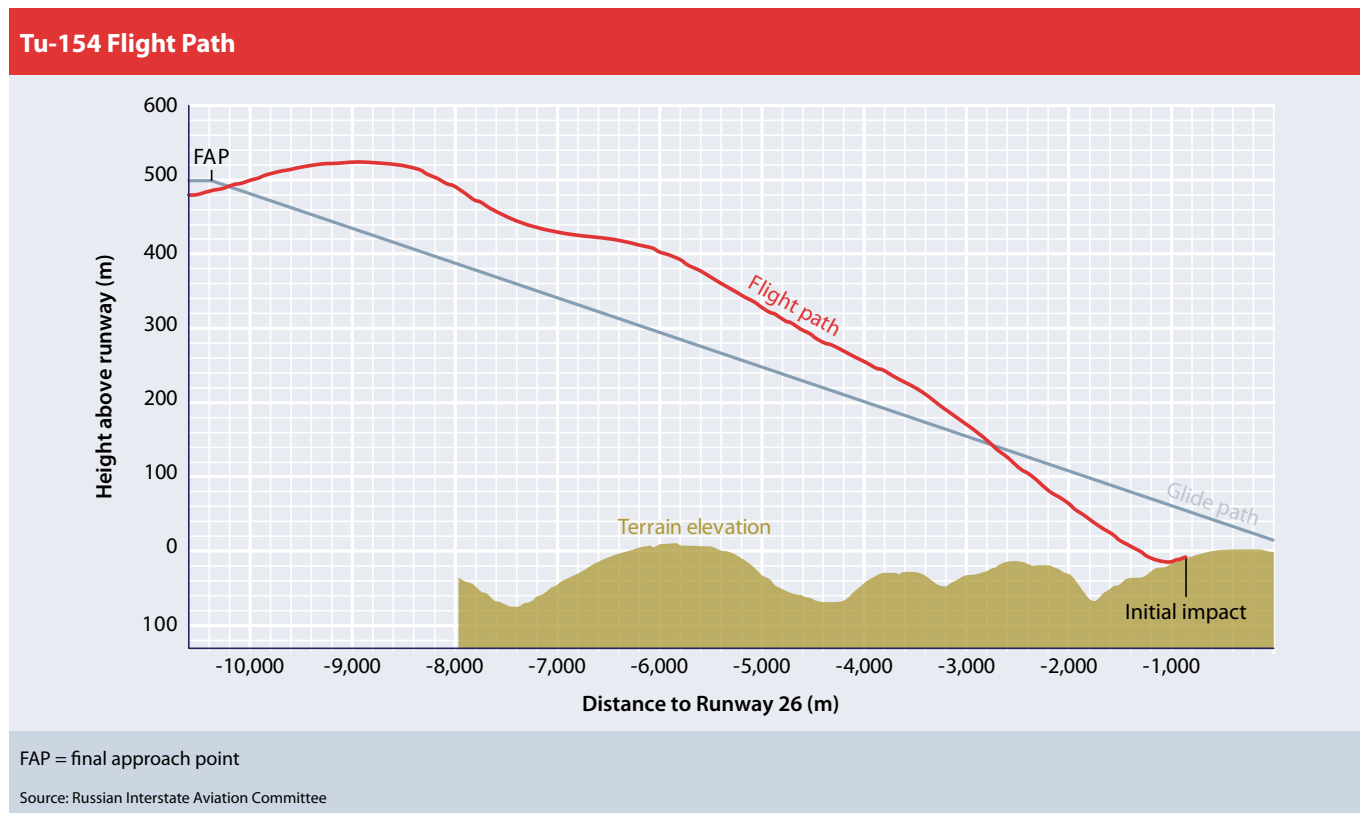
**Figure 1**

The report said that the crew demonstrated "passive behavior" during the approach. They did not conduct a full briefing or establish reference speeds. The Tu-154 crossed the outer marker at 420 m (1,378 ft), or 120 m (394 ft) higher than the published crossing altitude, and at 300 kph (162 kt), or about 35 kph (19 kt) higher than the appropriate airspeed.

The crew increased the descent rate to 8 m/sec (26 ft/sec) in an attempt to establish the aircraft on the proper glide path. This descent rate, which resulted in a glide path of 5 degrees, was maintained almost until impact.

The initial impact occurred near the middle marker. The aircraft was about 11 m (36 ft) above ground level and slightly left of the extended runway centerline when it struck the top of a tree about 1,100 m (3,609 ft) from — and 15 m (49 ft) below — the runway threshold.

The report said that analysis of recorded flight data and examination of the accident site indicated that the PIC attempted to initiate a go-around by pulling the control column all the way back. Angle-of-attack was near the stall value, and the aircraft was climbing when it clipped several more trees on rising terrain. The left wing then struck a large birch tree and separated from the fuselage. The aircraft rolled inverted and crashed in a swampy area.
