The NTSB cites misstatement of empty weight as a cause of a fatal S-61N crash; the operator disagrees.

Weighty Issues

This article is based on NTSB Accident Report NTSB/AAR-10/06, Crash During Takeoff of Carson Helicopters Inc.

Firefighting Helicopter Under Contract to the U.S. Forest Service; Sikorsky S-61N, N612AZ; Near Weaverville, California; August 5, 2008.

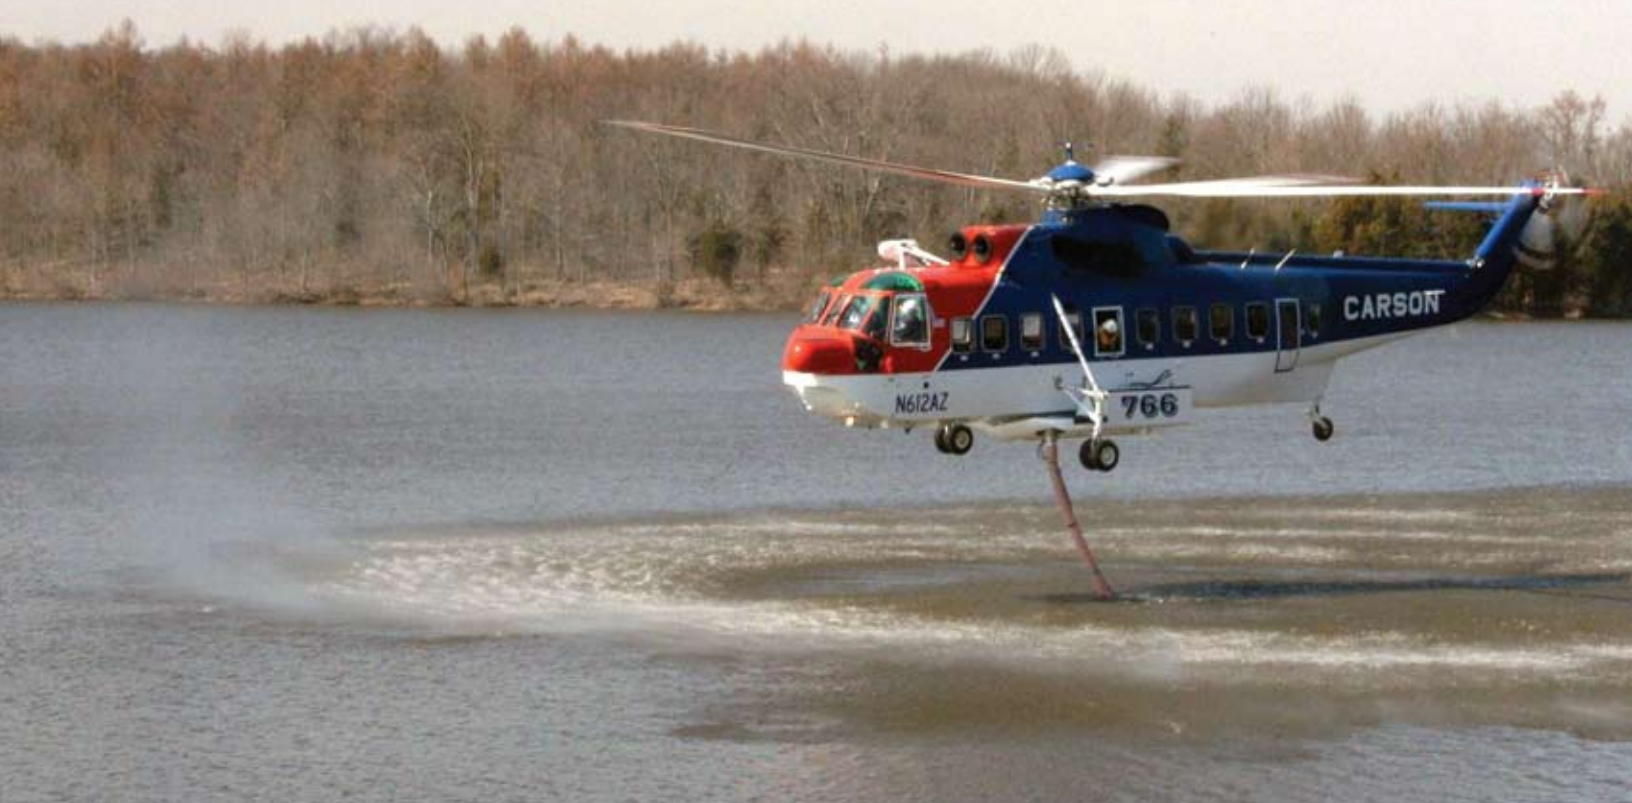
Witnesses said the helicopter's movement was “labored” as it lifted off and climbed about 20 ft before crashing into the ground.
