Dangerous Approaches

Straying outside the protected areas can be fatal.

BY DICK MCKINNEY AND ERIK REED MOHN

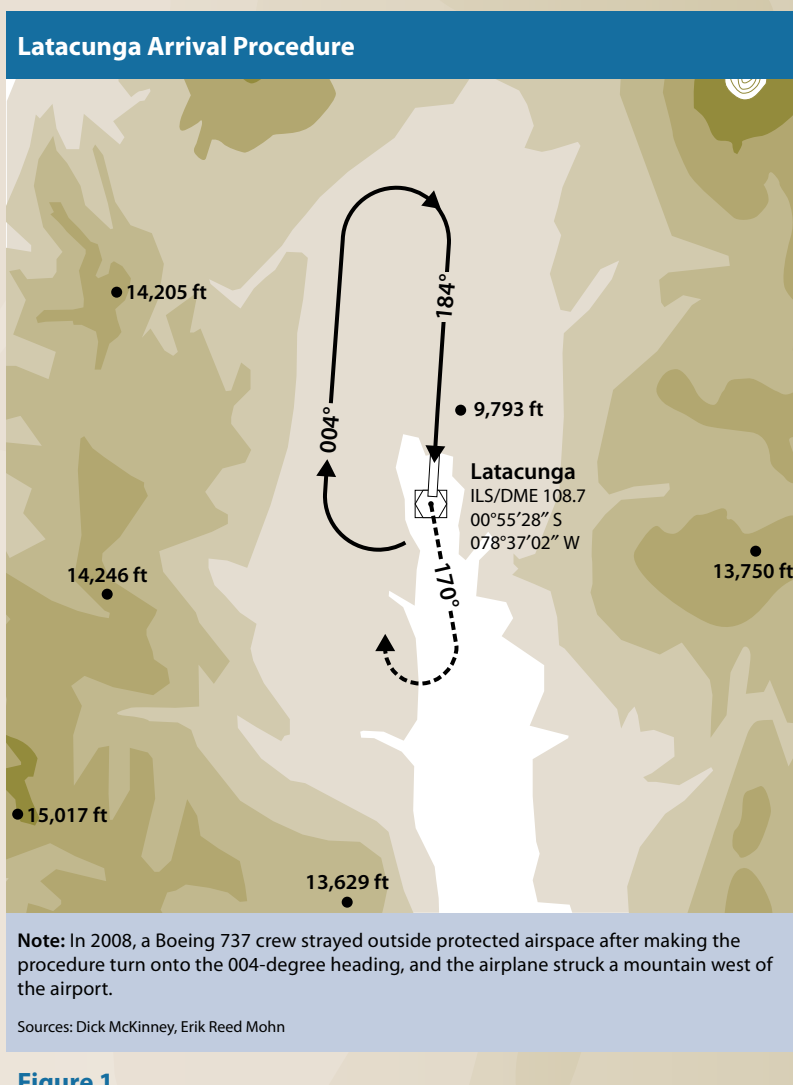
Figure 1

night of Aug. 30, 2008. The crew expected, and briefed for, a published arrival procedure that leads almost straight in to the instrument landing system (ILS) approach to Runway 18. However, when they contacted Latacunga Tower, they were told to fly a different arrival procedure, which requires crossing the Latacunga VOR/DME (VHF omnidirectional radio/distance measuring equipment) station south of Runway 18 and turning to a heading of 004 degrees. This basically places the aircraft on a right downwind leg for Runway 18 (Figure 1).

The aircraft must track 004 degrees until reaching the ILS turn-in point, which is defined as 9 nm DME on the 340-degree radial of the VOR. For an aircraft with conventional navigation equipment, such as a 737-200, navigating to the turn-in point requires some dead reckoning skills. The area west of the airport is protected from obstacles only up to 4 nm from the runway centerline; beyond that lies high, rugged terrain.

Cockpit voice recorder (CVR) data indicated that as the 737 neared the VOR, the crew was “behind the aircraft” and attempting to navigate via both instrument and visual references. The arrival chart specifies a maximum speed of 200 kt, but recorded flight data indicated that the 737’s calibrated airspeed was 210 kt as it crossed the VOR and began a shallow right turn to the north. Airspeed increased to 225 kt during the turn. The high speed, wind drift and 22-degree bank angle caused the aircraft to roll out on downwind 7 nm west of the runway centerline, outside the protected area. Shortly thereafter, Quito Radar lost radar contact with the aircraft.

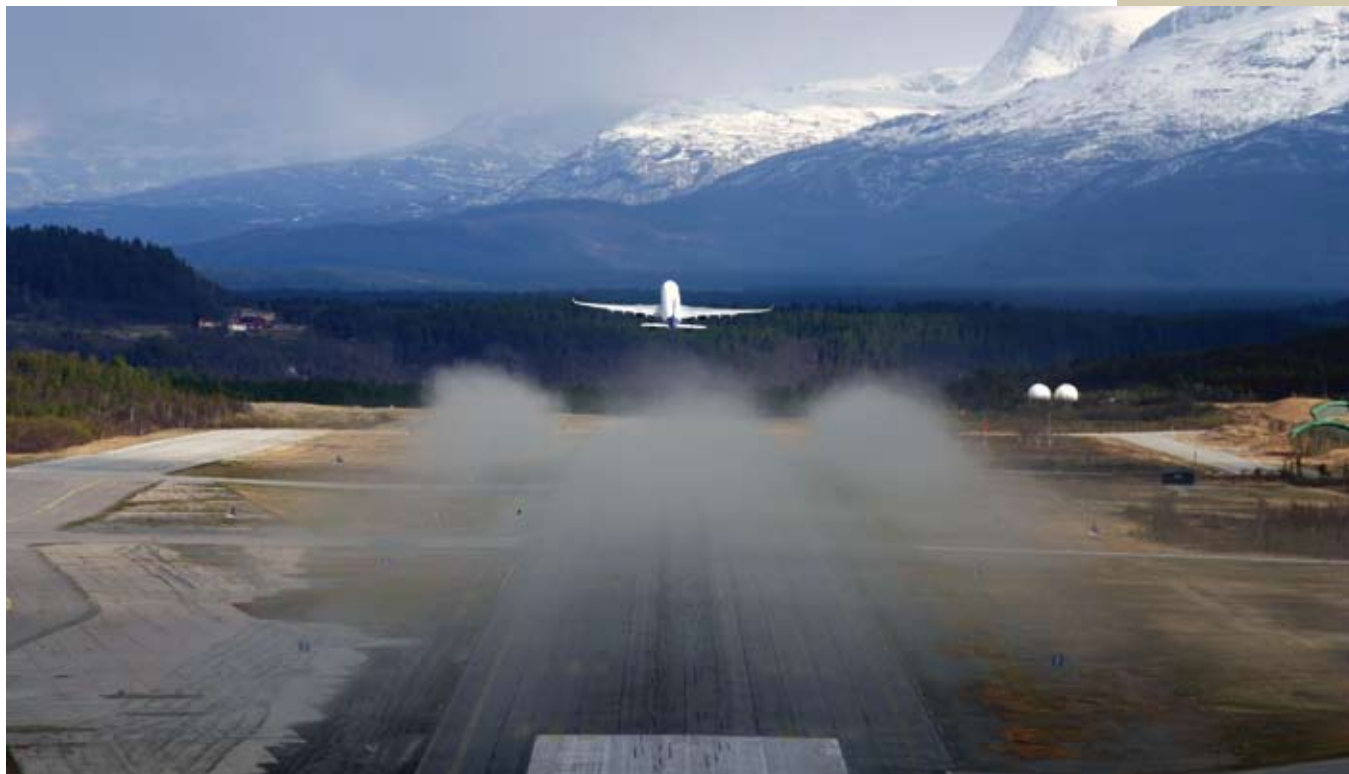
A similar accident at Bardufoss Airport in northern Norway the night of Nov. 14, 1989, killed the pilots and the two passengers when their Cessna Citation 551 struck a mountain outside a protected area for a procedure turn onto the ILS approach to Runway 29. The accident investigation board concluded that the aircraft “was on the wrong track, and the speed was 100 kt too high” when the accident occurred.

Terrain rises precipitously near the airport in Bardufoss, Norway, where an approach accident occurred in 1989.

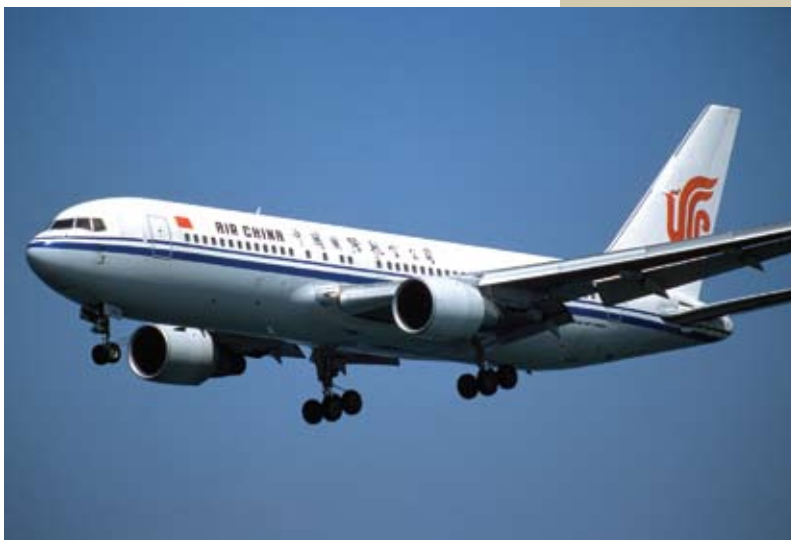
The approach was a TERPS-based procedure that required a Category C aircraft to remain within 1.7 nm of the runway threshold. The accident report said that the crew descended too low, too soon, lost sight of the runway and hit a 670-ft hill approximately 2.5 nm (4.6 km) north

This 767 struck a hill in South Korea in 2002 when the crew descended too low during a circling approach
