# Absence of Reasonableness

**A 100-tonne takeoff weight error eluded several checks.**

*This article is based on ATSB Transport Safety Report AO-2009-012, “Tailstrike and Runway Overrun; Melbourne Airport, Victoria; 20 March 2009; A6-ERG, Airbus A340-541,” Dec. 16, 2011. The report is available at <atsb.gov.au>.*

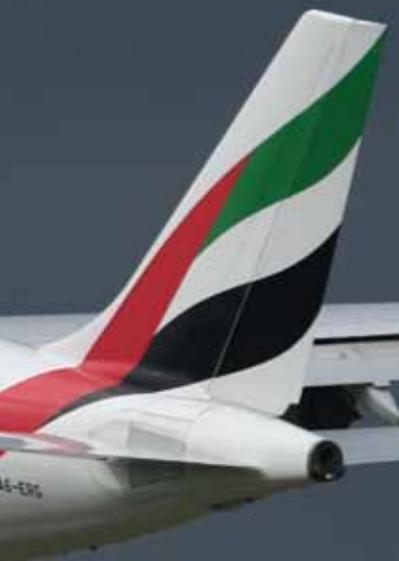
**This A340 was substantially damaged in a tail strike and overrun at Melbourne Airport.**

The A340 was landed on Runway 34 at 2336 and, after a brief inspection by aircraft rescue and fire fighting personnel, was taxied to the terminal, where the passengers disembarked normally. Examination of the aircraft revealed severe abrasion of skin panels on the bottom of the rear fuselage, deformation of fuselage frames and stringers in the area, and a cracked rear pressure bulkhead.

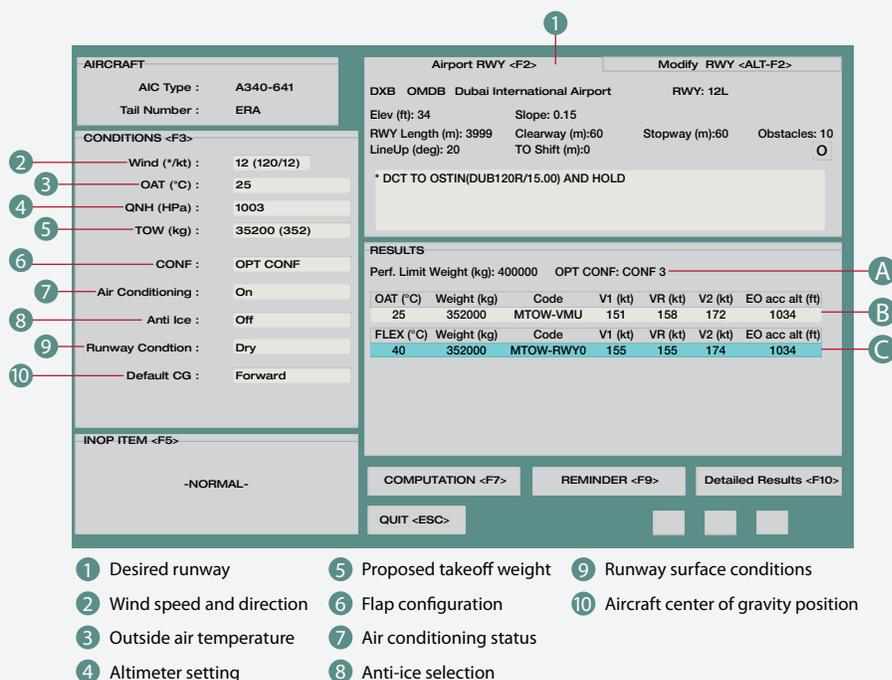
**Figure 1**

parameters (takeoff reference speeds and flap and engine settings) for the takeoff from Runway 16,” the report said. Among the data required to be entered into the EFB were wind speed and direction, outside air temperature and takeoff weight (Figure 1, p. 14).

“When entering the takeoff weight into the EFB, however, the first officer inadvertently entered 262.9 tonnes, instead of the intended 362.9 tonnes, and did not notice that error,” the report said. In human factors terminology, the data-entry error was a *slip*. “Most likely, the first officer made a typing slip, where the ‘2’ key was accidentally pressed instead of the adjacent ‘3’ key,” the report said.
