Fractured Gear

A metallic particle was the only sign of the impending fatal failure of the AS332's main rotor gearbox.

The U.K. Air Accidents Investigation Branch (AAIB), in its final report, said the crash followed the catastrophic failure of the main rotor gearbox,

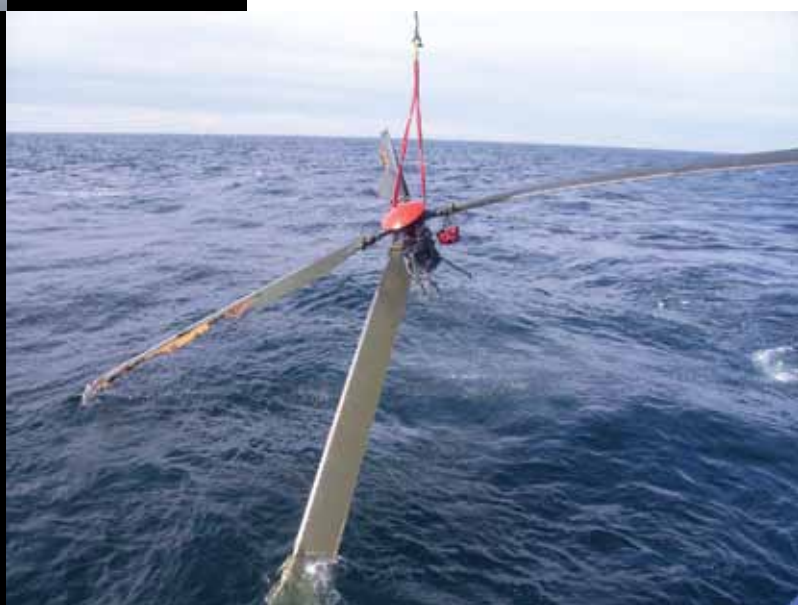
The main rotor blades separated from the helicopter before impact and were pulled from the North Sea during the recovery effort.

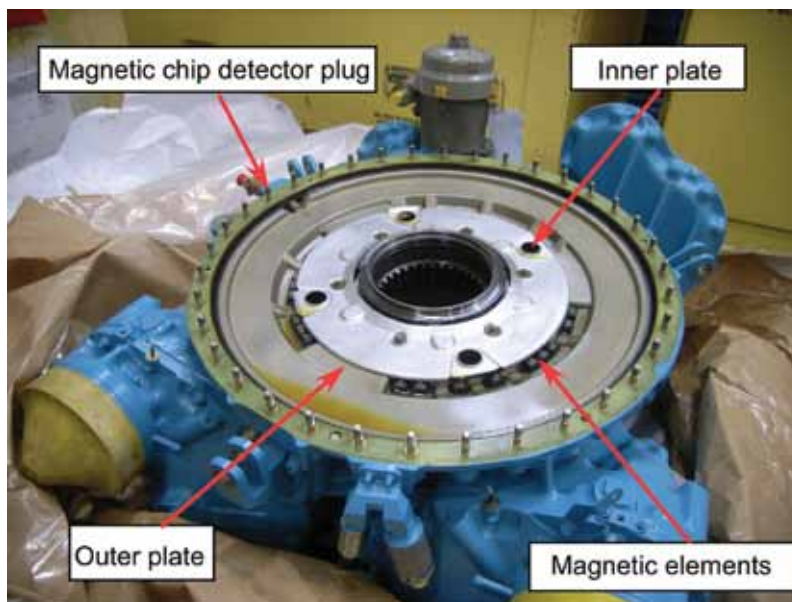
Photographs from the accident report show the main module of an AS332 L2’s main rotor gearbox, with the epicyclic module removed, above, and the epicyclic module ring gear from the accident helicopter, soon after it was recovered from the sea, below.

The report also noted that the introduction of a ring of magnets on the main rotor gearbox in AS332 L2s and EC225s “reduced the possibility of [detecting] metallic debris, generated in the epicyclic module, by the main module magnetic chip detector or by inspection of the oil filter.”

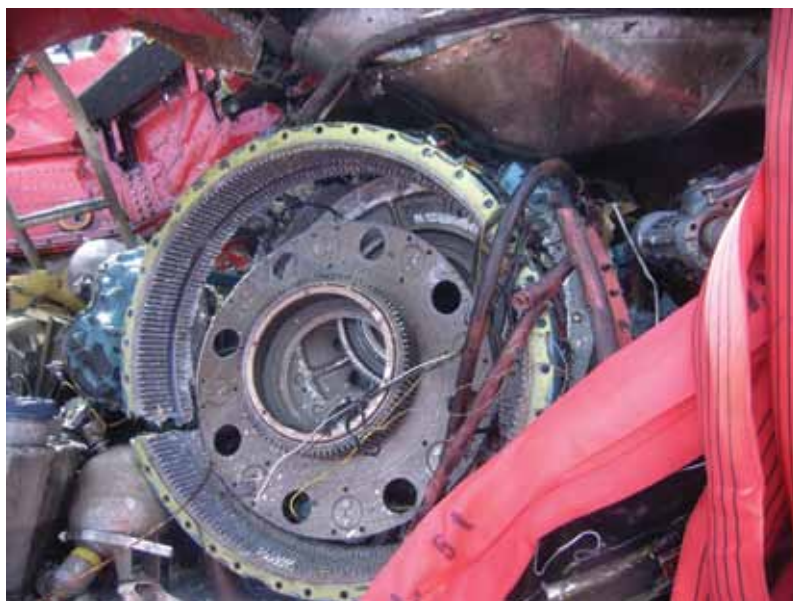
The accident investigation focused on the failure of the gearbox epicyclic module. Investigators found considerable damage throughout the epicyclic module, “consistent with it operating for a period of time whilst contaminated with debris,” the report said.

Examination of the metallic particle that had been removed on March 25 from the epicyclic module magnetic chip detector confirmed that it had come from the surface of the outer race of a second stage planet gear bearing, the report said. The same area was the point of origination for a fatigue crack, which grew until the gear failed and broke into several sections. The section where the crack originated was not recovered from the sea.
