During more than a dozen hard landings and rollovers of Boeing McDonnell Douglas MD-11s in the past two decades, the U.S. National Transportation Safety Board (NTSB) is pressing for changes in training to help pilots better handle the airplane during landing.

‘Shocking’ Touchdowns

BY LINDA WERFELMAN

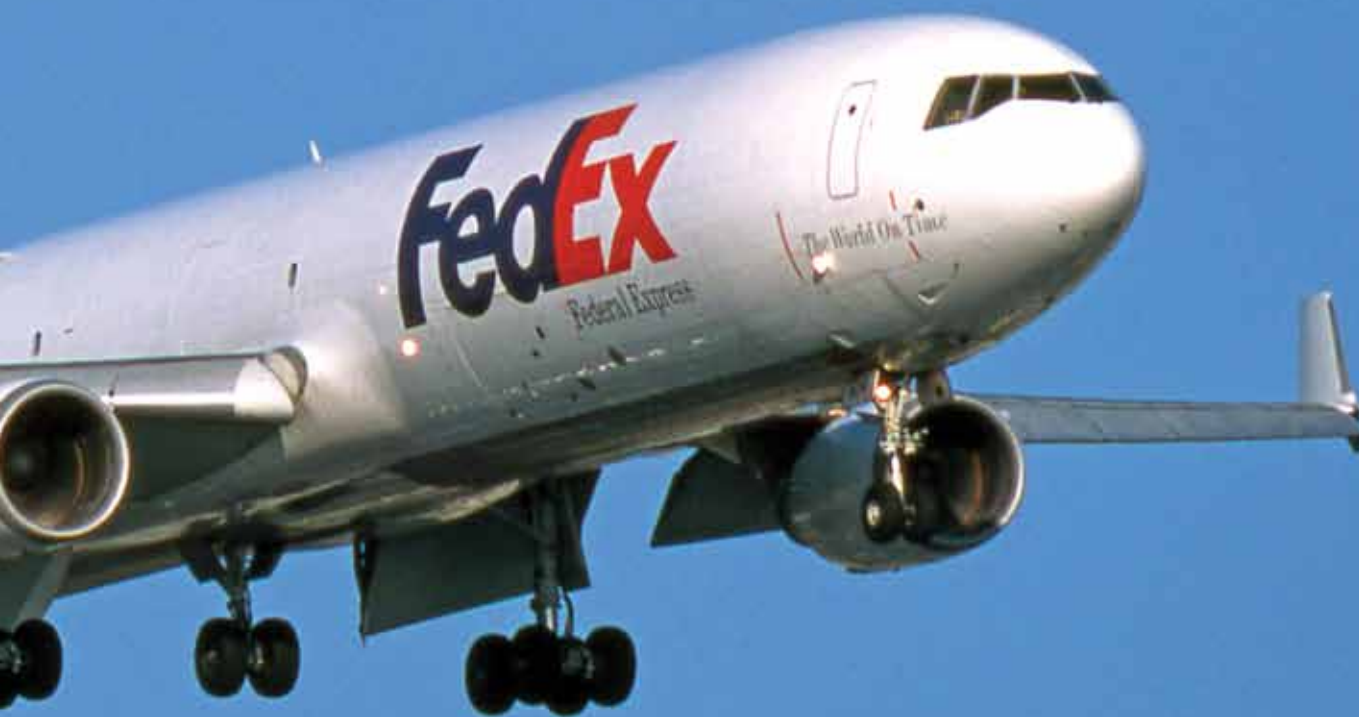
The NTSB says pilots need better training to avoid unexpected bounced landings in MD-11s.

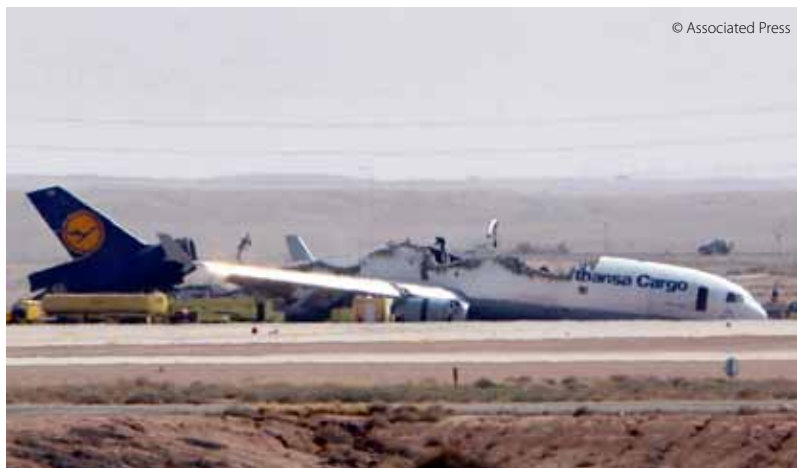
The investigation is continuing into the crash of this Lufthansa Cargo MD-11F in July 2010 in Riyadh, Saudi Arabia. The fuselage broke apart after a bounced landing.
