# 500 Meters to Spare

**Dutch report on a high-speed rejected takeoff explores the ‘RTO dilemma.’**

BY MARK LACAGNINA

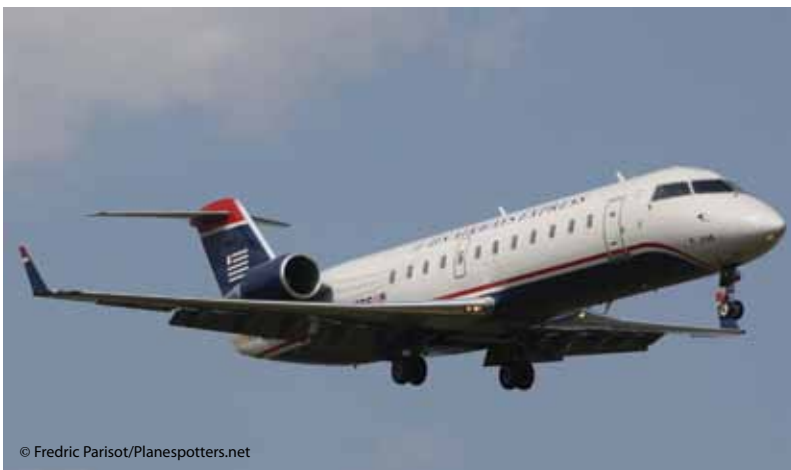
Only an engineered material arresting system kept this CRJ200 from plunging down a steep cliff during a high-speed RTO at Charleston, West Virginia, U.S., in January 2010.

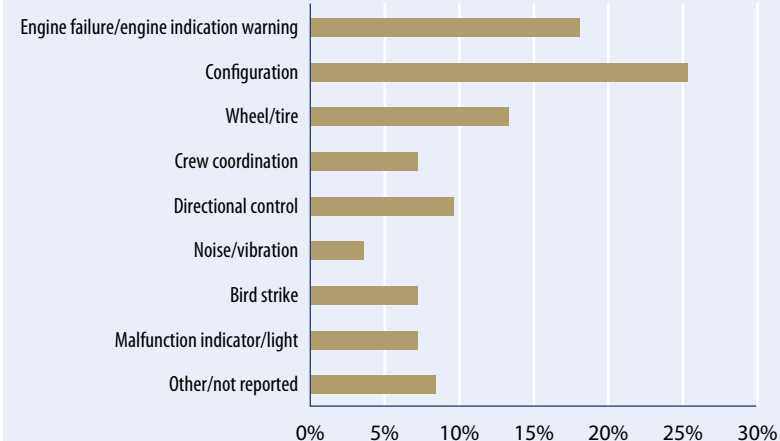
**Figure 1**

Configuration issues — including incorrect flap and flight control settings, and weight and balance problems — topped engine failures as prompting 26 percent of the high-speed RTOs during the period (Figure 1).

Among the other reasons for initiating a high-speed RTO were problems with wheels or tires (13 percent); directional control (9 percent); crew coordination, bird strikes and

### Causes of High-Speed RTOs, 1994–2008

malfunction indications (7 percent each); and noises or vibrations (3 percent).
