Procedural Disregard

Failure to comply with recommended arrival and communication procedures played a big part in the fatal midair collision of two EMS helicopters, the NTSB says.

BY LINDA WERFELMAN

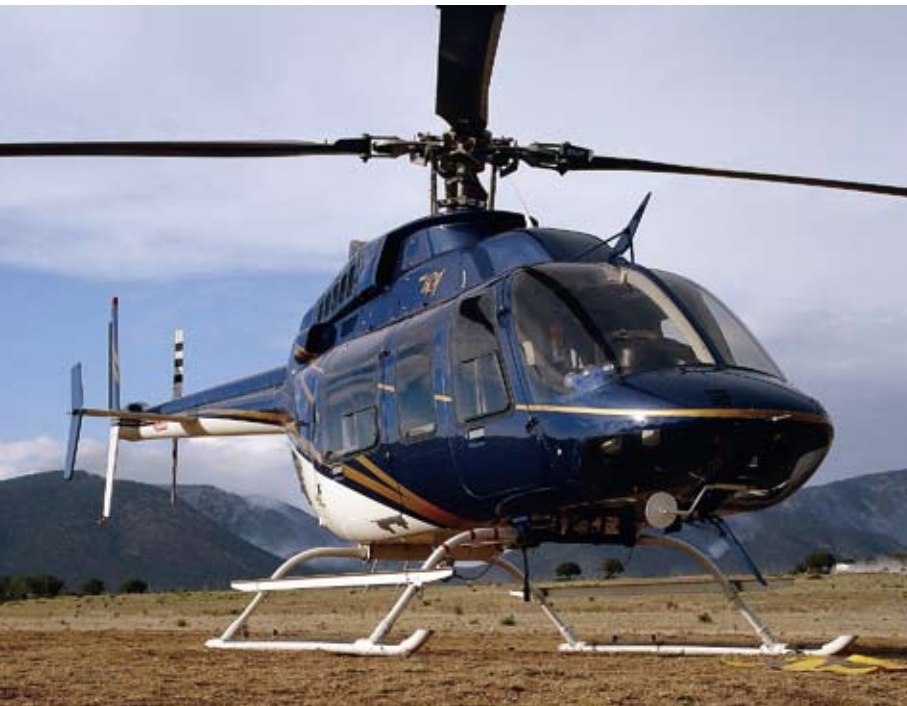
At the time of the crash, Classic Helicopter Service operated three aircraft, including this Bell 407.

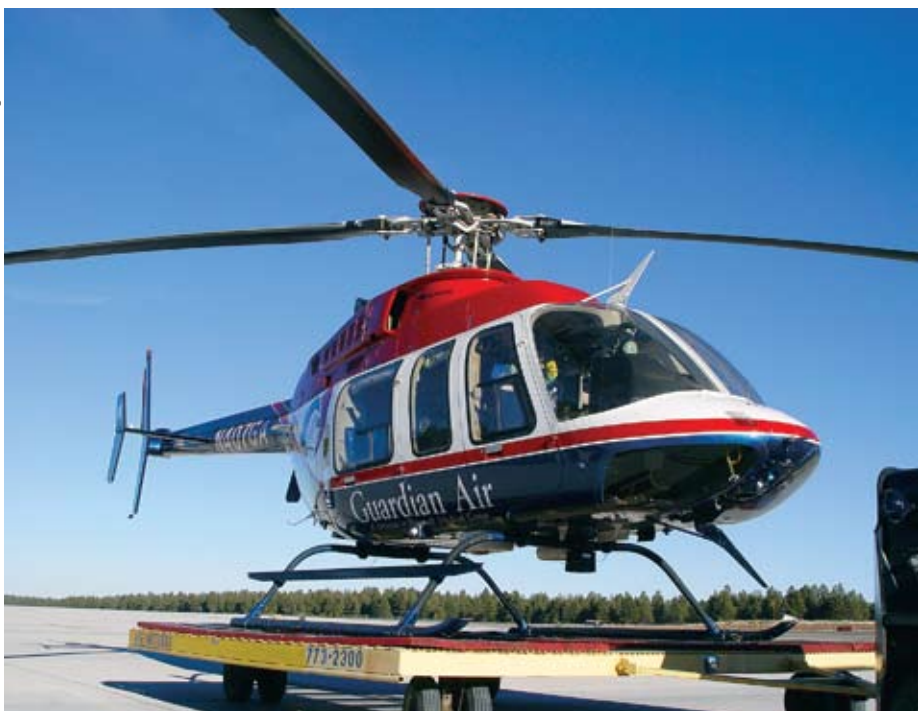
The pilot of Air Method's Angel 1 stopped at nearby Flagstaff Pulliam Airport before continuing to the hospital helipad.
